County of Harnett  
Building Inspections Department  
Planning Services

**Certificate of Compliance: \_\_\_\_\_ Occupancy:**

ADDRESS : 386 CAROLINA OAKS CIR SUBDIV: CAROLINA OAKS 64 LOTS  
 CONTRACTOR : BILL CLARK HOMES LLC PHONE : (252) 355-5805  
 OWNER : BILL CLARK HOMES LLC PHONE :  
 PARCEL : 01-0544- - -0012- -25-  
 APPL NUMBER: 11-50026550 CP NEW RESIDENTIAL (SFD)  
 DIRECTIONS : T/S: 04/29/2011 10:09 AM JBROCK ----  
 TAKE 401 S OUT OF LILLINGTON TO ELLIOTT  
 BRIDGE RD GO RIGHT ON ELLIOTT BRIDGE RD  
 TO WILL LUCAS RD GO RIGHT TO S/D ON  
 RIGHT CAROLINA OAKS LOT AROUND BACK  
 CORNER LOT 25

(REPAIR / 29111 - FT13)

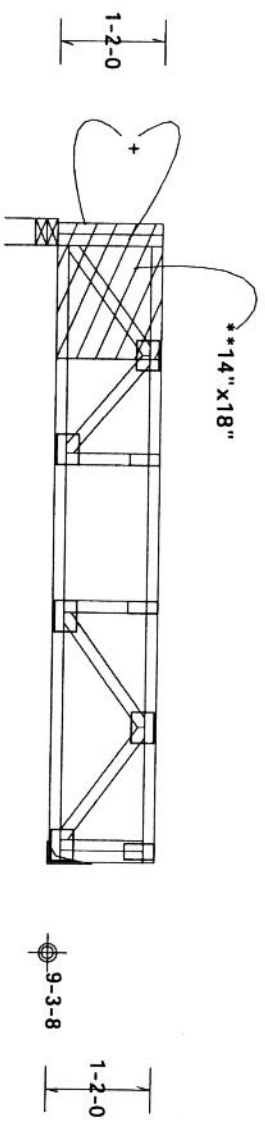
This truss is repaired to remove 3.5" from the left end and then add 3" back to the left end as shown. Refer to drawing R8976 11202026 for plates and other data not given here.

++ CAREFULLY REMOVE UNWANTED PORTION OF TRUSS SHOWN. REMAINING PORTIONS OF TRUSS AND ALPINE PLATES MUST REMAIN FULLY EMBEDDED & FREE FROM DAMAGE.

+ FIELD APPLIED 4X2 SP #2 (OR BETTER) MEMBERS, CUT TO FIT TIGHT IN PLANE OF THE TRUSS. NOTE 2 NEW MEMBERS ADDED.  
 \*\* (2) NEW 1/2"X(SIZE SHOWN) TRIMMED TO FIT APA RATED 32/16 SHEATHING (PLYWOOD OR OSB) ATTACH ONE GUSSET TO EACH FACE OF THE TRUSS WITH 1 ROWS OF 0.128"X3.0" NAILS SPACED 3" OC., THROUGHOUT ALL MEMBERS WITHOUT SPLITTING THE LUMBER.
