ADDRESS : 195 HIGH MEADOW DR SUBDIV: NEILLS CREEK FARMS PHASE 1
 CONTRACTOR : LAWRENCE HOMES, INC. PHONE : (919) 528-7767
 OWNER : OWENS GERALD & LEIGH PHONE :
 PARCEL : 04-0663- - -0061- - -
 APPL NUMBER: 13-50032550 CP NEW RESIDENTIAL (SFD)
 DIRECTIONS : T/S: 02/20/2014 08:26 AM VBROWN ----
 HIGH MEADOW DRIVE ANGIER 27501. NEILLS
 CREEK FARMS #20 AT END OF CUL DE SAC.

Subject: Structural Framing Evaluation
Location: 195 High Meadow Drive (Angier, NC)
Project No: RSF140316
Inspection Date: 5/21/2014

Truss
F07-R

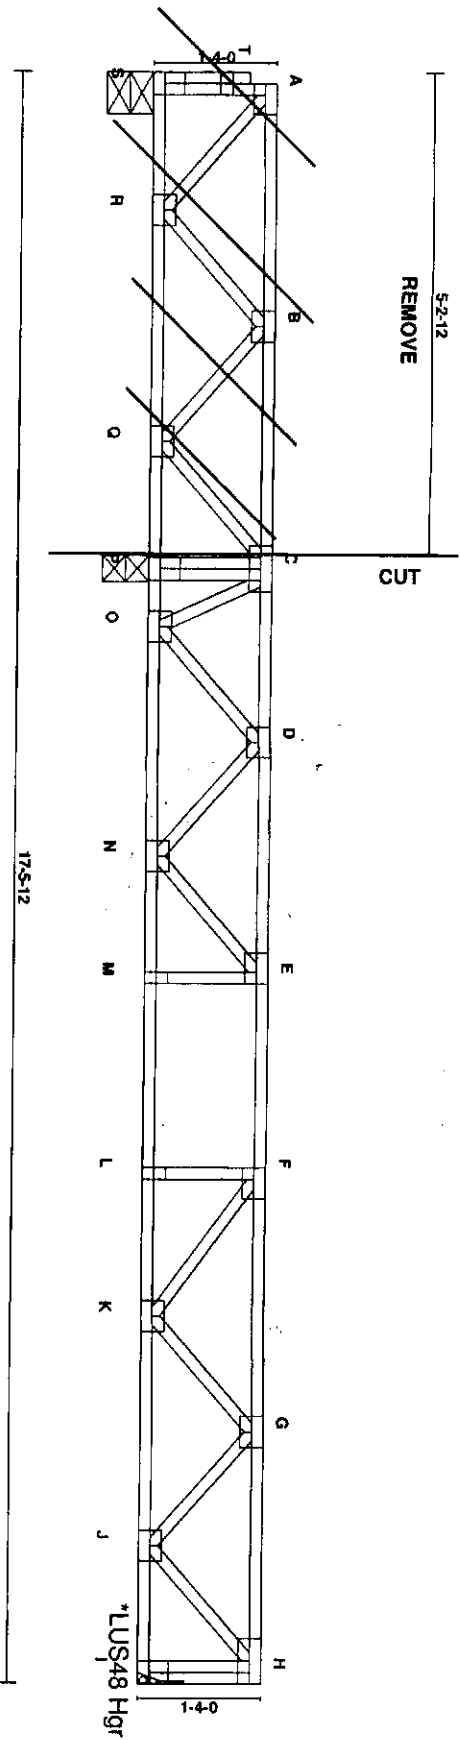
1. Repairs made to FO7 floor trusses at front wall of basement are adequate as is. No further action required.
2. Repairs made at fireplace to provide required flu clearance are adequate as is. No further action required.

REPAIR DETAIL

REPAIR - TO CUT-OFF LEFT SPAN OF TRUSS.

CUT CLEANLY THRU LUMBER/PLATES
ADJACENT TO INTERIOR BEARING.

NO FURTHER REPAIRS NEEDED.
