ADDRESS : 163 WILDWOOD WAY SUBDIV: CAROLINA SEASONS PH2 SECT 2 59
 CONTRACTOR : BILL CLARK HOMES LLC PHONE : (252) 355-5805
 OWNER : CRESTVIEW DEVELOPMENT LLC PHONE :
 PARCEL : 09-9567-03- -0006- -12-
 APPL NUMBER: 13-50032553 CP NEW RESIDENTIAL (SFD)
 DIRECTIONS : T/S: 12/10/2013 08:42 AM JBROCK ----
 CAROLINA SEASONS #69

Truss Fabricator: **R&D Thiel dba Carpenter Contractors of America**
Job Identification: **REPAIR / 43448-1D1 PBA;C -A1**
Truss Count: **1**
Model Code: **IRC**
Truss Criteria: **IRC2009/TPI-2007(STD)**
Engineering Software: **Alpine Software, Version 13.01.**
Minimum Design Loads: **Roof - 40.0 PSF @ 1.15 Duration**
Floor - N/A
Wind - 100 MPH ASCE 7-05 -Closed

TRUSS REPAIR

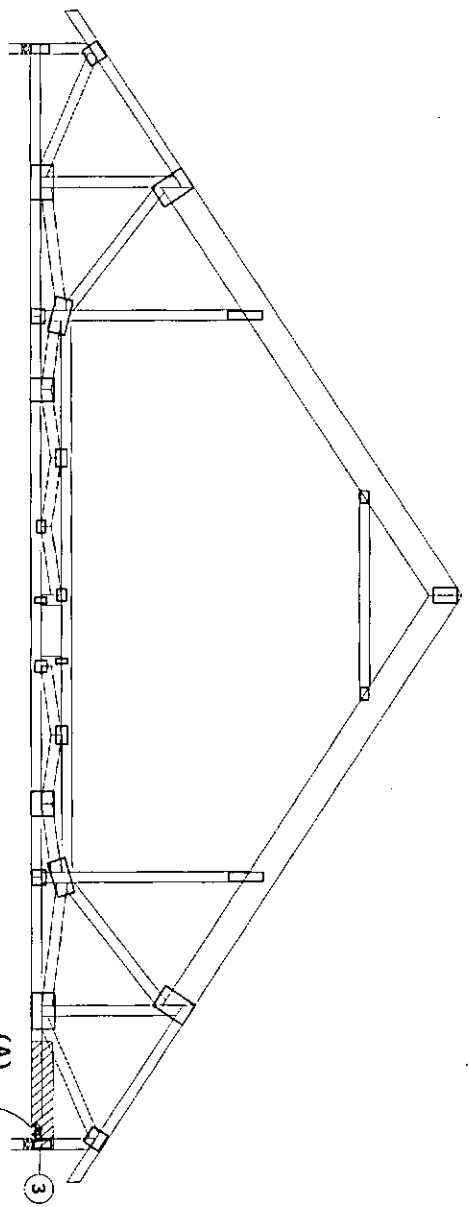
(43448-101 PMA.C - A1)

This truss is repaired for a damaged bottom chord (excessive wane) at right end of truss as shown. Refer to drawing R8976 13353020 for plates and other data not given here.

EXCESSIVE WANES ON
 BOTTOM CHORD NEAR
 RIGHT END OF TRUSS
 0-10-8
 R=2333 U=309 W=3.5"

Repair(s) must comply with Alpine designs & specifications Shore Truss and any supported spans in proper position as repair is being made.

(A) (2) 2X8X 3-0-0 SP #2 12A SCAB; ATTACH ONE SCAB TO EACH FACE OF TRUSS WITH 10d BOX (0.128"X3.0") NAILS @ 4"OC, PLUS A CLUSTER OF (3) NAILS IN RIGHT END VERTICAL WITHOUT SPLITTING LUMBER.
