ADDRESS : 125 ROBERT BRANCH CIR
CONTRACTOR : COMFORT HOMES INC
OWNER : R & K DEVELOPING LLC & ANDERSON
PARCEL : 08-0652- - -0097- -44-
APPL NUMBER: 15-50037084 CP NEW RESIDENTIAL (SFD)
DIRECTIONS : T/S: 09/10/2015 03:05 PM JBROCK ----
MILL BRANCH #44

SBS#4011/COMFORT HOMES/44 MILL BRANCH

A02

REPAIR DETAIL

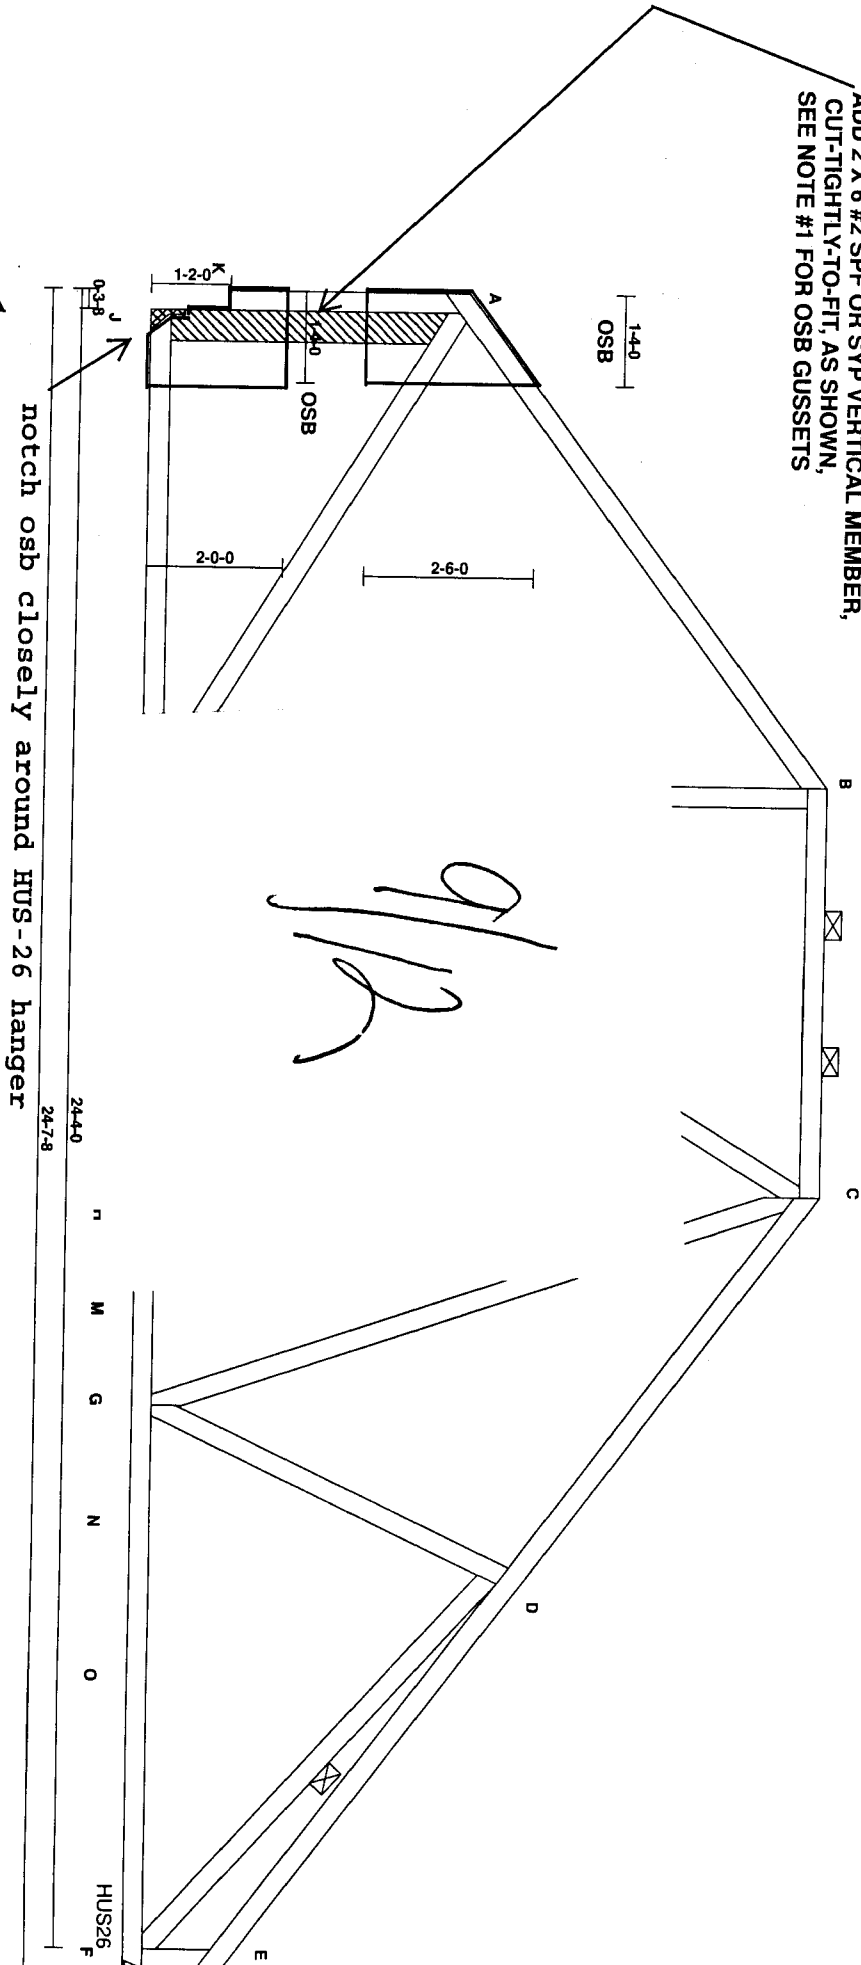
REPAIR - NOTCHED BOTTOM CORNER, TALL END:

notch osb closely around HUS-26 hanger

ADD 2 X 6 #2 SPF OR SYP VERTICAL MEMBER,
CUT-TIGHTLY-TO-FIT, AS SHOWN,
SEE NOTE #1 FOR OSB GUSSETS

1. 7/16" OSB each face. 10d nails (.128" x 3.0" min.) staggered 2.5" o/c one face through all members, clinched on back ply.
