ADDRESS : 78 VIC MCLEOD CT
 CONTRACTOR : WJH LLC
 OWNER : MASTIN BAKER INVESTMENTS LLC
 PARCEL : 07-0589- - -0102- -34-
 APPL NUMBER: 17-50042299 CP NEW RESIDENTIAL (SFD)
 DIRECTIONS : T/S: 09/19/2017 09:02 AM JBROCK ----
 COTTLESTONE #30
 210 S TAKE L ONTO S MAIN ST THEN R ONTO
 E FRONT ST
 CALLED IN PREMISE 1/10/18 LL @3:11PM
 PREMISE#13602734

STRUCTURE: 000 000 38X38 4BDR 2.5BA MONO W/ GARAGE

PERMIT: CPSF 00 CP * SFD

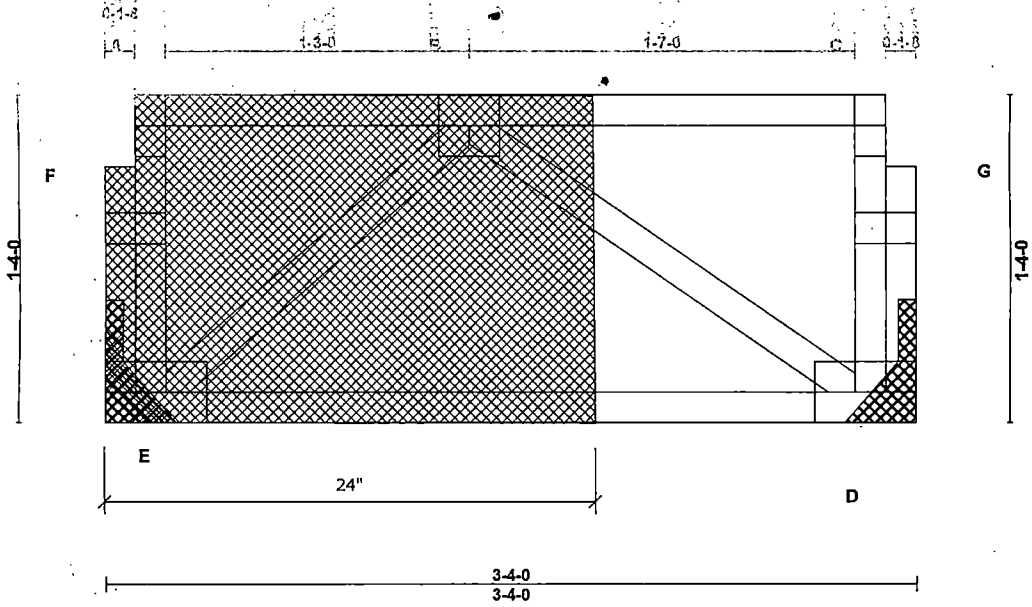
| TYP/SQ | REQUESTED COMPLETED | INSP RESULT | DESCRIPTION RESULTS/COMMENTS |
|---|---|---|---|
| R425 02 | 2/12/18 2/12/18 | KS DA | FOUR TRADE ROUGH IN TIME: 17:00 VRU #: 003088002 T/S: 02/09/2018 01:33 PM JBROCK --- 1. Plann calls for 3 jack studs at end of garage door opening. 2. 2x4 to the left of garage door shall be double-bored over 60 percent. 3. Trap in garage leaking. 4. F08 floor truss at base of stairs has gussets that no longer are attached. Need truss engineer's repair. 5. Drain stand pipe empty in hall bath. (leak from trap) 6. |

Repair for damaged plates at A, F and E.

Attach 3/4" Plywood or OSB (23/32" APA Rated Sheathing Exposure 1) as shown to each face of truss with 10d (.131" x 3") nails 4" oc in all members.
