FIELD REPORT

Project **Jarco Drive (252)**
 Location **Fuquay Varina, NC**
 Client **Nichols Buildings, Inc - Owen Nichols**
 Contractor **Nichols Buildings, Inc - Owen Nichols**

Project No. **33:4336**
 Report No. **2**
 Day & Date **Wednesday 07/18/2018**
 Weather **89° Sunny**
 On-Site Time **1.00**
 Lab Time **0.00**
 Travel Time* **0.00**
 Total **1.00**
 Re Obs. Time **0.00**

PHOTOGRAPH LOG
Steel Visual Inspection – Jarco Drive (252)
Fuquay Varina , North Carolina
ECS Project No. 33: 4336
07/18/2018

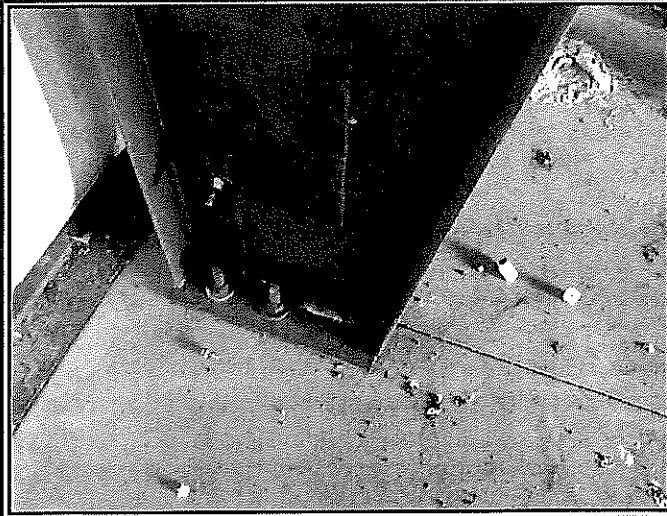
(1) Anchor Bolts on all Column bases has proper lengths, more than (1/2") bolt extrusion through the nut - Proper engagement.

(1) Anchor bolts @ Column line – 4/D

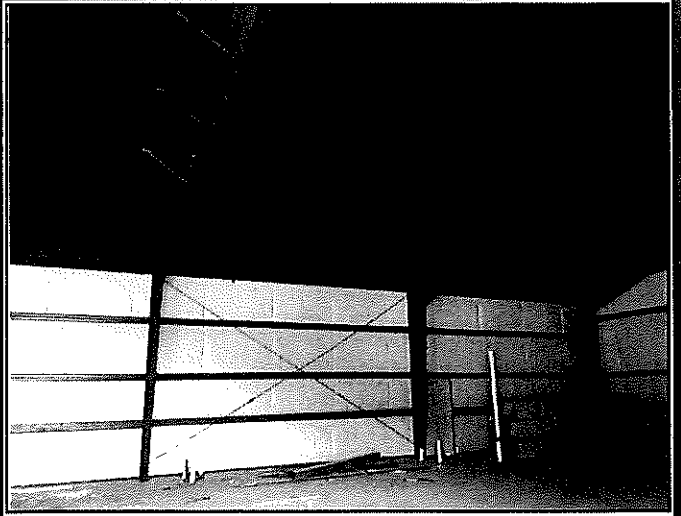
(2) All wire bracings on the roof and sides along column lines (4) and (5) were installed properly, however, the contractor needs make sure they are properly tightened for them to provide required lateral support.

(2) Cable Braces and Insulation on the roof

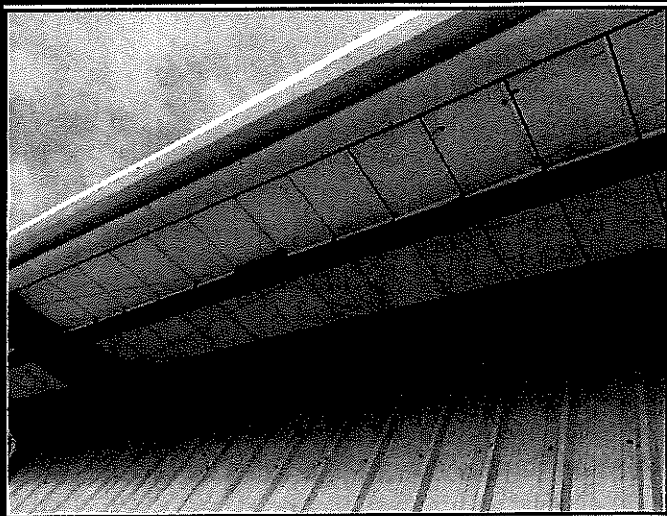
(3) Cable Brace on the roof – on the outside .
