Application for Repair

SEPTIC SYSTEM EVALUATION

Date: April 3, 2020
Report for: Ronald & Leanne Gabriel
Inspection address: 5269 Cokesbury Road, Fuquay Varina, NC 27526
Realtor: Allison Griffith (eXp - Marti Hampton Team)
Home Built: 1994

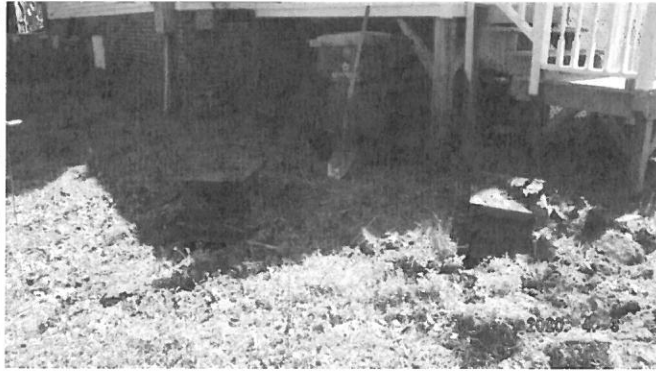
Septic tank location.

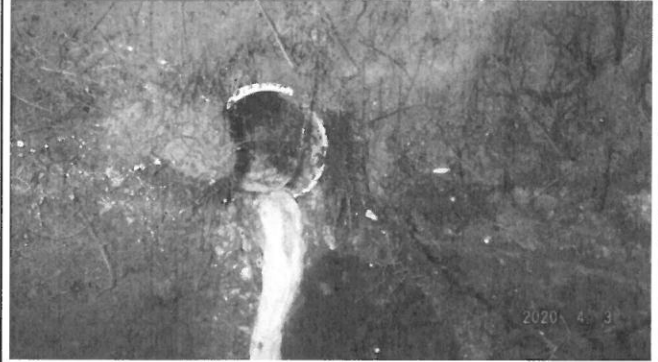
Inlet drainpipe shown not fully extending into the septic tank and roots shown at inlet pipe penetration

- **The septic tank inlet drainpipe was noted as not fully extending into the septic tank.**
- **Roots were noted as being present around the inlet drainpipe penetration.**
- **Non-biodegradables were noted as being present inside of the septic tank. Non-biodegradables do not decompose inside of the tank and remain in place unless removed. These solids can restrict flow and/or clog the outlet drain and/or drain lines if allowed to remain in the system.**

- **The septic tank inlet drainpipe was noted as not fully extending into the septic tank.**
- **Roots were noted as being present around the inlet drainpipe penetration.**

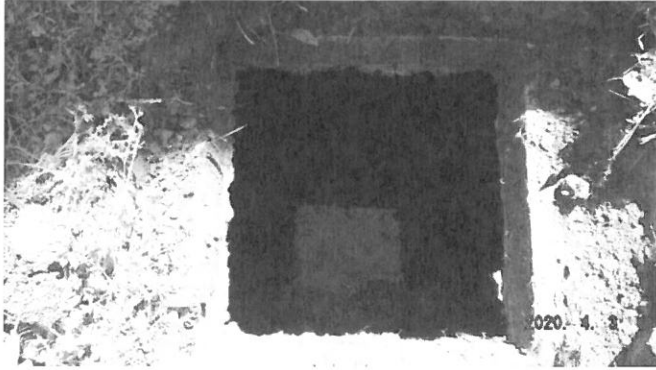
Primary chamber shown open for inspection

1) The septic tank was located approximately 12 feet off the back-left of the house foundation. The primary chamber was excavated, opened and inspected. **Accumulated solids were measured as being high but still at an acceptable level.**

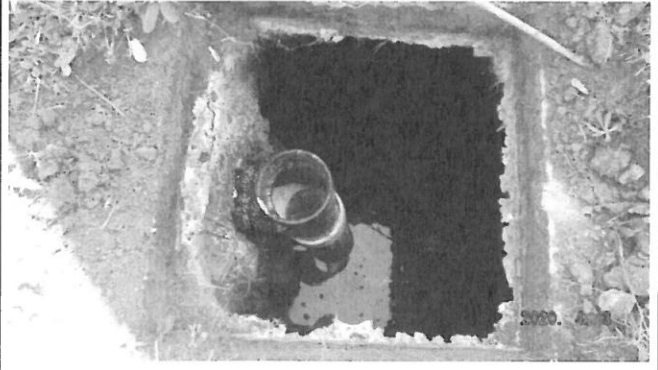
Secondary chamber shown open for inspection

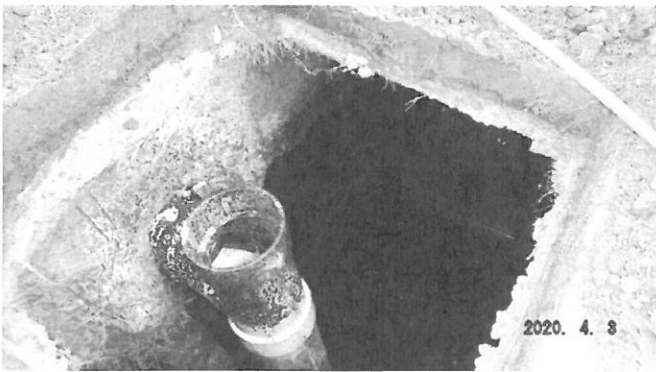
Lower effluent level shown

3) Water levels under normal conditions inside the septic tank would place the wastewater effluent level at the invert of the outlet drain (the bottom edge of the outgoing drainpipe) and typically, the outgoing drainpipe is installed at a lower elevation inside the septic tank than that of the incoming drainpipe. **The effluent level inside the septic tank was observed being as much as 18" inch lower than what normal conditions would be.** The home would have had to have been vacant for close to 18 months for the current effluent level to be considered attributed to naturally occurring evaporation alone. If this system is not verified as having been inactive for a very long period of time, leaking in the septic tank itself should be considered as the reason for the lower effluent level. The states way to determine if a tank is compromised is by performing a leak checking test in order to verify that structural integrity of the septic tank. Leak checking requires that the effluent level inside the tank needs to be filled back to a normal level and then checked after a 24- hour time period. Only a 1/2" reduction in water level is allowed to be present within this time period. If more than 1/2" in reduced lower effluent levels are present, the tank structural integrity is considered to be compromised and repair/replacement are considered to be required.

- **The effluent level inside the septic tank was observed being as much as 18” inches lower than what normal conditions would be.**
 - **Note:** A procedural method of “leak checking” is used to validate the septic tank structural integrity is compromised.

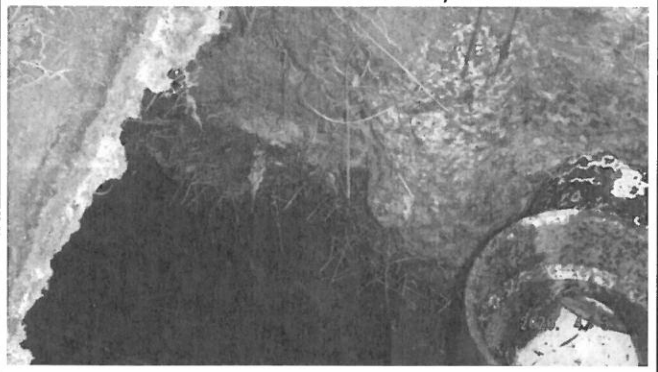
Roots shown on backside of secondary chamber

- **Roots were noted as being present on the backside of the secondary chamber (See photo).**
- **A wire was noted as being placed right above the secondary chamber opening. It I suggested that the wire be relocated to prevent damage to the wire when excavating the secondary chamber.**

- **The secondary chamber lid was noted as having a large crack (see photo).**
- **Roots were noted as being present on the backside of the secondary chamber (See photo).**

- It is suggested that a preventative maintenance treatment of a root killer be added in the septic system to kill off any root mass intruding into the drain lines. Any products (specified for septic system use) that consist mostly of copper sulfate will kill off existing roots and prevent further root growth from growing in and around the drain lines.

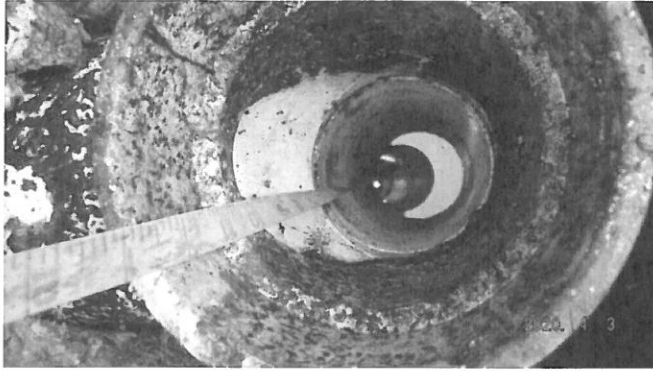
A lower effluent level shown

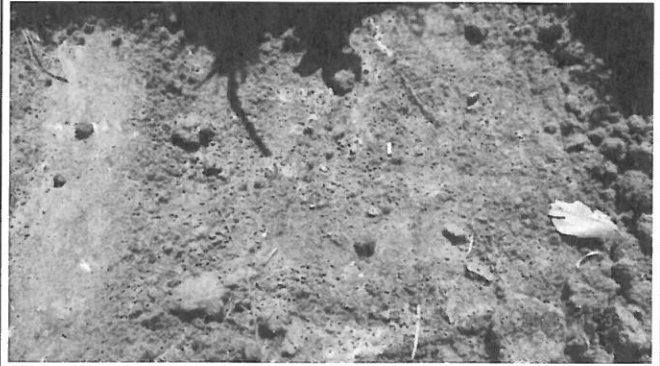
Distribution box lid shown with several large cracks

4) Probing for the distribution box in the known area of the drain field was successful and the distribution box was located but not opened for a visual inspection. **The distribution box lid was noted as having several large cracks all along the middle and not excavated or removed as it was suspected of breaking if attempted to remove.** The location of the distribution box was marked with an orange flag. A field distribution box distributes equal volumes of wastewater effluents to the typically installed multiple individual drain field lines. The known area of the drain field (the back section of lot per the permit) was walked to inspect for surface water. No evidence of prior or current adverse conditions of wastewater breaching the surface dirt grade was observed at the time of the inspection****but this is mostly inconclusive as the system has been vacant for an unknown period.**

- **The distribution box lid was noted as having several large cracks along the center. Further evaluation/excavation was not completed due to concerns that more extensive damage might occur if an attempt to remove the lid was completed. At minimum the distribution box lid should be replaced with a new one and with**

checking the structural integrity of the entire distribution box should be evaluated to determine if the component warrants repairs.

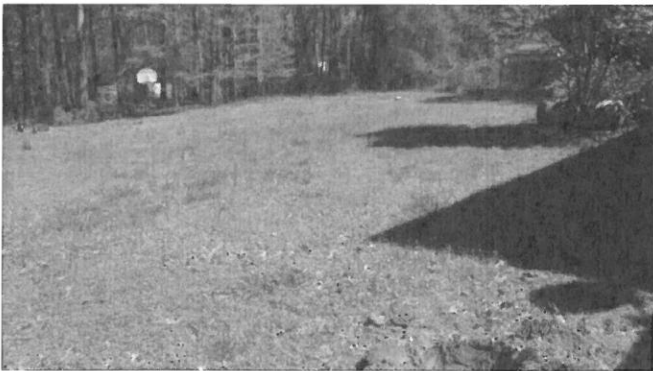
Area of drain field

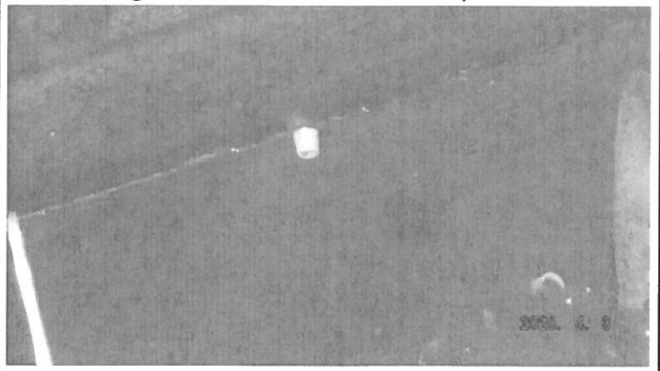
Non-biodegradables shown inside of septic tank

- **Non-biodegradables were noted as being present inside of the septic tank. Non-biodegradables do not decompose inside of the tank and remain in place unless removed. These solids can restrict flow and/or clog the outlet drain and/or drain lines if allowed to remain in the system.**

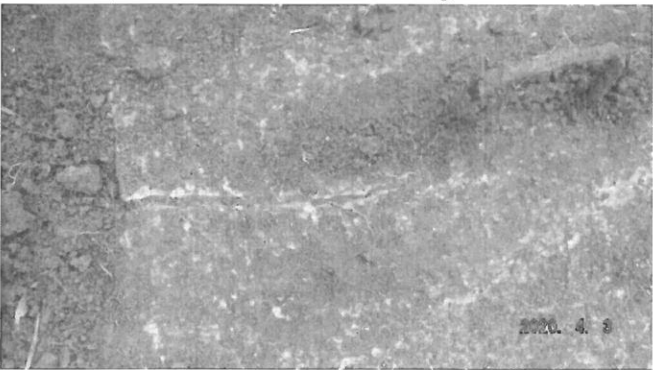
Secondary chamber lid shown with large crack

2) The secondary chamber was excavated, opened and inspected. **The secondary chamber lid was noted as having a large crack.** Accumulated solids were noted as being at an acceptable
