Septic System Inspection Report

Client Name KEN DALTON
 Prop. Addr. 15 RIVERWOOD DR
FUQUAY VARINA, NC 275526
 Email Address kdalton@crossrdschurch.com
 Phone No 919 812 1238
 Agent Name _____

Date / Time of Inspection: 4/01/2021

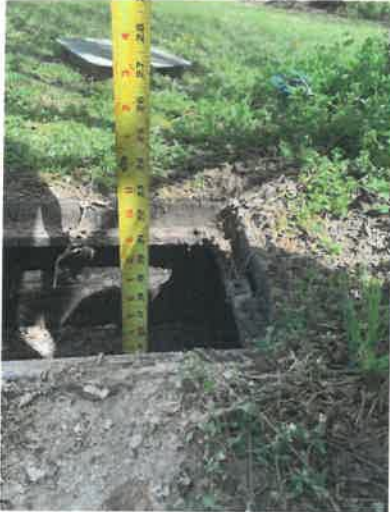
Comments: **DBOX NEEDS REPLACEMENT**

Comments: **THERE ARE NO SPEED LEVELERS IN THE OUTLET PIPES.**

EFFLUENT POOLING IN DBOX INDICATES SEPTIC FIELD MAY IS SATURATED OR MAY BE CLOGGED

Result of investigation into soil absorption system: **EFFLUENT IS POOLING AT DBOX, THIS MAY INDICATE SEPTIC FIELD IS SATURATED OR MAY BE CLOGGED.**

CONTACT THE HEALTH DEPARTMENT TO FURTHER EVALUATE ENTIRE SEPTIC SYSTEM DUE TO EFFLUENT
SURFACING CAUSING A HEALTH HAZARD
ADD SPEED LEVELERS TO DISTRIBUTION BOX TO CREATE EQUAL FLOW TO EACH TRENCH
HEALTH DEPARTMENT IS NEEDED TO PLAN SOLUTION TO REPAIR OR REPLACE SEPTIC FIELD
MEASURMENTS AND PICTURES SHOW LINES ARE TO CLOSE, LINES HAVE SEVERE DIP IN MIDDLE OF LINES, ARE
CLOGGED WITH ROOTS, CRUSHED AND HAVE A BUILDING WITH A CONCRETE SLAB DIRECTLY OVER THEM.
SEPTIC REPAIR FIELDS ARE ALSO COMPROMISED DUE TO OTHER BUILDING PLACED ON THEM OR THEY ARE EXTREAMLY
WET.

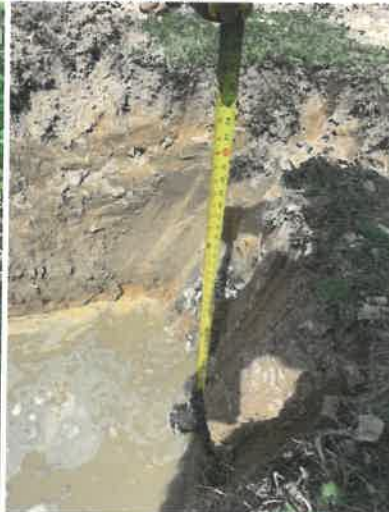
SEPTIC SYSTEM IS NOT FUNCTIONAL, LINES ARE 5' FROM CENTER OF EZFLOW
EFFLUENT IS SURFACING FROM SEPTIC TANK AND DBOX
8' FROM DBOX BOTH LINES DROP TO 32" AT 12' FROM DBOX BOTH LINES GO BACK UP TO 20" (SEVERE DIP)
100' OF 120' OF LINES ARE EITHER COMPROMISED OR NOT FUNCTIONAL, BUILDINGS LOCATED ON TOP OF SYSTEM
DESIGNATED FIELD NEXT TO GARAGE DOESN'T ALLOW ENOUGH SPACE TO REPLACE LINES DUE TO TWO MARKED
POWER LINES ON BOTH LEFT AND RIGHT SIDES OF SEPTIC FEILD
80' FROM D BOX BOTH LINES FOUND CRUSHED.

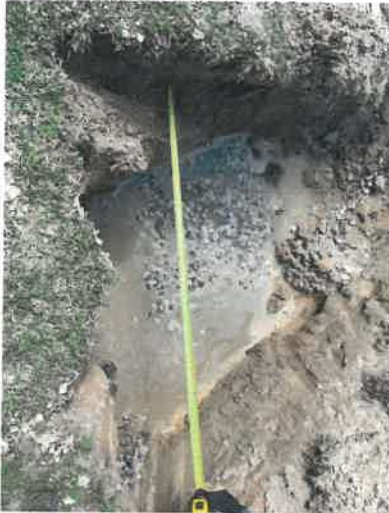
LINES TOO CLOSE

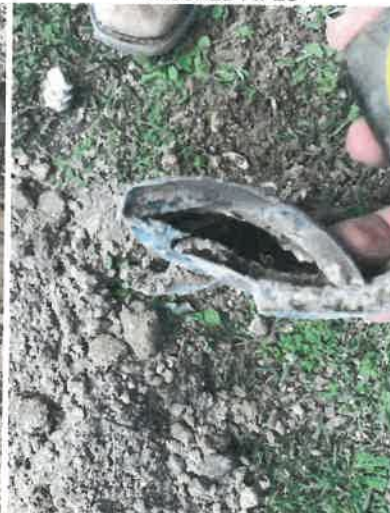
CRUSHED PIPES

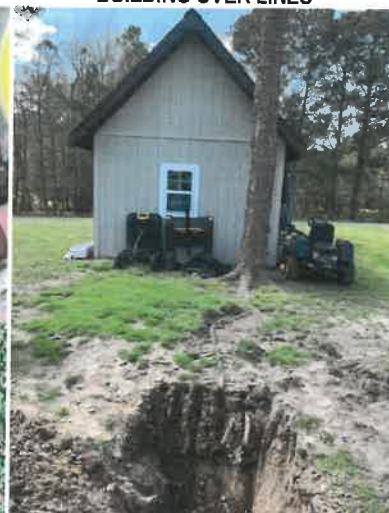
BUILDING OVER LINES

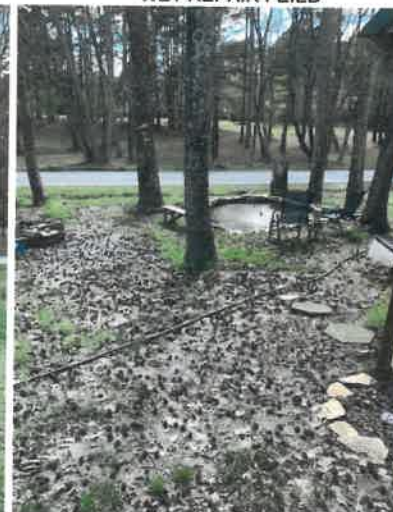
WET REPAIR FIELD
