Application for Repair

NCSI

INSPECTION REPORT:

**PROPERTY ADDRESS: 134 Pear Tree Lane
Fuquay Varina, NC 27526**

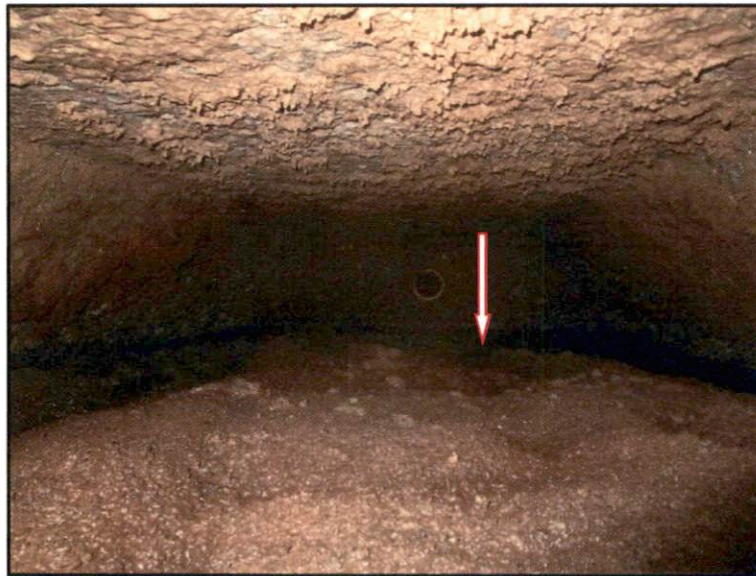
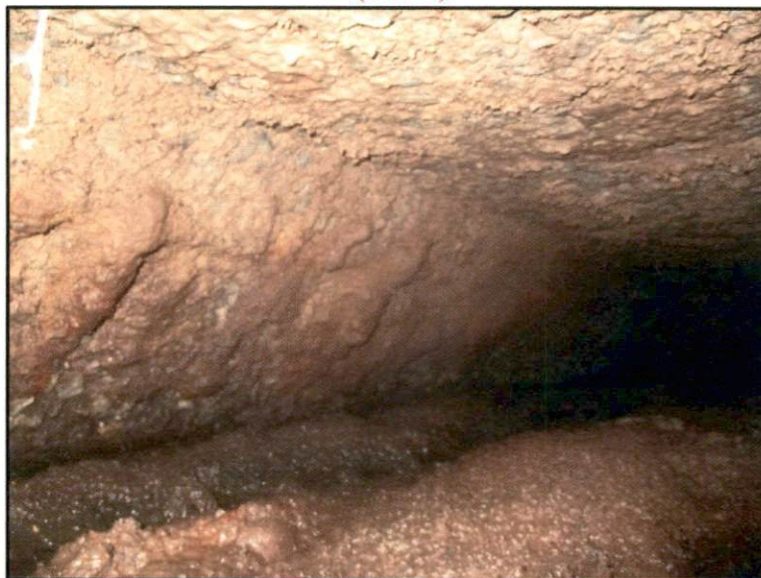
Single Chamber (Scum):

- 1). Considering the current depth of mixed solids, sludge, and the thickness of surface scum, in addition to **non-biodegradable materials**, it is recommended that septic tank be pumped and cleaned. FYI: Systems of this age may require pumping maintenance more frequent. For your maintenance records, it is recommended that seller provide the date of the last scheduled pumping and the service provider that performed the service.

- 1). Considering the current depth of mixed solids, sludge, and the thickness of surface scum, in addition to non-biodegradable materials, it is recommended that septic tank be pumped and cleaned. Septic tanks of this age should be pumped on a 3 to 5 year rotation, or sooner, if necessary (see page 8 for additional information and pictures).

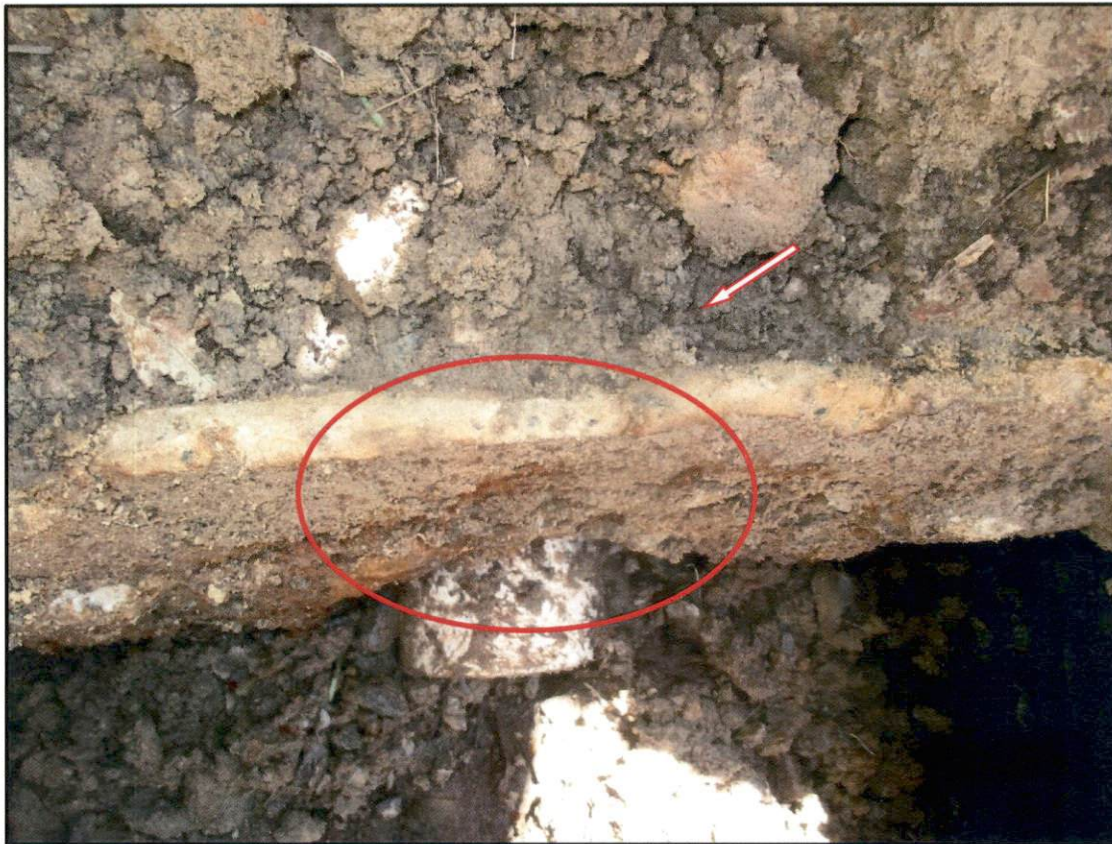
Outlet End Wall:

- 2). End wall of tank appears to have extensive deterioration. Further evaluation by Service Provider will be necessary to determine if this area can be repaired. (see page 9 for additional information and pictures).

- 2). Outlet end wall and around outlet supply pipe has extensive deterioration. Service Provider should re-inspect this area, after pumping, and make the necessary repairs.

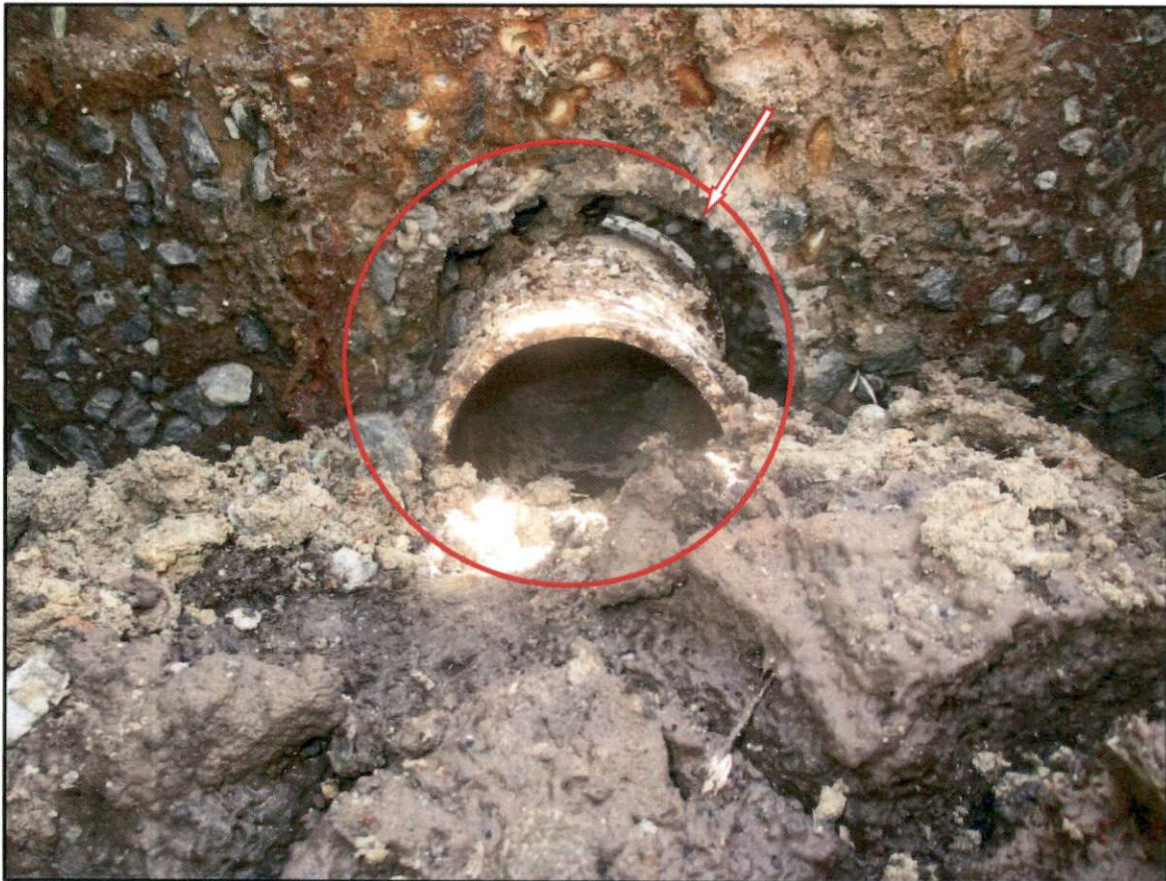
Existing Inlet Wastewater Supply Pipe:

- 3). To prevent the infiltration of ground water and roots, in addition to possible effluent leakage, it is recommended that Service Provider re-seal around the outlet wastewater supply pipe in septic tank and pump tank with non-expansion grout or with the appropriate hydro-cement sealant.

- 3). To prevent the infiltration of ground water and roots, in addition to possible effluent leak-age, it is recommended that Service Provider reseal around the outlet wastewater supply pipe in septic tank with non-expansion grout or with the appropriate hydro-cement sealant (see page 10 for additional information and pictures).

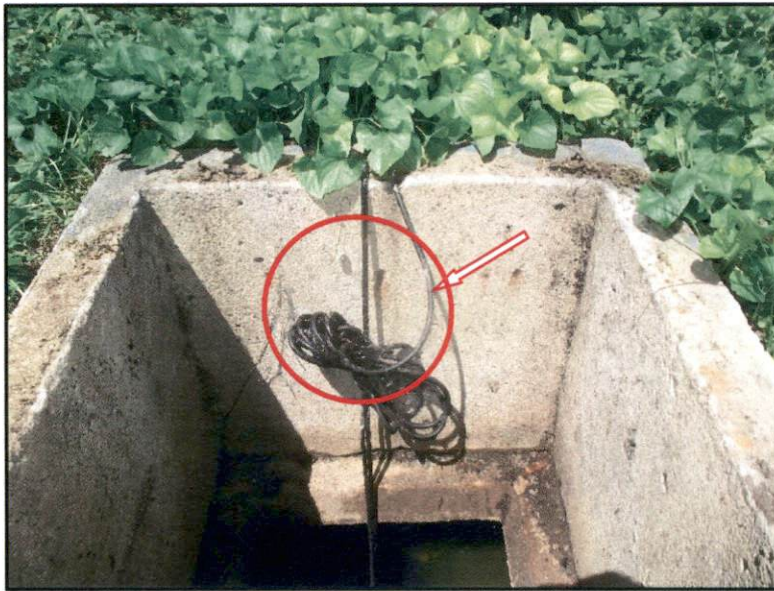
Existing Wiring:

- 4). To prevent an interruption of service, it is recommended that Service Provider make the necessary upgrades to the wiring and electrical components.

- 4). To prevent an interruption of service, it is recommended that Service Provider make the necessary upgrades to the wiring and electrical components servicing the pump tank (see page 11 for additional information and pictures).

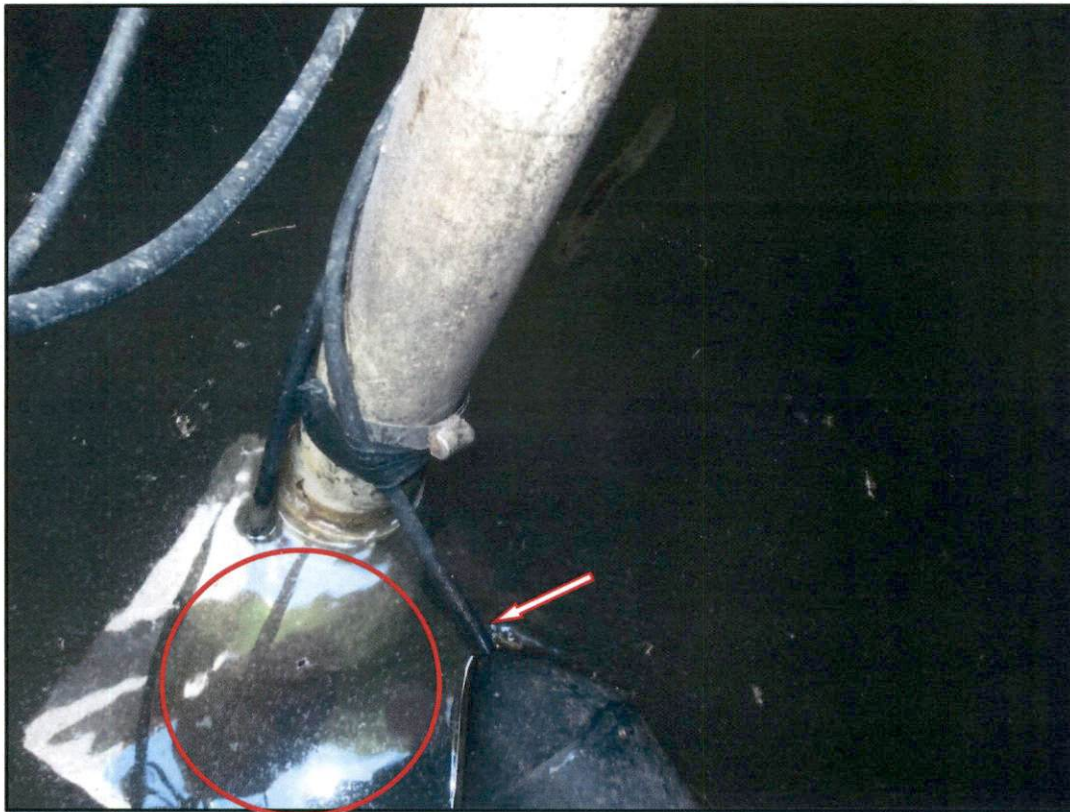
Effluent Pump:

- 5). At time of pump cycle, effluent pump appeared to be short cycling. Further evaluation and a repair or replacement of pump is recommended. Service provider should make the necessary repairs to floats and pump to assure that effluent is being delivered to the soil absorption area as intended.

- 5). At time of pump cycle effluent pump appeared to be short cycling. Further evaluation and a repair or replacement of pump is recommended. Service provider should make the necessary repairs to floats and pump to assure that effluent is being delivered to the soil absorption area as intended (see page 12 for additional information and pictures).

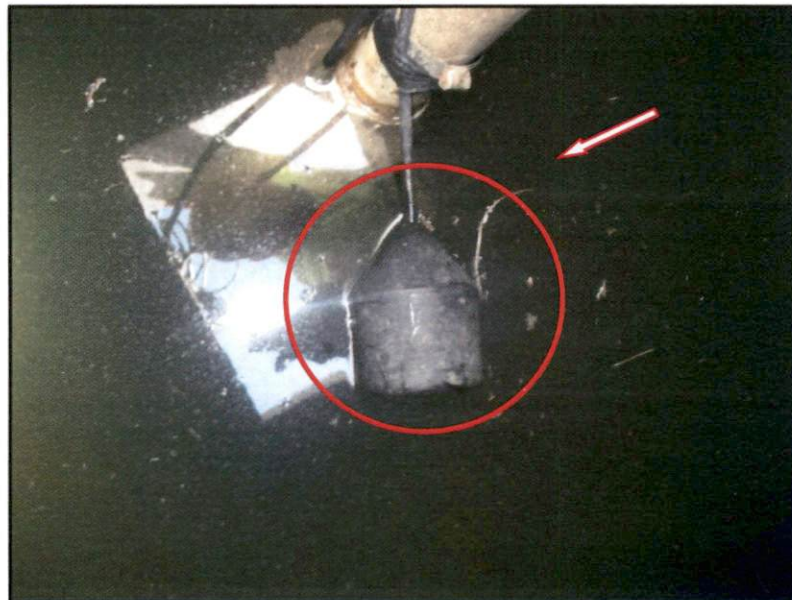
Existing Float:

- 6). The highwater alarm box, most likely is located in home and could not be confirmed functioning at time of inspection. Further evaluation by a homeowner or home inspector is recommended to determine that alarm functions on both audio and visual when activated by highwater alarm float. FYI: Activated alarm is a warning that effluent pump is not functioning, and a backup of sewage is eminent. This pre-warning device is necessary and, should be functioning at all times.

- 6). Highwater alarm float should be functioning at all time. It is recommended that Service provider make the necessary repair to assure alarm is functioning (see page 13 for additional information and pictures).

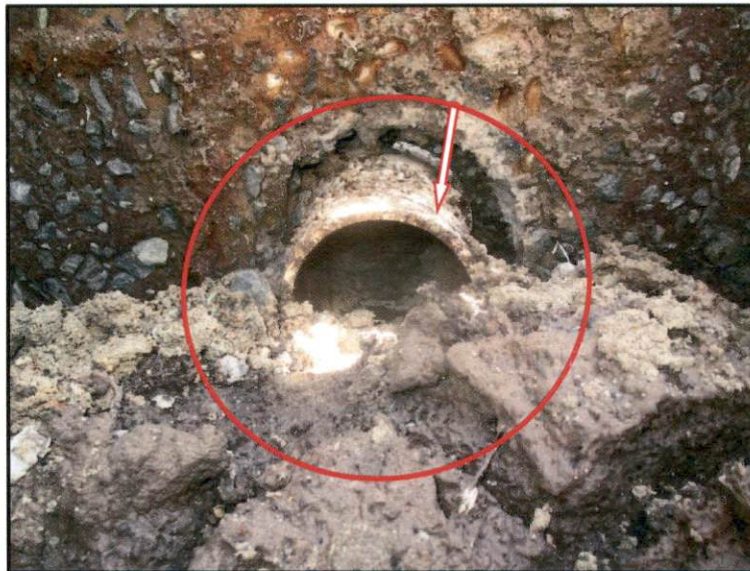
Existing Outlet:

Septic tanks installed **before**, January 01, 1999, are manufactured with a pre-cast concrete outlet baffle tee. Original tee has been removed and PVC straight pipe has been installed between the septic tank and pump tank. For your information, baffle tees are designed to prevent sludge, mixed solids, scum and in some case, non-biodegradable products from drifting over into the pump tank. These waste items can create clogs and blockages in effluent pump resulting in an interruption of service. It is recommended that that an outlet PVC sanitary baffle tee with effluent strainer be installed (see repair items). This updated improvement is not uncommon in older systems and is highly recommended. Invert of inlet wastewater supply line and invert of outlet wastewater supply line may not be installed at the correct height. Scum thickness was estimated to be approximately 10 to 12 inches in depth. Column sampling revealed sludge and mixed solid measurement to be approximately 14 inches. The depth of mixed solids and sludge in subject tank is consistent with tanks that have not had recent general pumping maintenance performed.

- 7). Because of the age of system, consideration should be given to install a PVC sanitary baffle tee with an effluent strainer. This updated improvement is not uncommon in older systems and is highly recommended with pump systems. For your information, a sanitary tee with effluent strainer prevents sludge, mixed solids, scum, and in some cases non bio-degradable products, from exiting the tank and lodging in the pump tank, causing a blockage which can disrupt the flow of effluent to the soil absorption area beneath the lines.

- 7). Because of the age of system, consideration should be given to install a PVC sanitary baffle tee with an effluent strainer. This updated improvement is not uncommon in older systems and is highly recommended with pump systems. For your information, a sanitary tee with effluent strainer, prevents, sludge, mixed solids, scum, and in some cases non bio-degradable products, from exiting the tank and lodging in the pump tank, causing a blockage which can disrupt the flow of effluent to the soil absorption area beneath the lines (see page 14 for additional information and pictures).

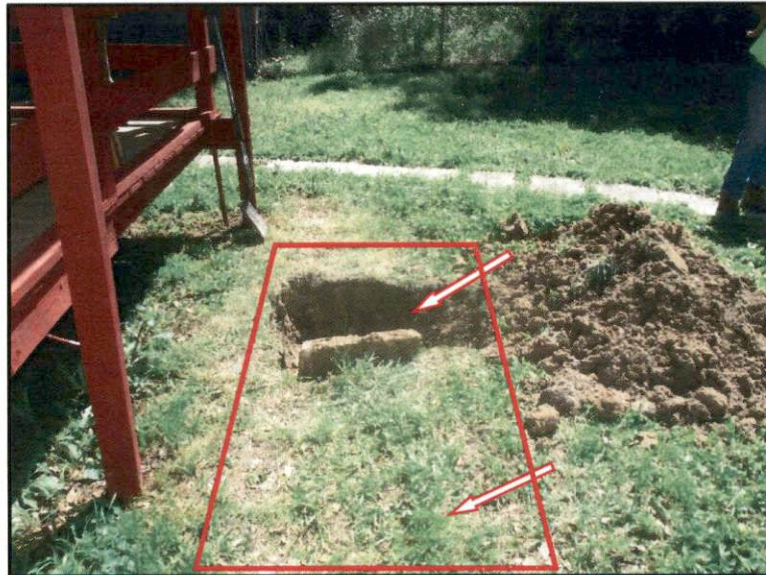
Existing Access Openings:

- 8). Because of the depth that tank is buried beneath the soil surface and the amount of time and difficulty in uncovering the inlet and outlet access lids to pump and clean the primary and secondary chambers, it is recommended installing risers over both these areas. In addition, it would be easier to remove and clean the effluent strainer, when soiled, if existing baffle is replaced with a PVC sanitary tee. To prevent the infiltration of surface water; risers should be a minimum of 6 inches above finished grade.

- 8). Considering the depth that tank is buried beneath the soil surface and the amount of time and difficulty in uncovering the inlet primary and outlet secondary chamber access openings to pump and clean the tank, it is recommended extending the risers to a minimum of 6 inches above finished grade (see page 15 for additional information and pictures).

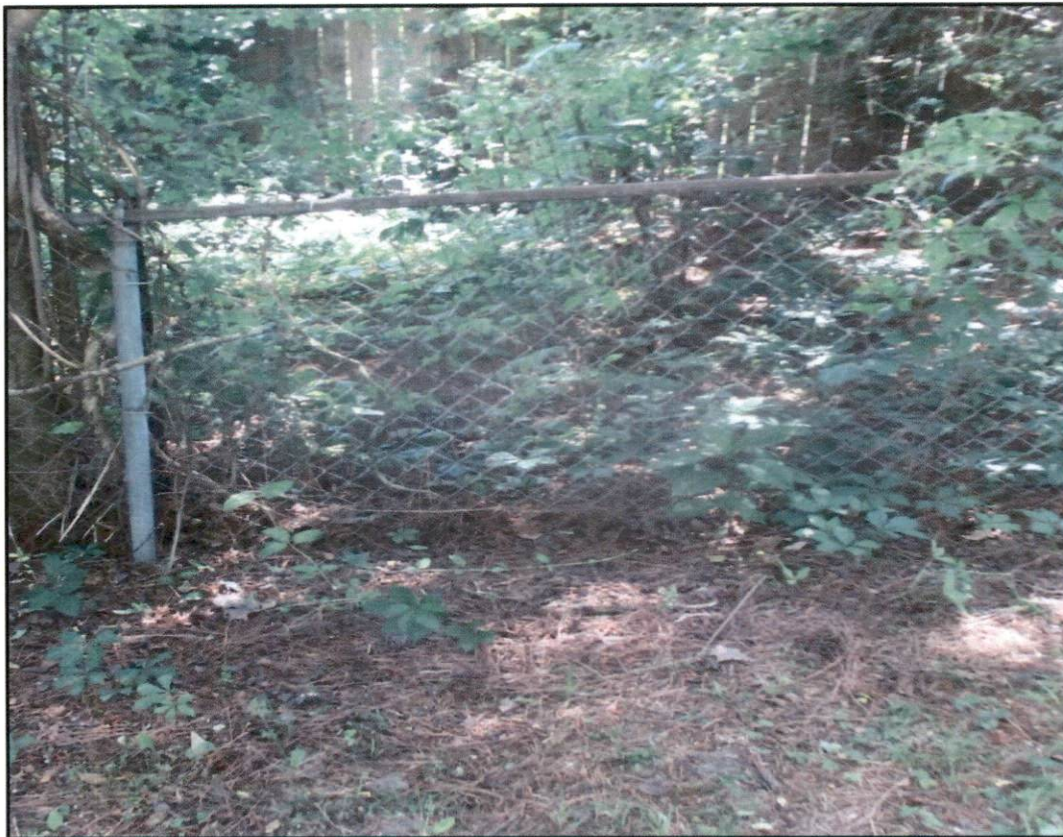
Possible Location of Leach Field:

At time of inspection, an unsuccessful attempt was made to locate and inspect the exact location of the distribution device and soil absorption area. Therefore, their actual physical could not be determined. FYI: A heavily vegetated area behind the barn is most likely the location leach field. At time of pump cycle water flow to this area was audible. **Septic systems are subterranean, without exposing the actual nitrification lines and the soil absorption area beneath the lines it is impossible to make an accurate assessment of their overall condition, especially in systems that are, or have been dormant for lengthy periods of time. More accurate assessments are done in homes that are occupied.** Caution should be observed to discourage vehicular traffic or disturbing the soil in and around the nitrification fields and the adjoining repair areas. A copy of the Septic Permit was not available at time of inspection. A copy of the original Operational Permit, if available, or any records of a previous repair permit should be obtained from the Harnett County Department of Environmental Health to verify the number of permitted bedrooms and to confirm the length of each nitrification line or lines. Properties deeded before, April 01, 1983, do not require a designated repair area, however, there appears to be adequate space available if a repair were to become necessary.

Nitrification field appears to consist of gravel aggregate laterals. Because of the thick vegetation growth, probing was unsuccessful in locating and identify the exact layout of leach field. **Septic systems are subterranean, therefore, without exposing the actual nitrification lines and the soil absorption area beneath the lines it is impossible to make an accurate assessment of their overall condition, especially in systems that are, or have been dormant for lengthy periods of time. More accurate assessments are done in homes that are occupied.** Caution should be observed not to disturb the soil in and around the nitrification field and the adjoining designated repair area. It is always recommended to properly maintain the vegetation growth over nitrification areas. Planting appropriate vegetation over the leaching field is key to allowing a septic system to properly treat household wastewater and ensure the safety of your family and the environment. FYI: All permanent structures should be a minimum of 5 feet from any or all portions of a septic system. In addition, it is important to avoid vehicular traffic over the nitrification area.
