Application for Repair

SEPTIC SYSTEM EVALUATION

Date: September 16, 2022
Report for: Shannon Rotondi
Inspection address: 267 Capitol Hill Road, Lillington, NC 27546
Realtor: Jerry Robtoy (Raleigh Realty)
System Design: 1980

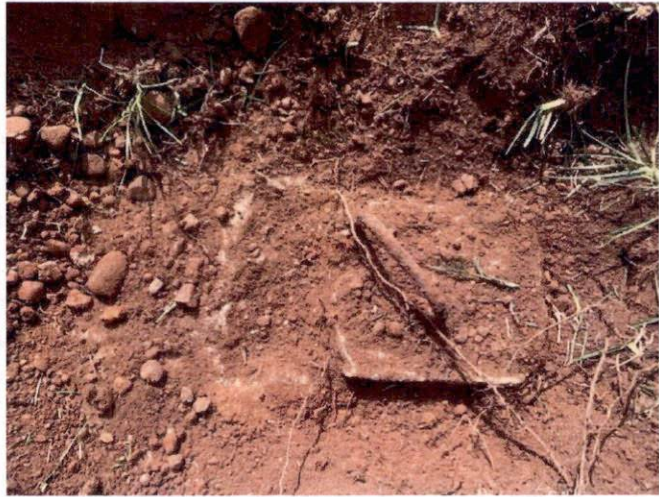
Outlet inspection port lid noted as damaged/broken

- **The outlet side panel lid was noted as damaged/broken (see photo).**
- **Minor deterioration was noted on the cement outlet baffle located inside the outlet chamber (see photo).**

- **The outlet side panel lid was noted as damaged/broken (see photo).**
- **Accumulated solids inside of the septic were measured as being higher than state recommended acceptable operating levels.**

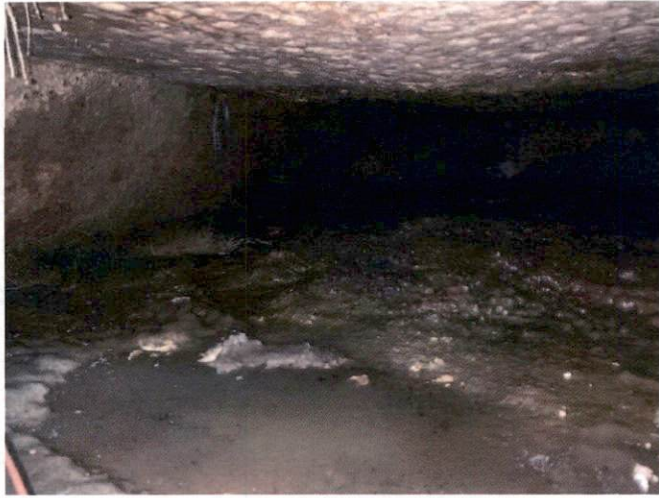
Inlet side of septic tank shown (inlet drain pipe noted as damaged)

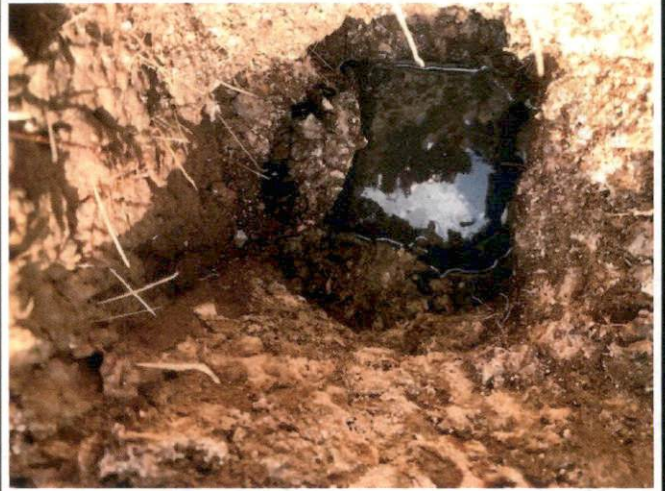
Effluent level noted as being 1" low

- **The effluent level inside the first septic tank was observed being as much as 1” inch lower than what normal conditions would be.**
 - **Note: A procedural method of “leak checking” is used to validate the septic tank structural integrity is compromised.**

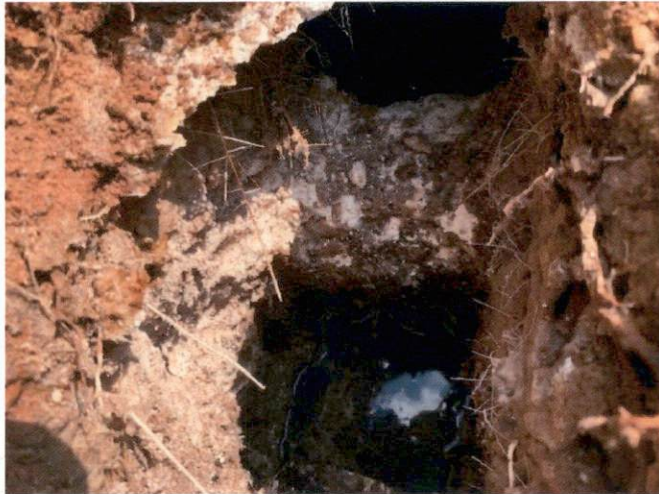
Minor deterioration shown on outlet baffle tee

- **Minor deterioration was noted on the cement outlet baffle located inside the outlet chamber (see photo).**
- **Minor deterioration was present inside of the distribution box. Although still functioning as intended it is suggested that the box be evaluated at the time of next scheduled maintenance service.**
- **Keep the landscape at the septic field location free of large shrubs/trees and mowed. This will prevent root intrusion into the drain lines and help promote transpiration of the effluent being dispersed from the system.**

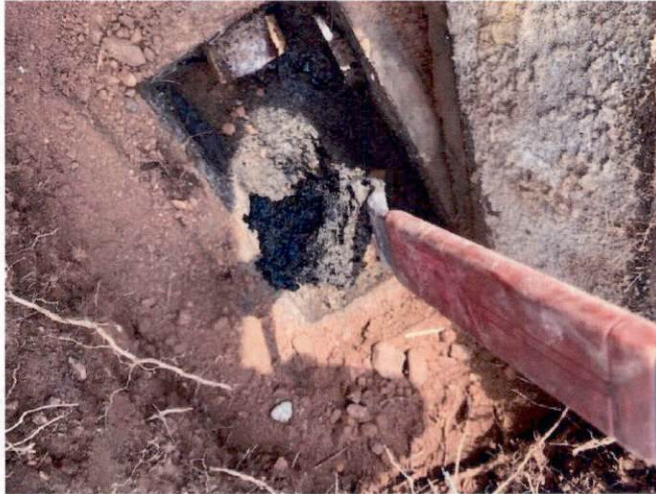
Solids shown collected inside of distribution box

- **The distribution box was noted as having solids collected in the bottom. Solids can collect inside of distribution box and deteriorate the interior sidewalls of the distribution box. Solids collected inside of the distribution box can also flow into the drain lines resulting in restriction of flow.**

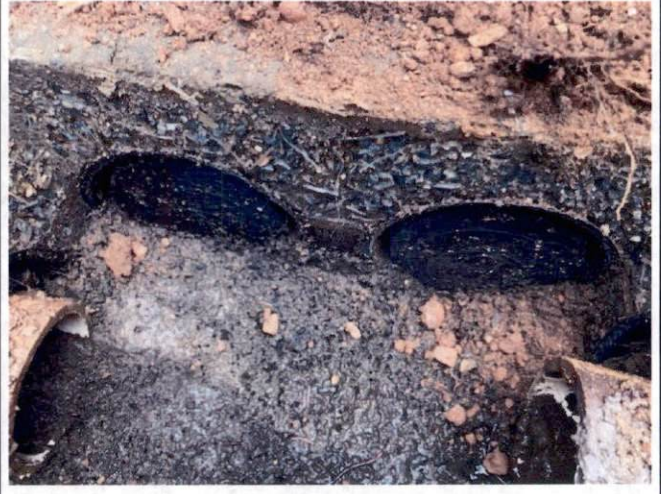
Distribution box shown with minor deterioration

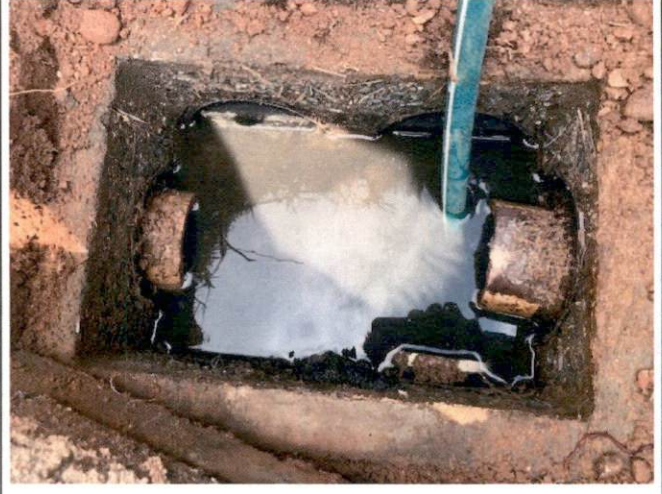
Drain lines noted as not taking water. Dbox flooded

- **When the distribution box was charged with water effluent was noted as not flowing to the two drain lines. There is a higher sustained effluent level inside of the distribution box at the two drain lines (see photo). The higher effluent level is an indication that there is a restriction in the outgoing drain line leading to the drain field/not properly flowing to drain field. Due to the sustained higher effluent level**

inside the distribution box at the two drain lines, have a qualified contractor further evaluate and make all necessary repairs.

- **When the distribution box was charged with water effluent was noted as not flowing to the two drain lines. There is a higher sustained effluent level inside of the distribution box at the two drain lines (see photo). The higher effluent level is an indication that there is a restriction in the outgoing drain line leading to the drain field/not properly flowing to drain field. Due to the sustained higher effluent level inside the distribution box at the two drain lines, have a qualified contractor further evaluate and make all necessary repairs.**
