On-site Wastewater Inspection Report

69 Dare Court
Angier, NC 27501

Inspected On Wed, Oct 12, 2022 at 12:30 PM

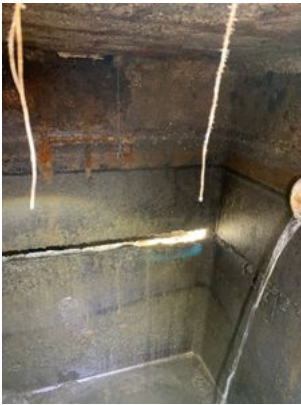
Yes, Baffle wall is in good condition

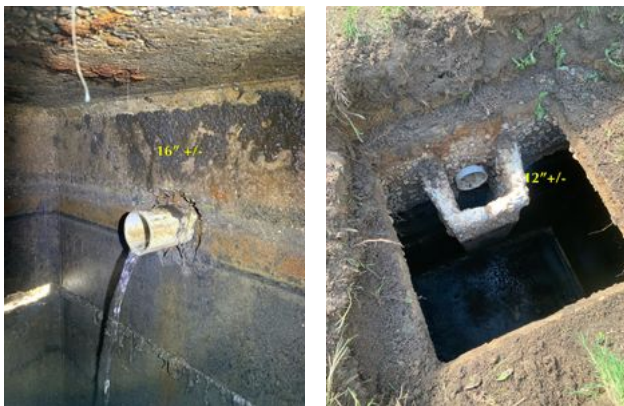
The inlet pipe appears to be lower than the invert of the outlet pipe. This could lead to sewage backups as the levels in the tank increase.

The inlet pipe was noted as being lower than the outlet pipe which will lead to sewage backups. Repair/replacement is required by a certified onsite wastewater contractor. The concrete outlet baffle is deteriorated and should be replaced with an PVC outlet T and filter.

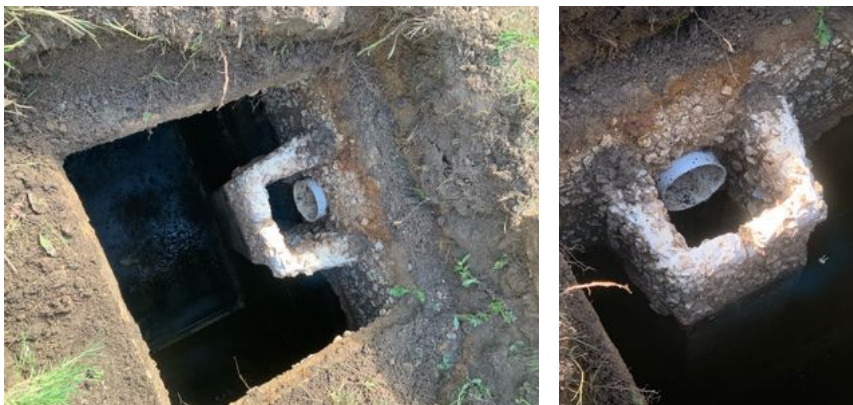
The concrete outlet baffle is deteriorated and should be replaced with a outlet T with filter.

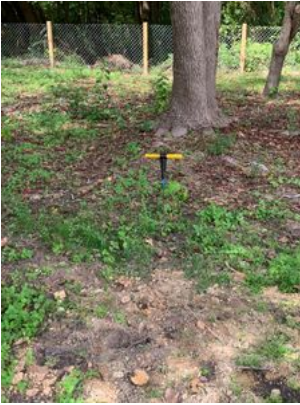
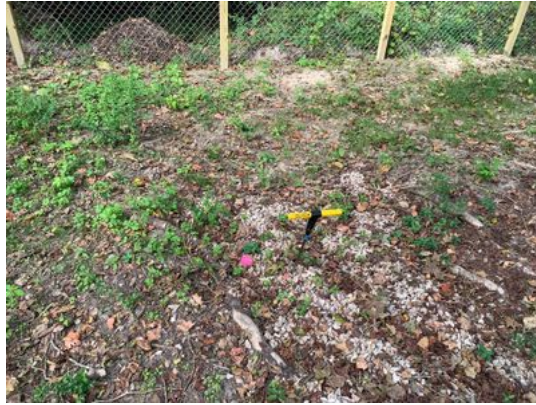
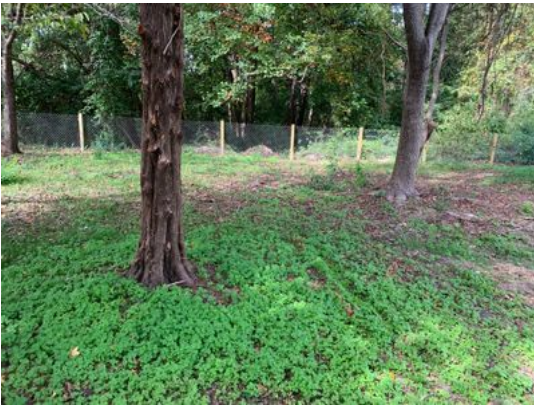
Vegetation growth which could intrude on the nitrification field dispersal lines was present. Gravel was visible towards the back of the drain field. This could be an indication that the drain line may have been dug up or damage during grading. There were piles of yard debris/soil just beyond the fence line which could have been removed from the drain field and led to damage.

The drain field showed signs of possible damage due to vegetation and/or excavation of the soil. Effluent did not appear to be properly draining as the soil was wet over the top of the right drain line.

A certified onsite wastewater contractor and the county health department should be contacted to determine if replacement of the septic tank and drain field require replacement.

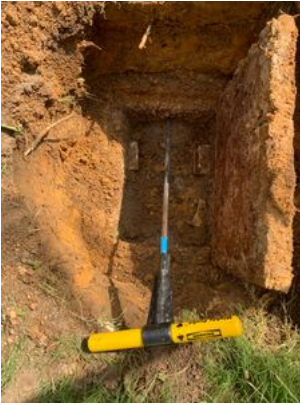
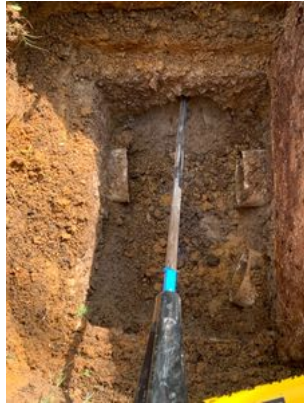
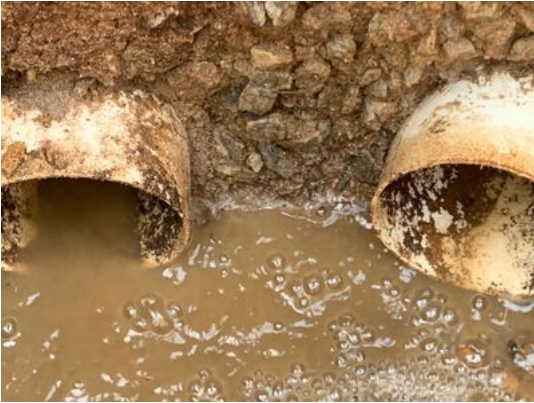
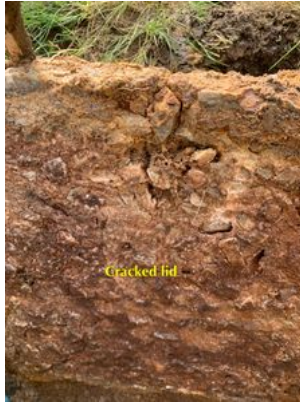
The side walls of the distribution box are deteriorated. The lid is cracked and effluent is not evenly discharging at the outlet pipes. Replacement of the Dbox is required.

The distribution box is deteriorated and requires replacement.
