Onsite Wastewater System Inspection

165 Buie Farm Road

09/26/2023, 08:30 AM

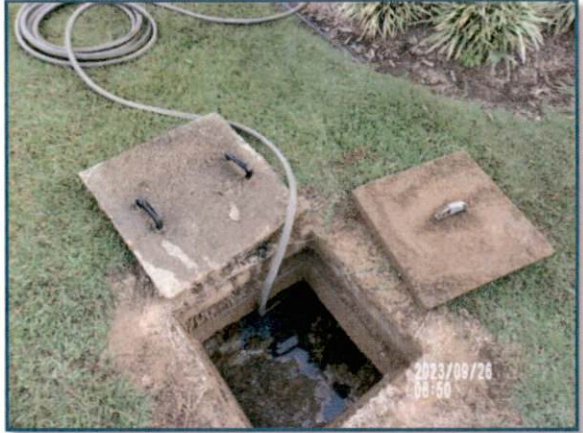
The septic tank inlet measured ten feet out from the front right corner of the house. The inlet contained a concrete access riser that brought access to grade level. The riser and the riser lid were in satisfactory condition, and they were sealed to the septic tank properly. The inner septic tank lid was in good condition, but the handle was broken. I managed to duct tape the handle back together, in order to remove it, but this lid should be replaced. The water level inside the inlet was at least two inches below the bottom invert of the inlet pipe, which is the proper operating level. I observed the inlet pipe for correct fall into the septic tank, and water was flowed inside the inlet pipe. The inflow into the tank was noted as sufficient and satisfactorily transferred wastewater from the plumbing, into the septic tank. I inspected the interior of the inlet compartment, above the water level, and the areas that I was able to see appeared to be in satisfactory condition. Since the septic tank was not empty at the time of the inspection, a complete inspection of the septic tank interior could not be performed. Lastly, I took a column sample from the inlet compartment of the septic tank, and I obtained ten inches of sludge, with less than an inch of scum, out of the forty-nine inch total liquid depth. This equates to approximately twenty percent solids; therefore, the septic tank does not need to be pumped out at this time. It is recommended that the tank be pumped out every three to five years, or when the percentage of solids is greater than one-third (33%) of the total liquid depth in either compartment.

P4. Septic Tank Inlet & Lids

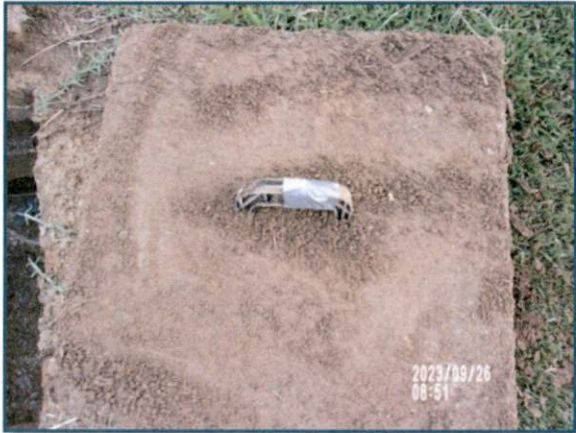
P5. Septic Tank Inlet Lid—Handle Broken

1. Further evaluation by Harnett County Environmental Health or a Licensed Soil Scientist is needed at this time to address the malfunctioning drain field.
2. Repair/replace distribution box.
3. Replace the septic tank inlet lid.

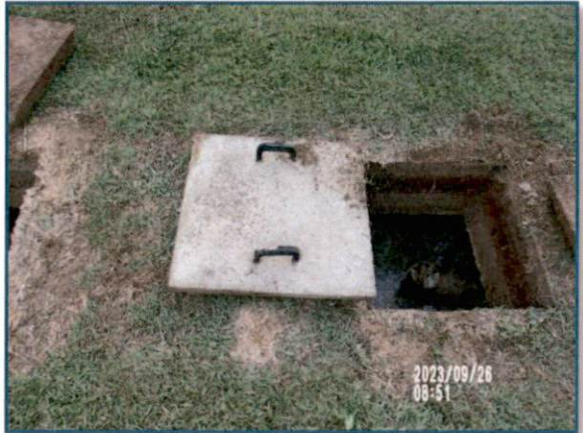
The outlet compartment of the septic tank was measured to be twelve feet out from the front right corner of the house, contained a concrete access riser and was at grade level. The riser, riser lid and inner septic tank lid were all in satisfactory condition and they were sealed to

P6. Outlet Riser Lid

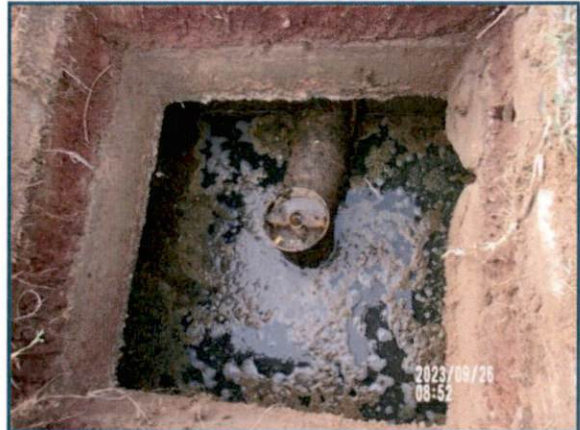
the septic tank. The operating water level in the outlet was at the bottom invert of the outlet pipe, which is the proper operating level. There was a PVC outlet filter tee present in the outlet of the septic tank that was found to be in good condition and the filter was cleaned. I inspected the interior of the outlet compartment above the water level, and the areas that I could see did not contain any defects, cracks or significant deterioration. Since the tank was not empty at the time of the inspection, a complete inspection of the interior of the outlet compartment could not be performed. There is a baffle wall present that separates the inlet and outlet compartments, and it was found to be in satisfactory condition above the water level, and it was properly vented. Lastly, I ran water into the outlet pipe of the septic tank to confirm that the effluent flows to the distribution box, and it did.

P14. Septic Tank Outlet Filter Tee

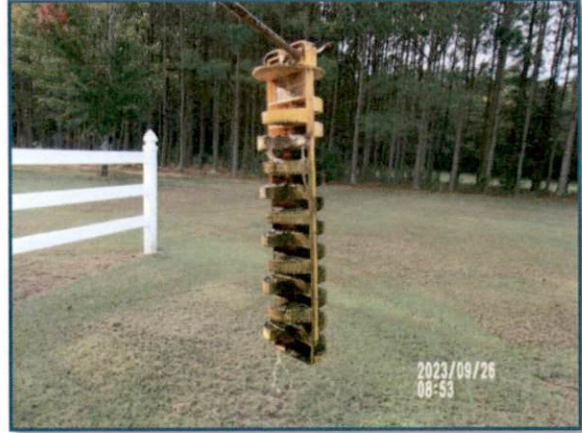
P20. Septic Tank Outlet Filter—Dirty

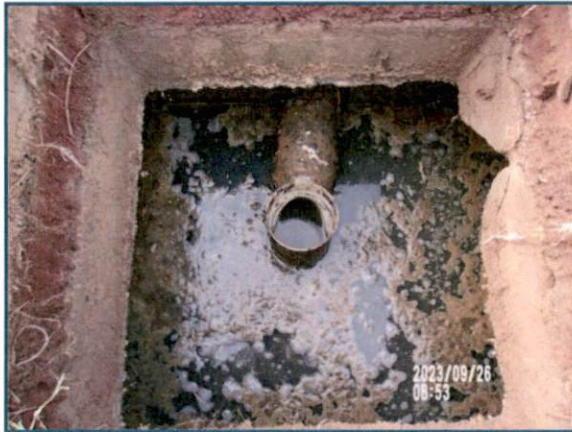
P21. Septic Tank Outlet Water Level

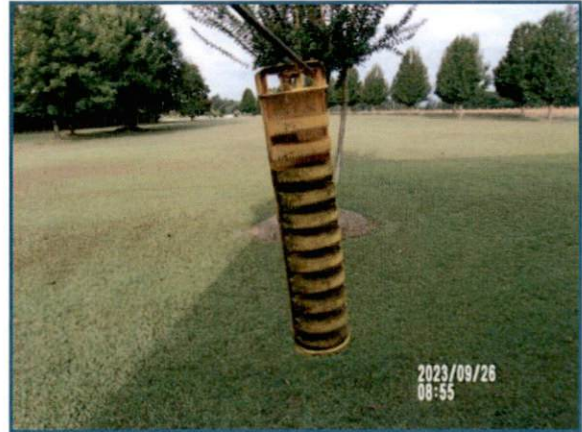
P22. Septic Tank Outlet Filter—Cleaned

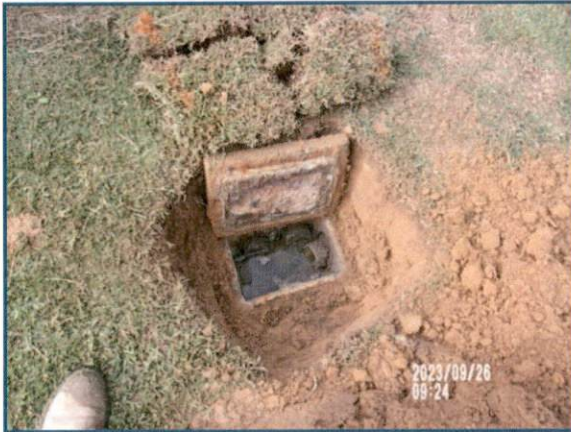
The distribution box was located and it measured four feet out to the right of the septic tank outlet and twelve feet back towards the right side of the house. I measured the box to be two feet on the opposite side of the fence than the septic tank, and twelve feet and six inches off the right hand side of the house. The distribution box and lid were severely deteriorated, and should be replaced at this time. When I first opened the lid I noticed that the water was standing above two of the outlets, and the water that was put inside the septic tank was only flowing out of the line closest to the front of the property.

P25. Distribution Box

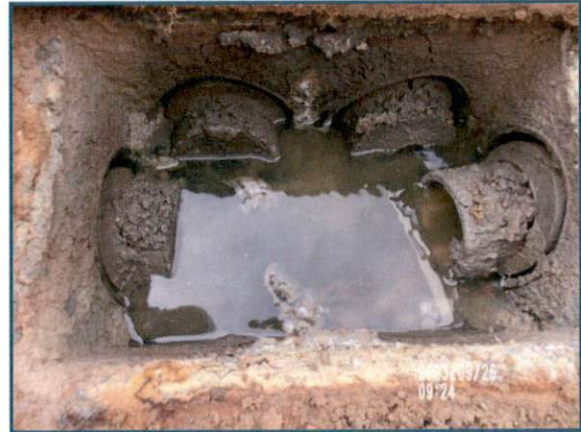
P26. Distribution Box—Before Flow Test

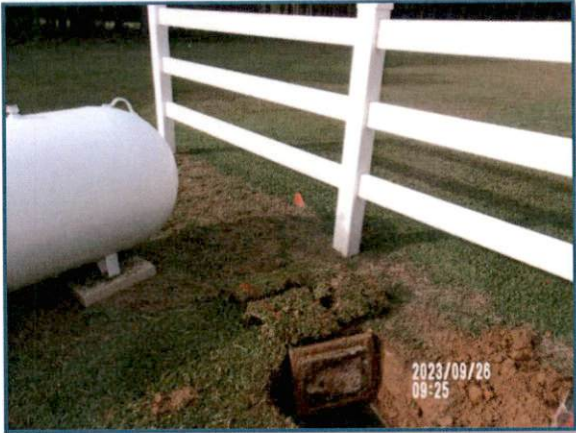
After the flow test was performed, I probed and located the drain field lines. There are three EZ-Flow drain field lines, and each of these run from the distribution box, towards the right side of the front yard, and on contour. All of the lines are three feet wide and 100 feet long, and each line was measured to be at least nine feet apart from each other, from their centers. Additionally, each line contained at least six inches of soil cover on top, which is the required amount of soil cover. Lastly, I did a final walk through of the system to look for any grading issues, non-permitted connections, or signs of past or current surfacing of waste water, and none were observed. It was apparent, however, that the two lines that were not accepting any effluent were overly saturated at the depth of the drain field media. Ten minutes after the conclusion of the flow test, I observed the distribution box again, and the water level was still

P27. Beginning of 1st Drain Line

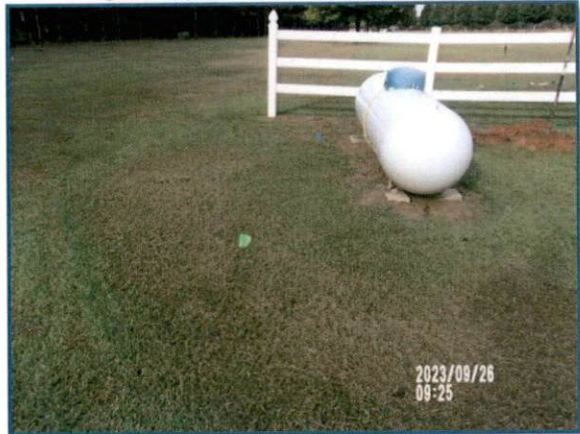
P28. Beginning of 2nd & 3rd Drain Lines

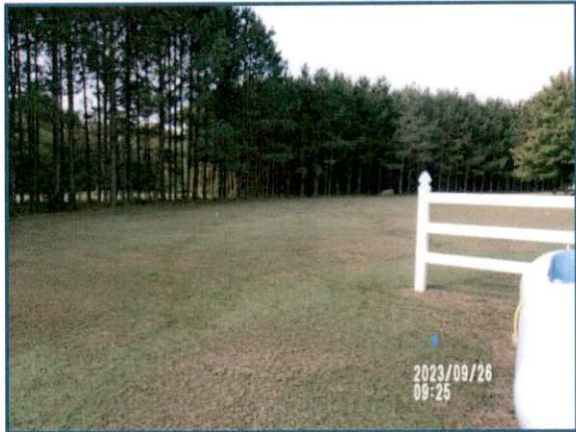
P29. Direction of Drain Field Lines

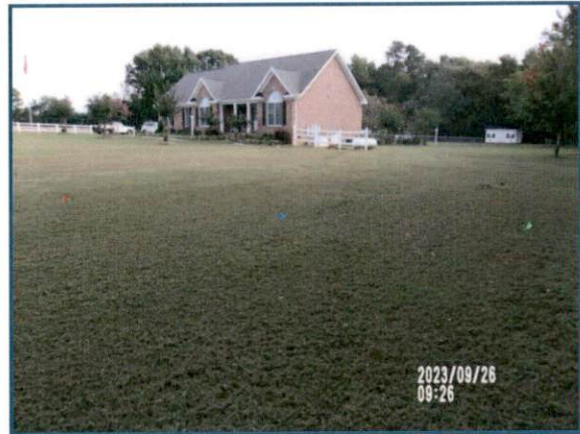
P30. End of Drain Field Lines

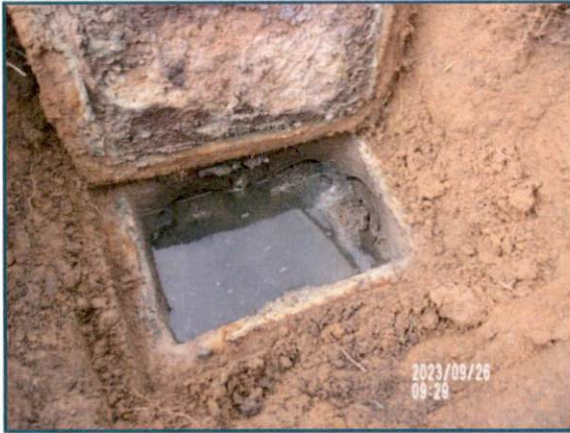
At this time I ran water into the outlet of the septic tank to perform a flow test. After only eight minutes the single line accepting effluent had reached its capacity, and the water began to back up into the box. It was at this point that I turned off the water to conclude the flow test. Since the flow rate was measured to be five gallons per minute, the total volume of the flow test was approximately 40 gallons. Because this system is designed to accommodate, at a maximum, six people at sixty gallons per person per day, the drain field needs to be repaired. It is possible that with a full house, the water will back up into the septic tank and above the inlet pipe, which will prevent proper plumbing drainage or possibly surfacing effluent in and around the septic system.

P31. Distribution Box—After Flow Test

above each of the three outlet pipes. Contact the local environmental health department to obtain a permit for repairing the drain field.

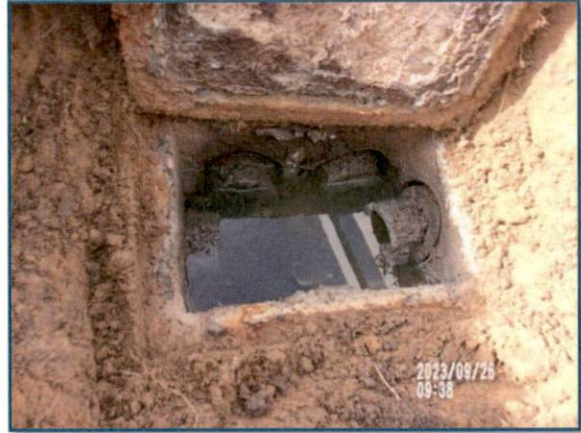
P32. DBox—Ten Minutes After Flow Test

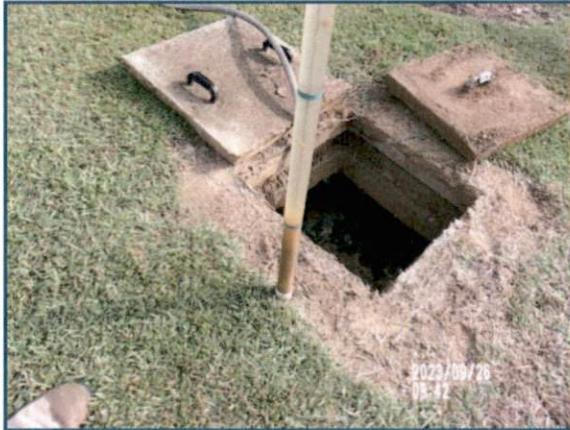
P33. Septic Tank Inlet Column Sample

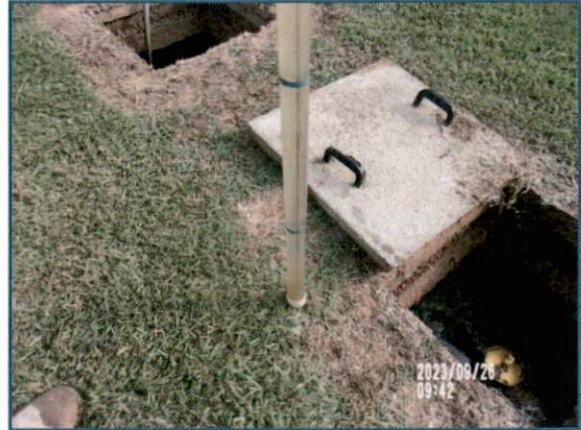
P34. Septic Tank Outlet Column Sample
