## **On-site Wastewater Inspection**

Pre-Inspection Contract, signed by Client is attached to Inspection Property Address \_\_\_\_\_8246 US-401,\_\_\_ Fuquay-Varina,\_\_\_, NC,\_\_\_\_27526\_ Street. Zip code Client Name: JEFF COBURN Current owner of Record NOT AVAILABLE\_\_\_\_ 5/6/2024 Date of Inspection \_3\_Advertised number of bedrooms as stated in MLS or as stated in attached sworn statement by owner or owner's representative. NA Gallons per day for designed system size or number of bedrooms as stated in available local health department information. ✓ Inspection shall include any part of the system located more than 5 feet from the primary structure that is a part of the operations permit. NA \_\_\_Copy of Operations permit from County Environmental Health Attached. NA System requires a certified subsurface water pollution control system operator pursuant to G.S 90A-44 Current Operator's Name attached. ✓ not available Most recent performance, operation and maintenance reports are: Type of water supply ✓ Well □ Public Water. □ Community Water □ Spring. □ NA Location of Septic Tank and Septic Tank details: 0 ft from house or structure NA ft from well if applicable NA ft from

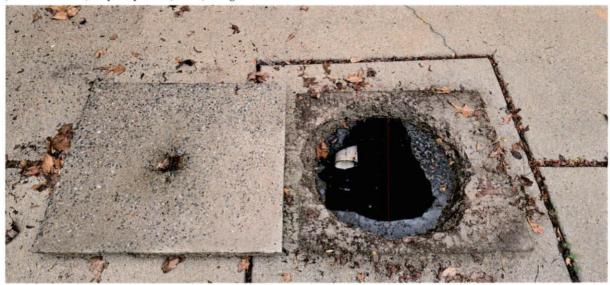
IMAGE TAKEN FROM SOLID SIDE. TECHNICIAN NOTICED

FAIRLY LARGE CRACK ON SIDE OF TANK. RECOMMEND WATER TEST TO SEE IF LEAKING EFFLUENT.

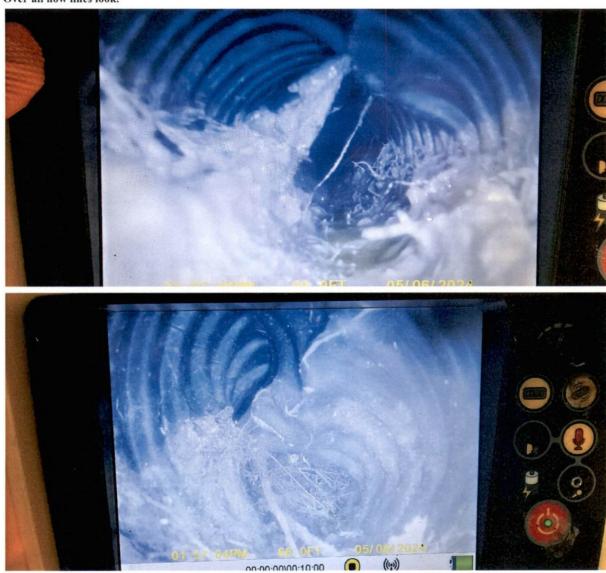
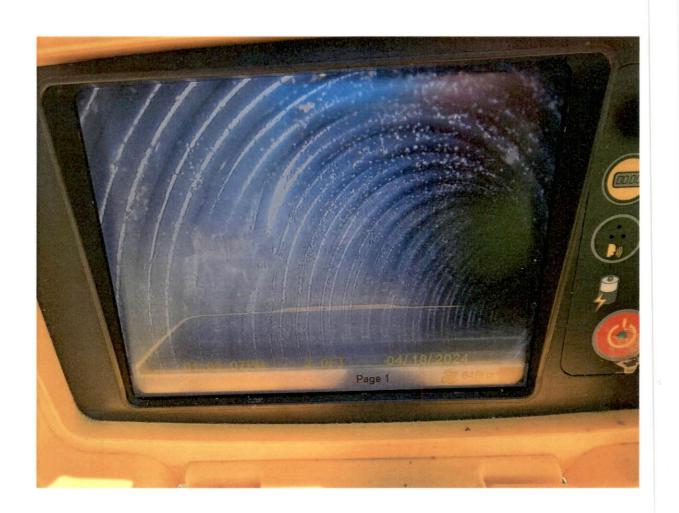
Over all how lines look.
