Application for Repair

Onsite Wastewater System Inspection

Inspection Title
2040 Arrowhead Road

Property Address
2040 Arrowhead Road
Dunn, N.C. 28334

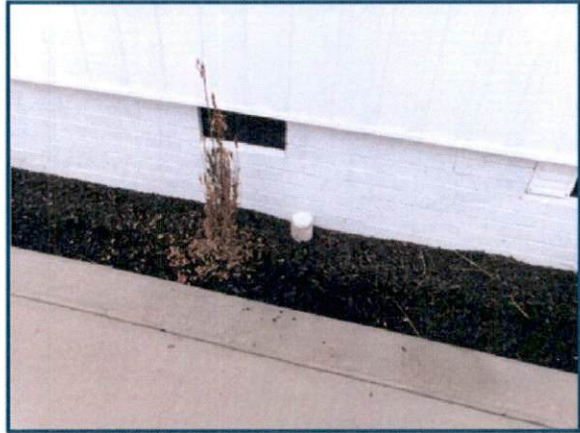
7. The cleanout located beside the foundation was glued shut with a test cap. There should be a screw type cleanout cap on this pipe so that it can be readily removed and replaced.

P4. Cleanout With Glued Test Cap

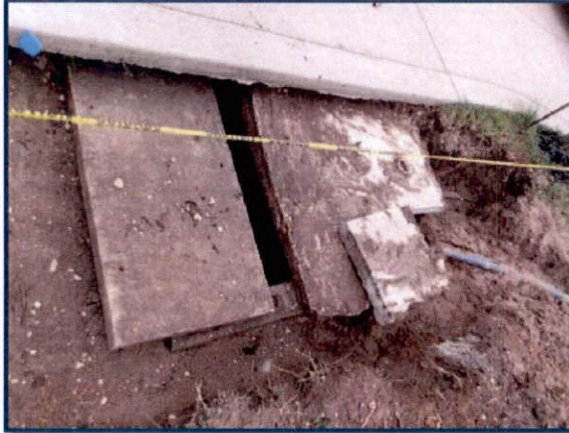
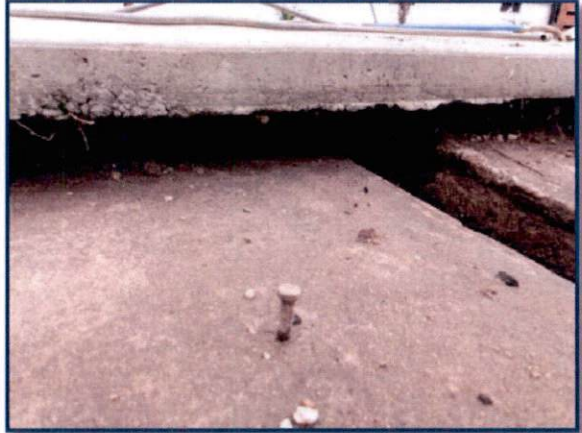
1. The entire left side of the septic tank is approximately six inches underneath the concrete driveway. This septic tank is not traffic rated, and should not be subjected to vehicular traffic.

P5. Septic Tank Underneath Driveway

P6. Septic Tank Underneath Driveway

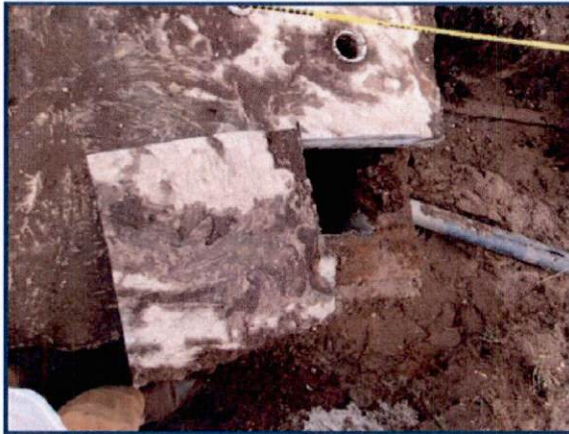
3. The larger slab covering the outlet end of the tank is too large to manually remove. To temporarily remedy this, the owner of the property cut out an eighteen inch by eighteen inch corner from the outlet end of the slab. This will need repair.

P7. Outlet End Slab Corner Cut Out

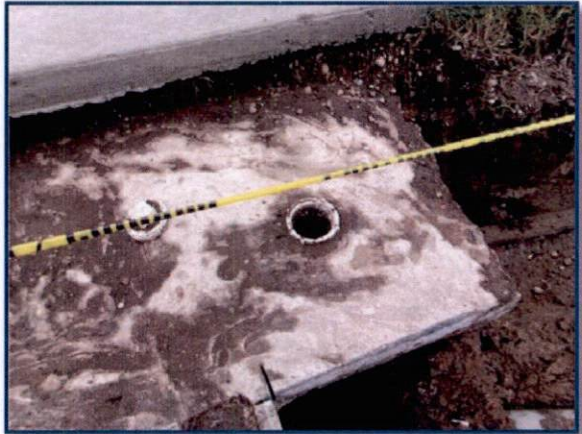
4. A cleanout was installed directly over top of the septic tank outlet tee. The purposes for this cleanout could include, but are not limited to: unclogging the drain field line, the addition of a root control chemical to the septic tank and drain field, or pumping out the septic tank. Since the cleanout is positioned directly over top of the outlet tee, and the pipe is only three inches in diameter, it does not seem probable that this cleanout was installed for the purpose of pumping the tank—most pumper hoses are four inches in diameter. However, there is no way to prove the exact reason for why this cleanout was installed in the slab, since I do not have knowledge of past system performance. A cleanout in this location is not commonly encountered.

P8. Cleanout Installed In Outlet Slab

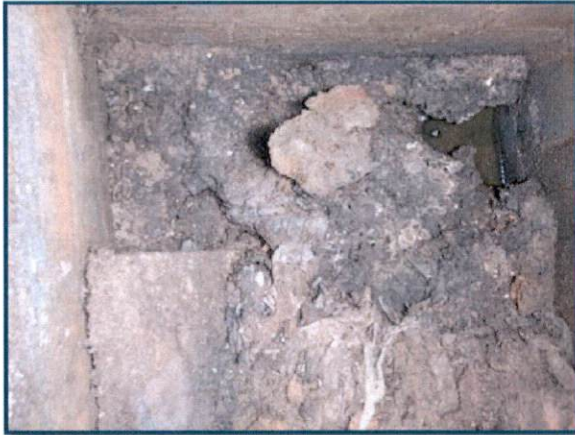
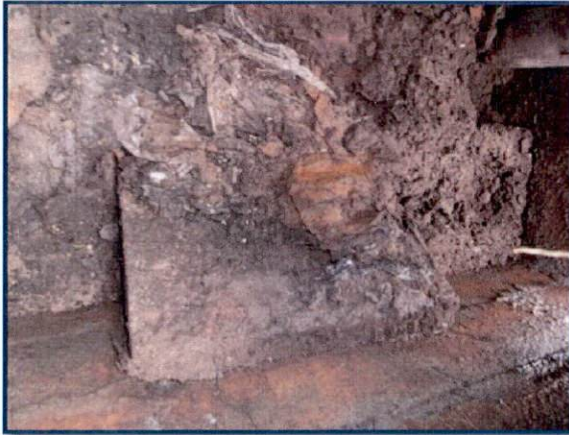
2. The current top of the septic tank is composed of one slab on the inlet end that measured two feet wide and five feet long, and another larger slab that covers the rest of the tank. The larger slab measured five feet long and four feet wide. The larger slab appears to have been handmade as a repair to the original slabs. This was based upon the fact that the original slabs were laying in the bottom of the septic tank.

5. There was no liquid waste inside of the septic tank. The only contents are a mixture of soil and solid waste. The depth of the soil and solid mixture varies between one to two feet. A septic pumping truck will not be able to remove the contents. The homeowner hired a septic pumper to remove the contents of the tank one day prior to the inspection. The pumper attempted to liquefy the mixture by running water into the tank; however, all that was able to be removed was the water that he introduced. It appears that the original slabs collapsed or fell into the tank, at which point the soil above the slabs fell into the tank as well.

P9. Soil, Solid Waste, & Slab In Septic Tank

P15. Soil, Solid Waste, & Slab In Tank

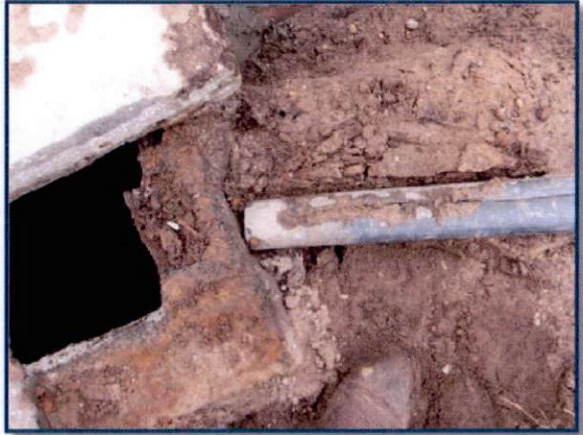
10. I observed there to be a second pipe at the outlet end of the tank, but this pipe was not connected to the tank, and I did not observe there to be any sign of a penetration for this pipe. I looked for any sign that a penetration was repaired, and that the pipe was abandoned, but I could not find one. The purpose of this pipe was undetermined.

P16. Second Pipe At Outlet Of Septic Tank

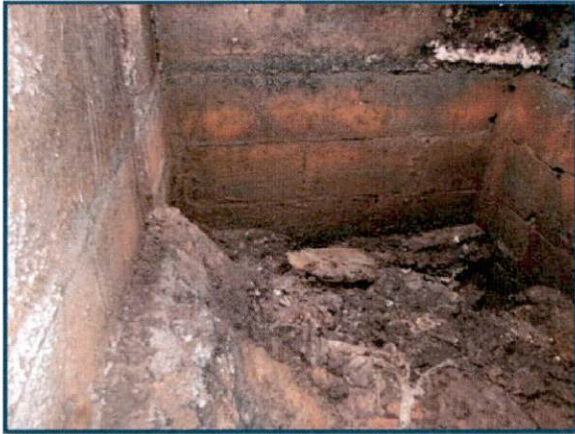
P19. Soil & Solid Waste In Septic Tank

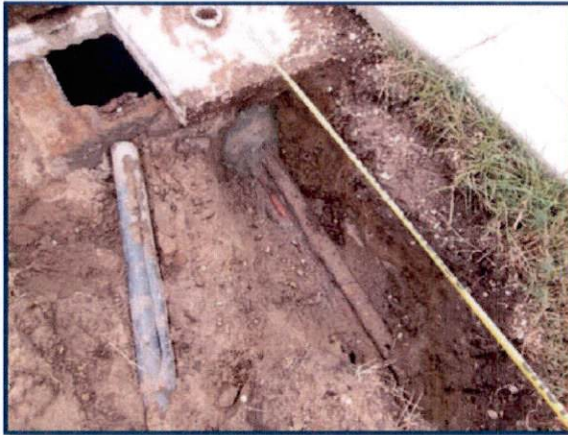
9. I attempted to locate the drain field line using a probe rod, but I was unable to penetrate the soil due to hardpan and native rock in the soil. Instead, I ran a camera into the drain field line. I was only able to locate approximately fifteen feet of the line due to the accumulation of sand and solids inside the terracotta drain tile.

P21. Terracotta Drain Tile For Drain Line

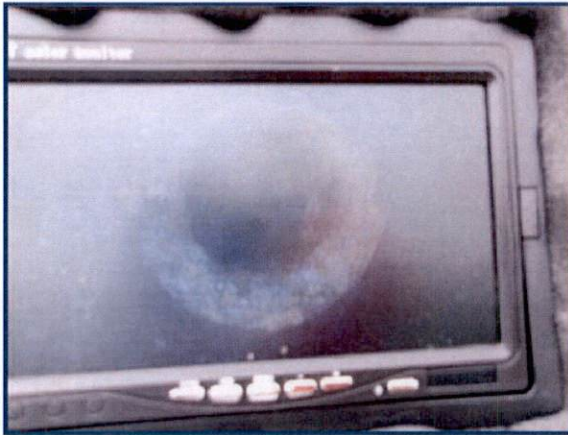
P23. Transition from Cast Iron To ABS

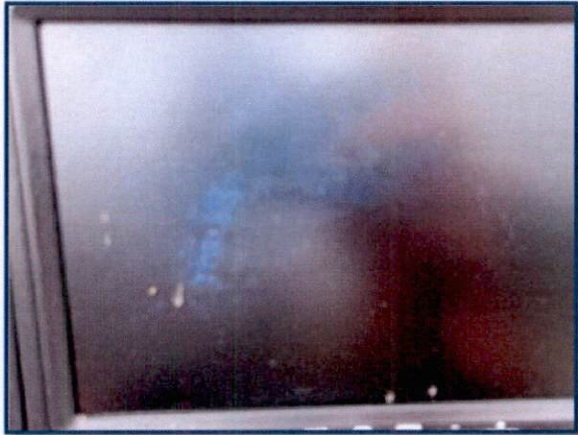
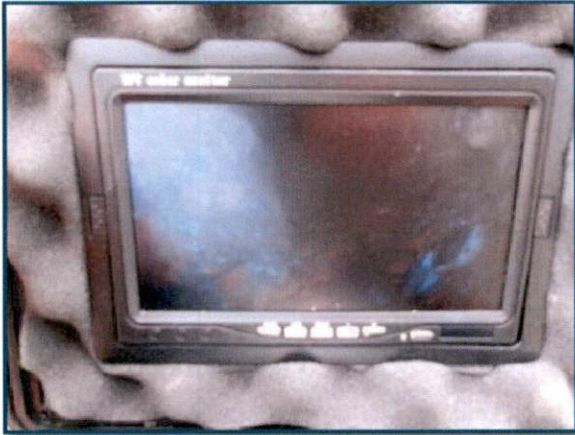
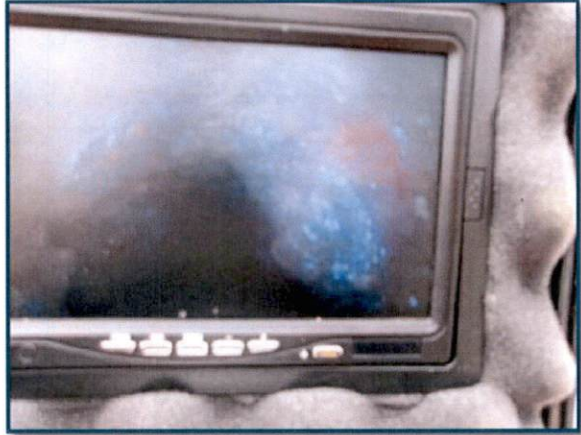
8. There was an obstruction observed inside the inlet pipe, between the house and the septic tank. I measured the obstruction to be approximately seven to eight feet from the septic tank. The obstruction appears to be corrosion on the bottom of the cast iron pipe.

P24. Obstruction in Cast Iron Inlet Pipe

P25. Obstruction in Cast Iron Inlet Pipe

P26. Obstruction In Cast Iron Inlet Pipe

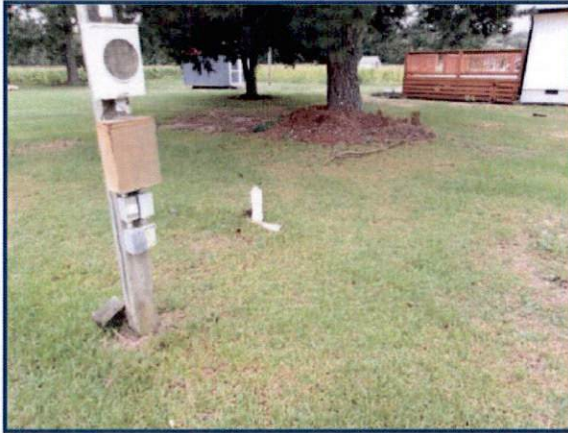
Next, I observed the boundaries of the property. Since the property lines were not marked, I am unable to measure the distance from the property lines to the septic system components. While observing the estimated boundaries of the property, I observed an old mobile home power service approximately forty-five feet to the left of the house. Near this power service, I observed there to be a plumbing drain for the mobile home site. Since there is no sewer available, there could be another septic system on the property. I am not sure if this plumbing drain is located on the same lot. If the plumbing drain is on the same lot, then a septic

inspection would be needed in order to determine if there is another septic system that is in satisfactory condition for use.

P31. Location of Plumbing Drain & Power Service
