Southeastern Soil & Environmental Associates, Inc.

October 06, 1997

Re: Soil/site evaluation and repair proposal, State Project 6.451009 (ID No. 2230-C),
Sarah W. Clark property, N.C. Hwy. 210, Harnett County, North Carolina

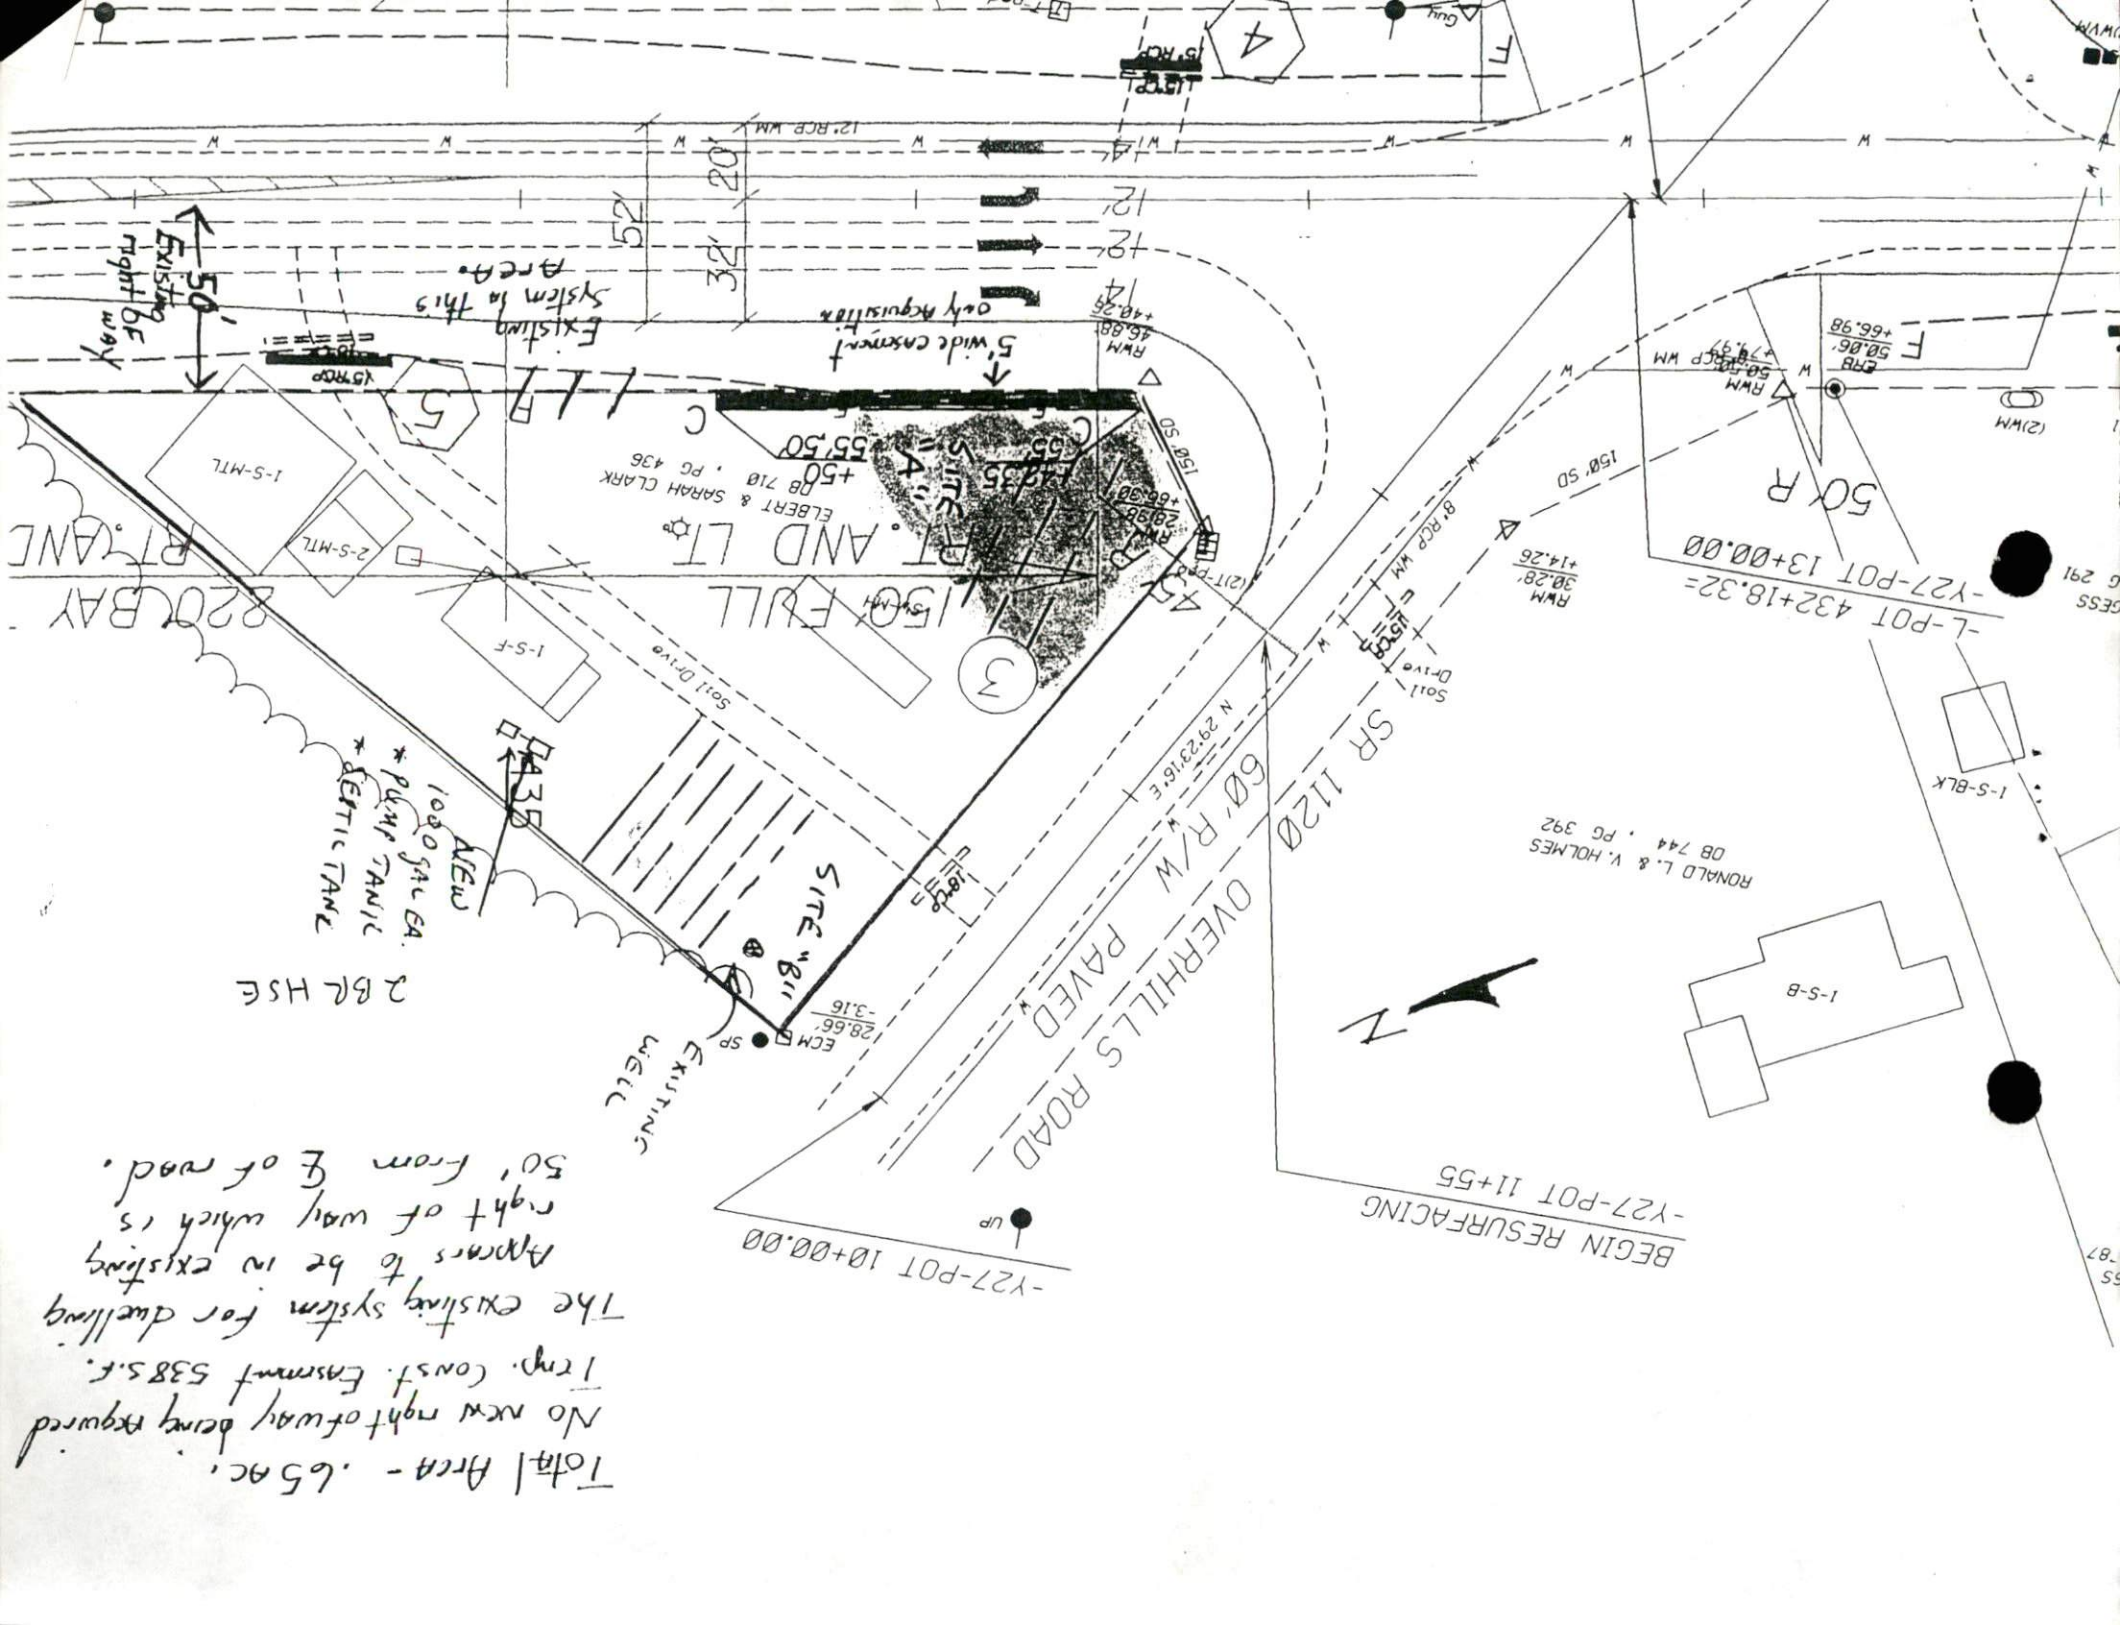
As shown on the accompanying map, portions of the existing system are located within the existing 50 foot right of way for NC 210. Two areas have been located that contain useable soils for the installation of a new drainfield (see map). Each area essentially lies on a linear (3-8 %) landscape. Soil borings conducted in these areas consisted of 8 to 36 inches of loamy sand underlain by sandy clay loam or clay extending to 48 or more inches. Soil wetness was typically observed greater than 27 inches below the soil surface. All other soil characteristics were either suitable or provisionally suitable to at least 27 inches.

Each of the two sites would require the use of an effluent pump. Site "A" requires a system installation with conventional drainfield as is. Site "B", however, would require the abandonment of the existing well (due to setback requirements) and location of a new well or connection to a municipal water tap.

Total Area - .65 ac.
 No new right of way being required
 Temp. Const. Easement 538.5 f.
 The existing system for dwelling
 appears to be in existing
 right of way which is
 50' from E of road.

Existing System in this
 Area
