• Site Visit On 5/24/07 By OT & GB

OVERHILLS CREEK
SECTION ONE

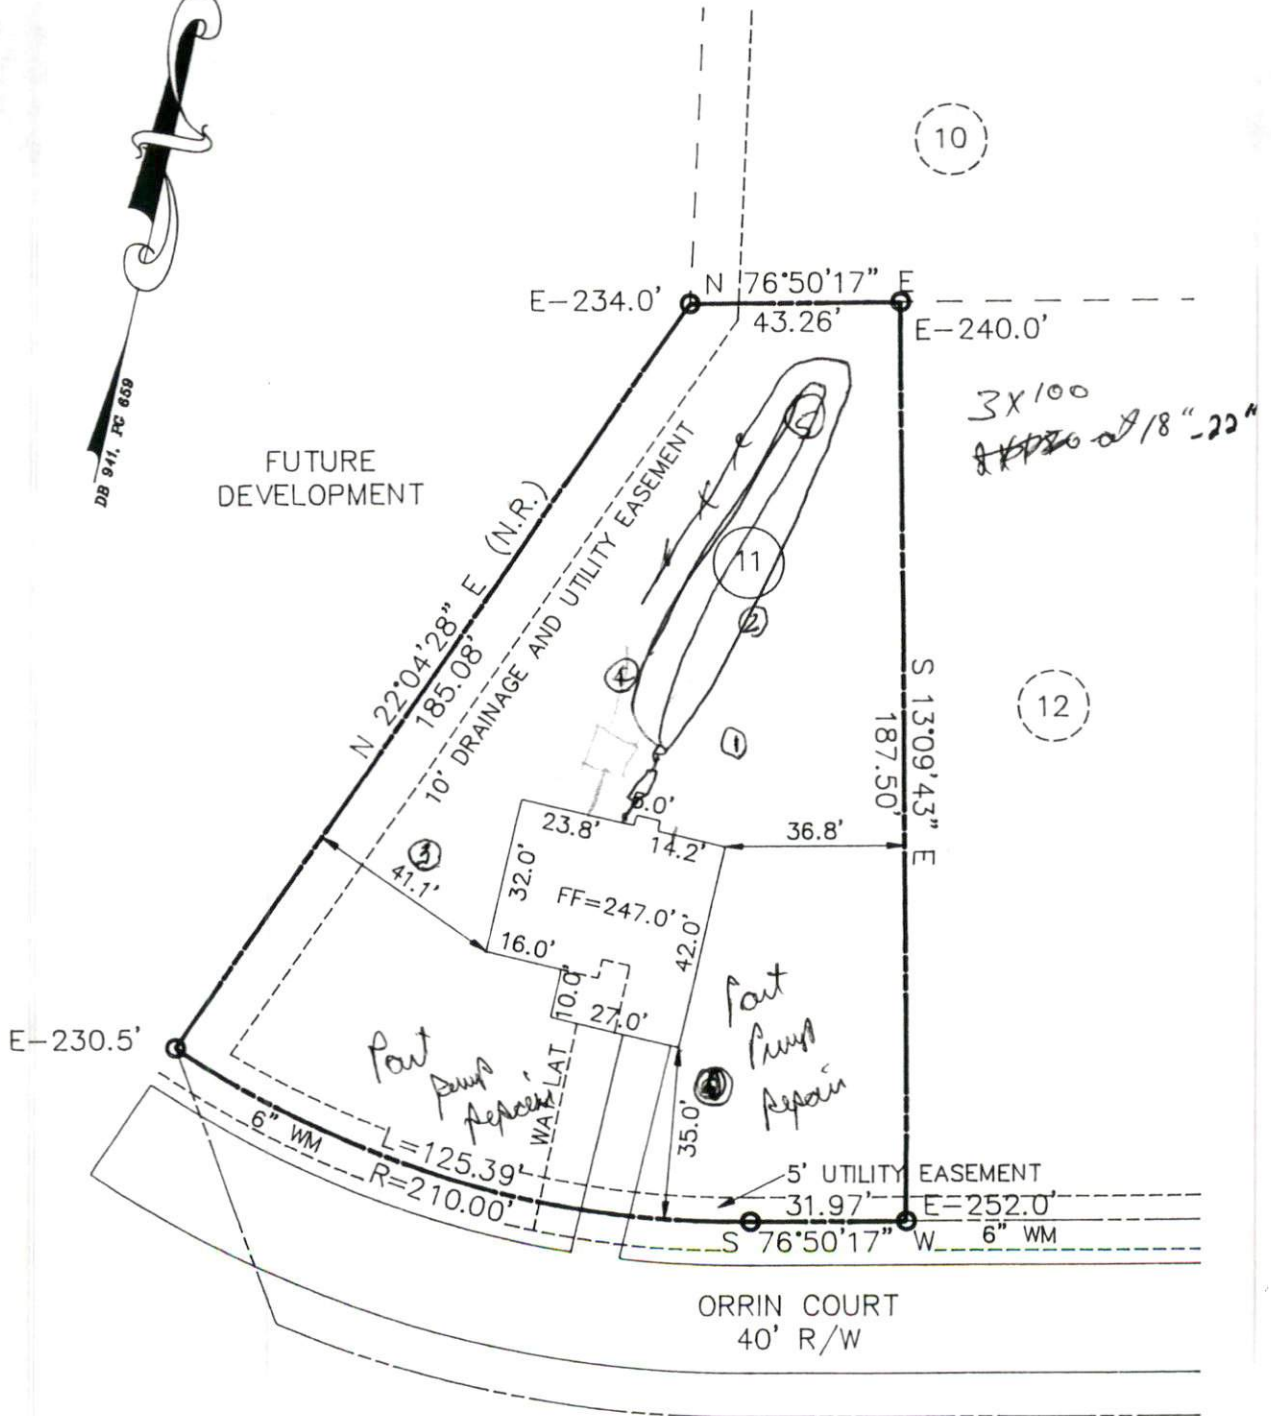
• Failure At Lower End Of Field Effluent Surcasing

• D-Box Dug Up During Visit

- 2 of 4 Lines Receiving All Effluent
- D-Box Deteriorating Severely
- Speed Dial Adjusted To Have Majority Of Flow Diverted To 2 Non-Failing Lines

• D-Box To Be Replaced; New Cover To Be Placed Over Failing Area
