TYNDALL
ENGINEERING & DESIGN, P.A.

Reference: Engineering Services
Focht Residence
99 Curtis Dr.
Erwin, NC 28339
TE&D Project No.: DRB2201-0154_C

Reference: Engineering Services
Focht Residence
99 Curtis Dr.
Erwin, NC 28339
TE&D Project No.: DRB2201-0154_B

Reference: Engineering Services
Focht Residence
99 Curtis Dr.
Erwin, NC 28339
TE&D Project No.: DRB2201-0154_A

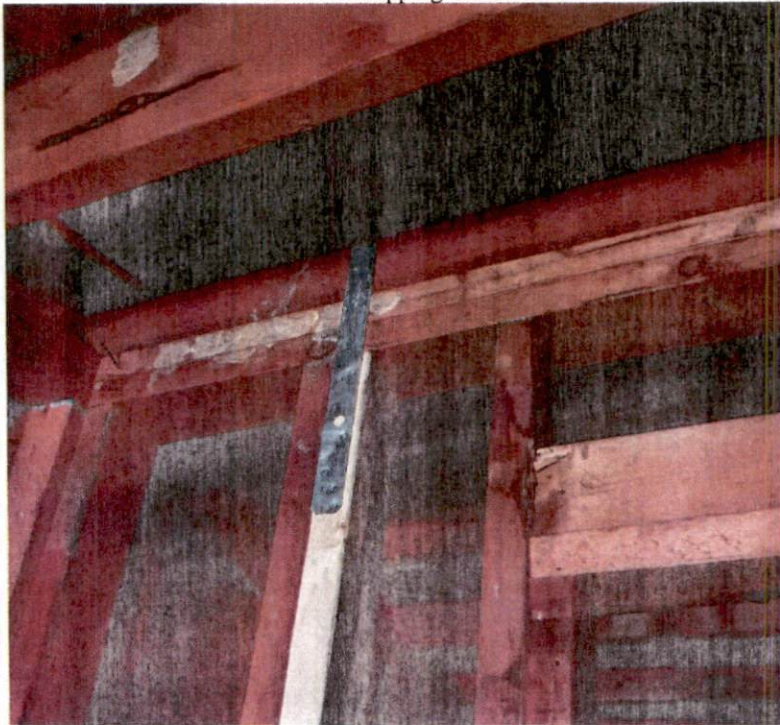
LSTA12 Strapping Installed

1. The LSTA12 strap was installed to the plan specified (2) 2 x 4 stud column and the existing (2) 1-3/4" x 9-1/4" LVL header. No further modification is required.
2. The ML28Z was removed and re-installed tightly per the manufacturer's specifications to the beam. No further modifications are required.

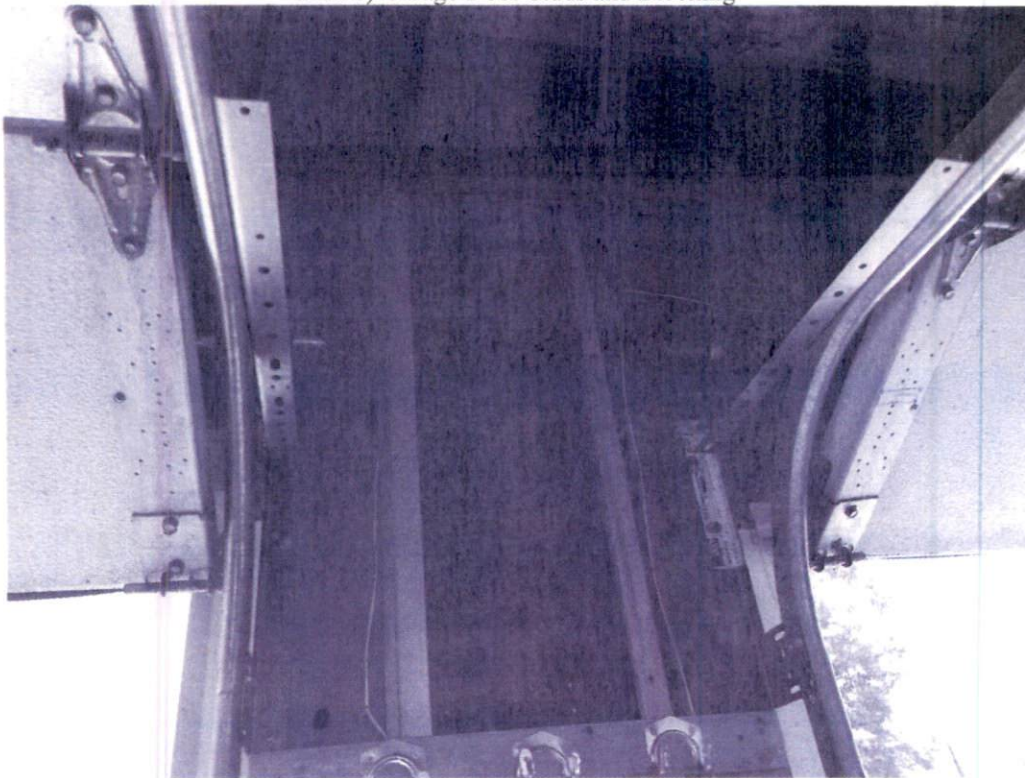
Item 6) Garage Door Studs and Blocking

5. The 2 x 10 band in the garage was secured to the wall framing and the trusses per our recommendations. No further modification is required.
6. The garage doors were framed with (2) 2 x 4 jacks and (3) 2 x 4 king studs at each end. Additionally, 2 x 10 blocking and CS-16 strapping were installed per our specification. No further modification is required.

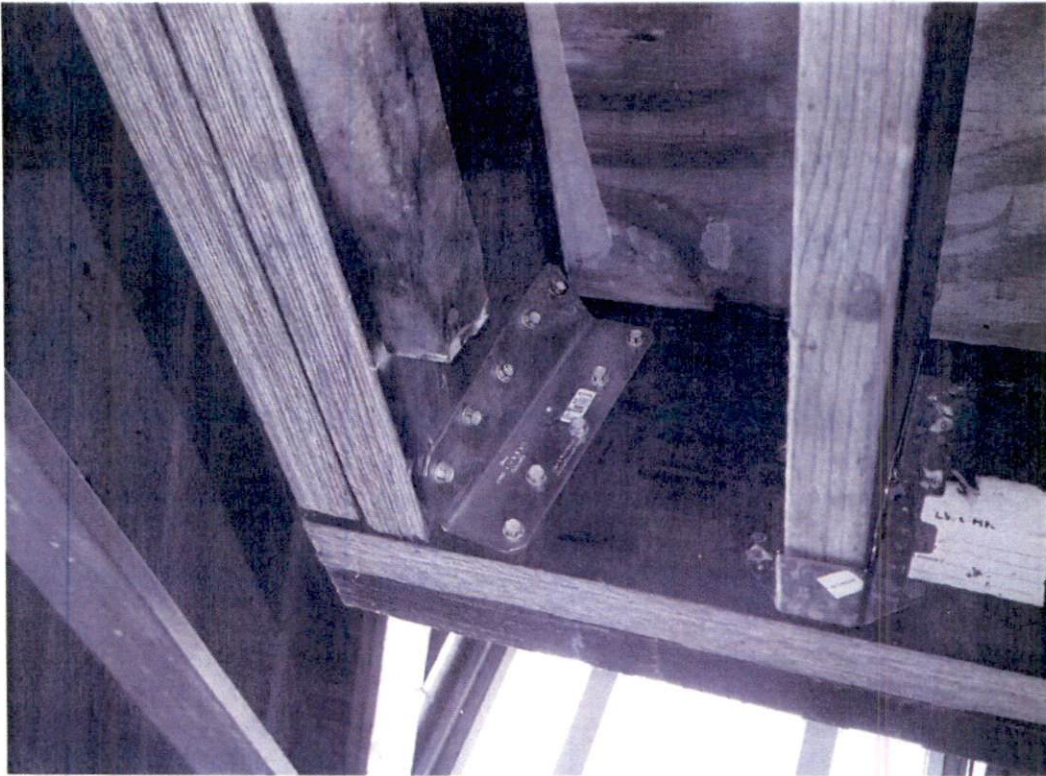
Item 9) DTT2Z holdowns

7. We observed Simpson DTT2Z holdowns with 8" x 1/2" diameter Titen HD screw anchors were installed per the structural plan. No further modification is required.

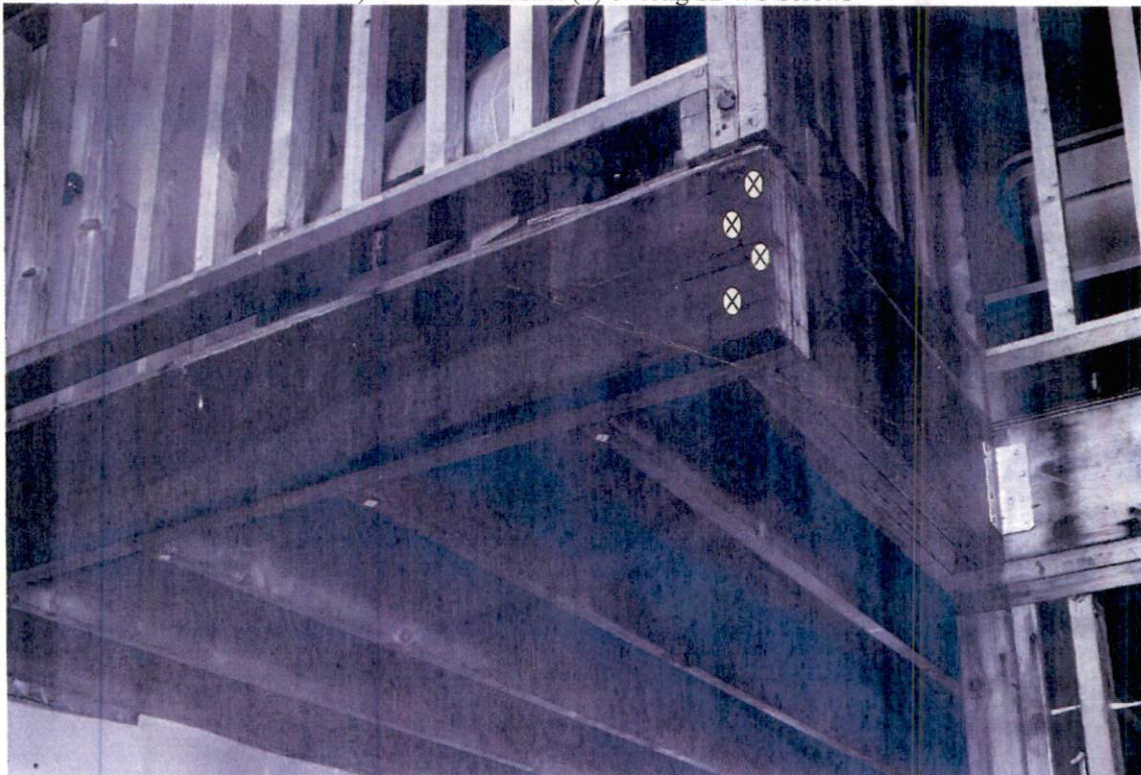
Item 4) Continued: Install (4) 8" long SDWS Screws

4. We observed the interior corner of the LVL beams were fastened together with a Simpson ML28Z hanger, however, the ML28Z hanger was not installed per the manufacturer's specifications. To reinforce the connection, the LVL beams are to be further fastened together with (4) 8" long SDWS screws installed from the face of the front LVL into the end grain of the second LVL beam. In lieu of SDWS screws, the ML28Z may be removed and re-installed tightly to the beam.

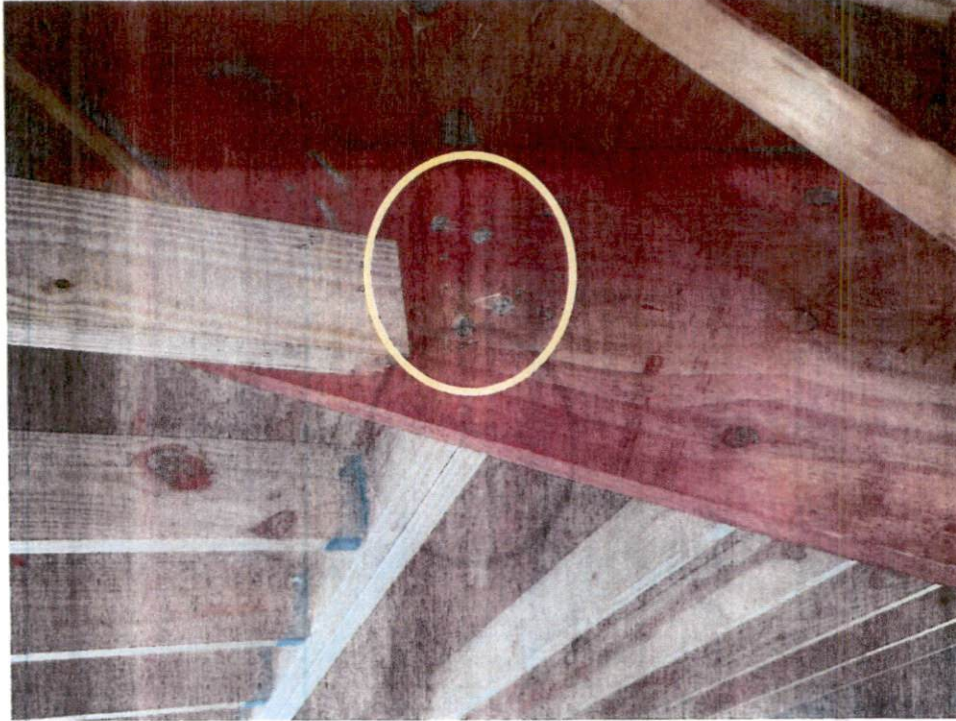
Item 1) Secured (2) 2 x 10 Header to Valley Rafters.

1. The (2) 2 x 10 beam was secured to the LVL valleys with (4) SDWS Screws at each end. No further modification is required.
2. The 2 x 6 header was installed with (1) 2 x 4 jack and (1) 2 x 4 king stud at each end in lieu of the plan specified (2) 2 x 4 jacks at each end. Based on our observations and analysis, this configuration is adequate to support the anticipated loading conditions. No further modification is required.
3. We observed the LSTA12 strap to have been installed to the door framing and 2 x 4 header, not to the plan specified (2) 2 x 4 stud column and the existing (2) 1-3/4" x 9-1/4" LVL header. The Simpson LSTA12 strapping is to be installed as specified in the plan.

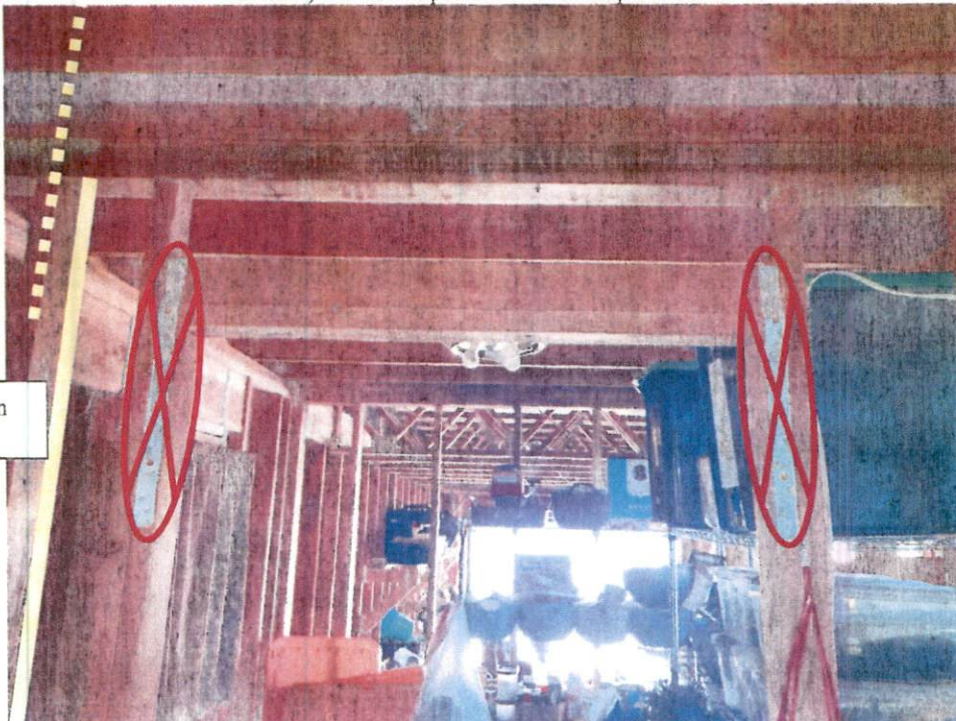
Item 3) Install Simpson LSTA12 Strap Per Plan

(2) 2 x 4 stud column with
Simpson LSTA12 strap

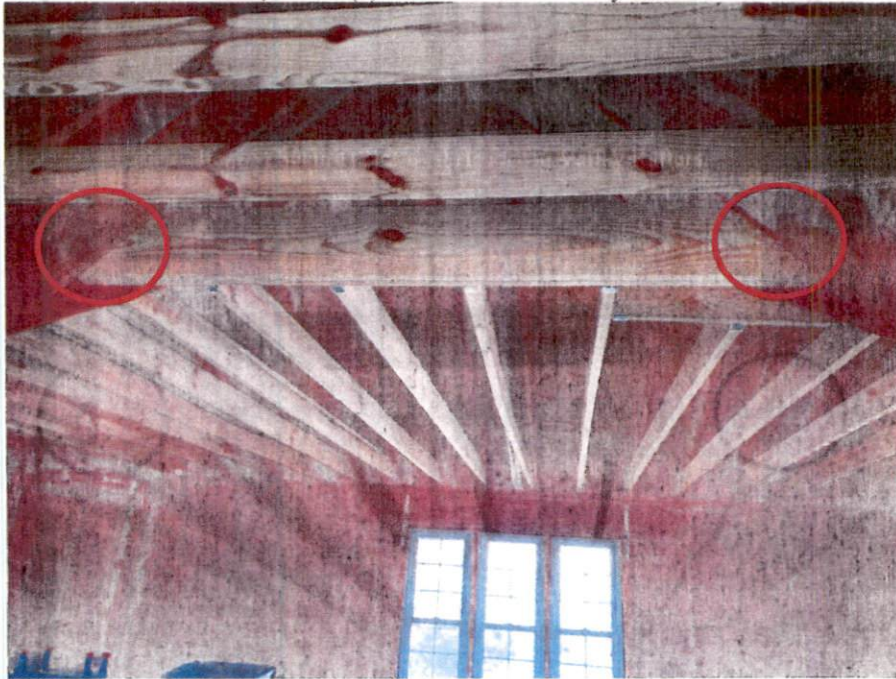
Item 3) Secure (2) 2 x 10 Header to Valley Rafters.

3. We observed the (2) 2 x 10 beam at the right gable was not secured to the valleys with Simpson LUS28-2 connectors per the structural plan. Based on our observations and analysis, the existing configuration is inadequate to support the anticipated loading conditions. TE&D recommends securing the existing (2) 2 x 10 beam to the LVL valley rafters with Simpson LUS28-2 connectors OR (4) SDWS screws at each end.

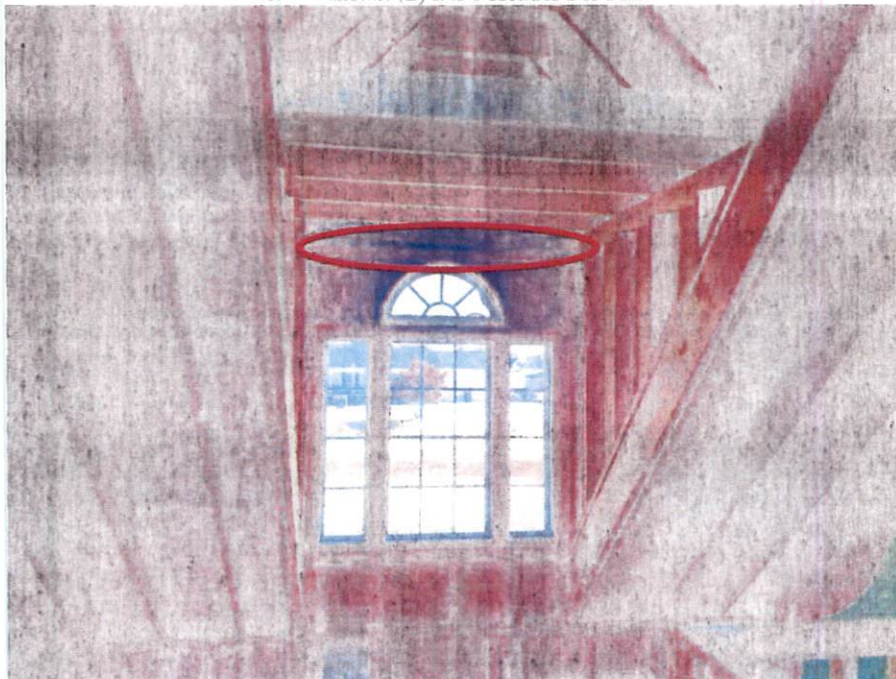
Item 4) Install (2) 2 x 6 Header Per Plan

4. We observed the (2) 2 x 6 header was not installed over the window in the left gable. Based on our observations and analysis, the existing configuration is inadequate to support the anticipated loading conditions. TE&D recommends installing the (2) 2 x 6 header per the original structural plan.

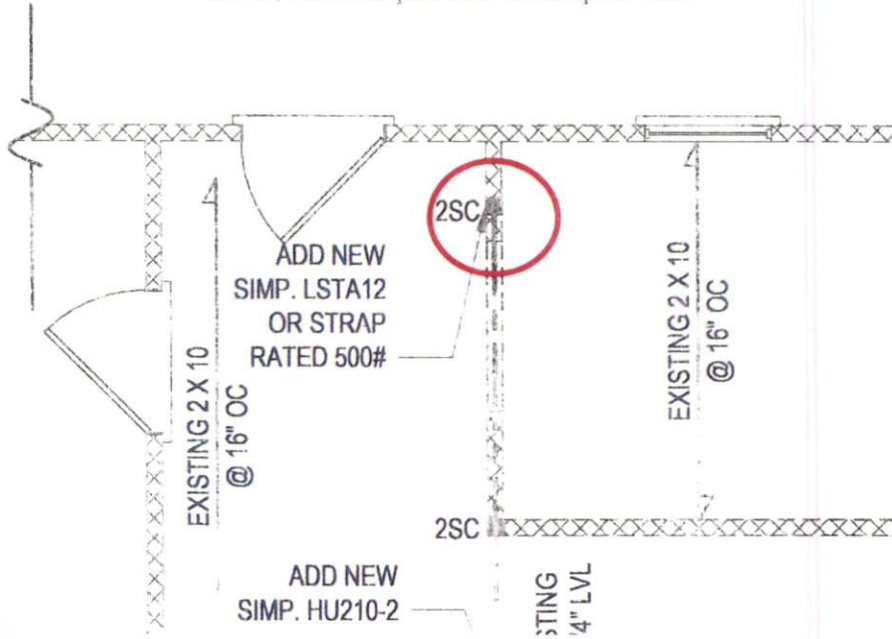
Item 5) Install Simpson LSTA12 Strap Per Plan

5. We observed the stud column at the rear of the pantry door was not secured to the header with Simpson LSTA12 strap installed per the structural plan. Based on our observations and analysis, the existing configuration is inadequate to support the anticipated loading conditions. TE&D recommends securing the stud column to the header with a Simpson LSTA12 strap per the structural plan.

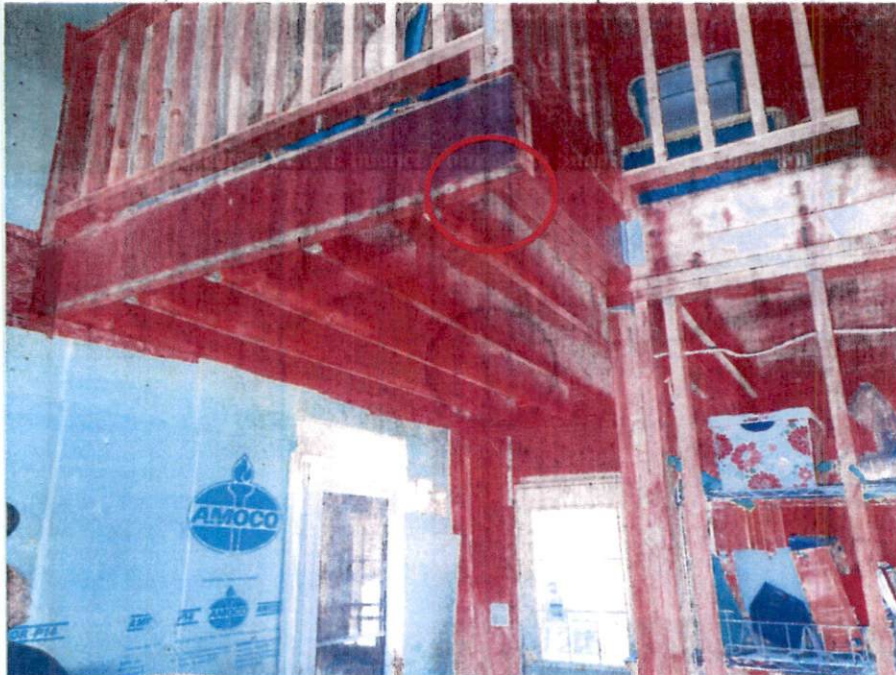
Item 6) Secure LVL's at Interior Corner with Simp. ML26Z Connector

6. We observed the (2) 1-3/4" x 9-1/4" LVL end beam at the left of the addition was not secured to the overhanging (2) 1-3/4" x 9-1/4" LVL per the structural plan. Based on our observations and analysis, the existing configuration is inadequate to support the anticipated loading conditions. TE&D recommends securing the interior corner of the LVL beams together with a Simpson ML26Z connector per our previous letter sealed on 11/18/2022.

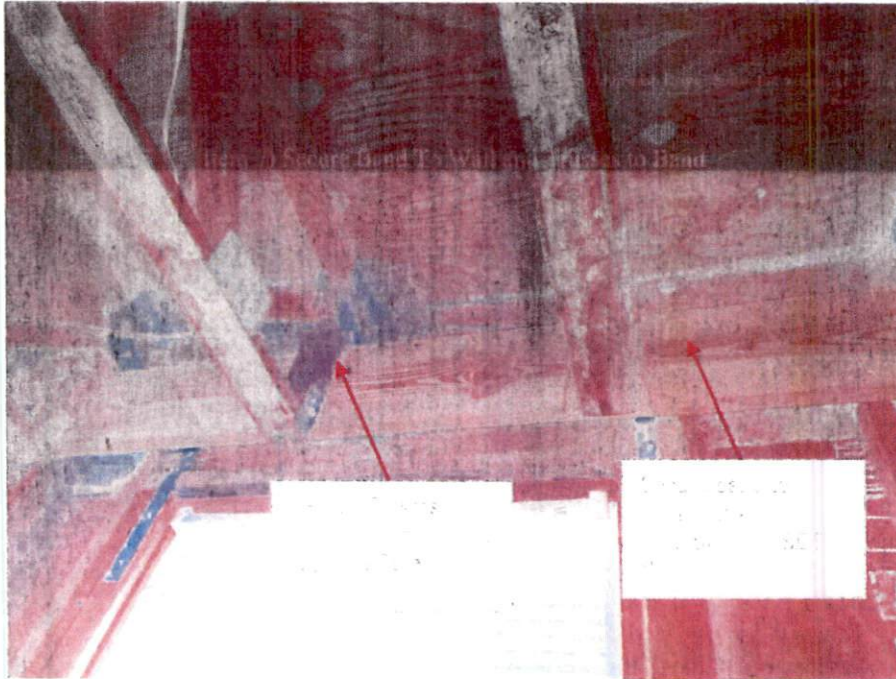
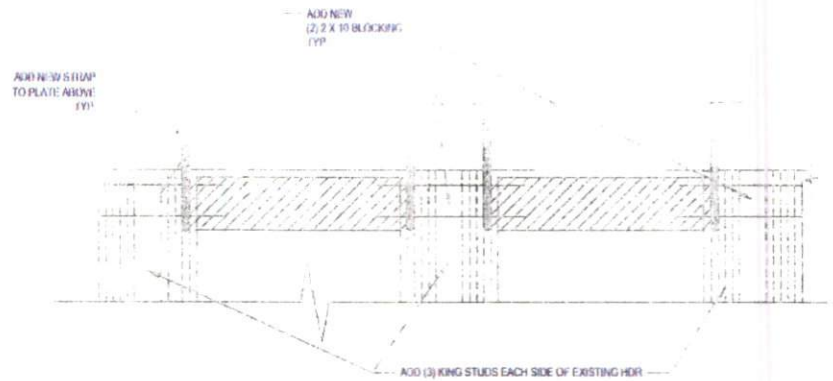
Item 7) Secure Band To Wall and Trusses to Band

7. We observed the 2 x 10 band supporting the floor trusses in the garage was not adequately secured to the wall. Based on our observations and analysis, the existing configuration is inadequate to support the anticipated loading conditions. TE&D recommends securing the band to the existing walls with a minimum of (4) SDS screws at each stud. The trusses are to be secured to the band with a minimum of (5) SDS screws per connection.

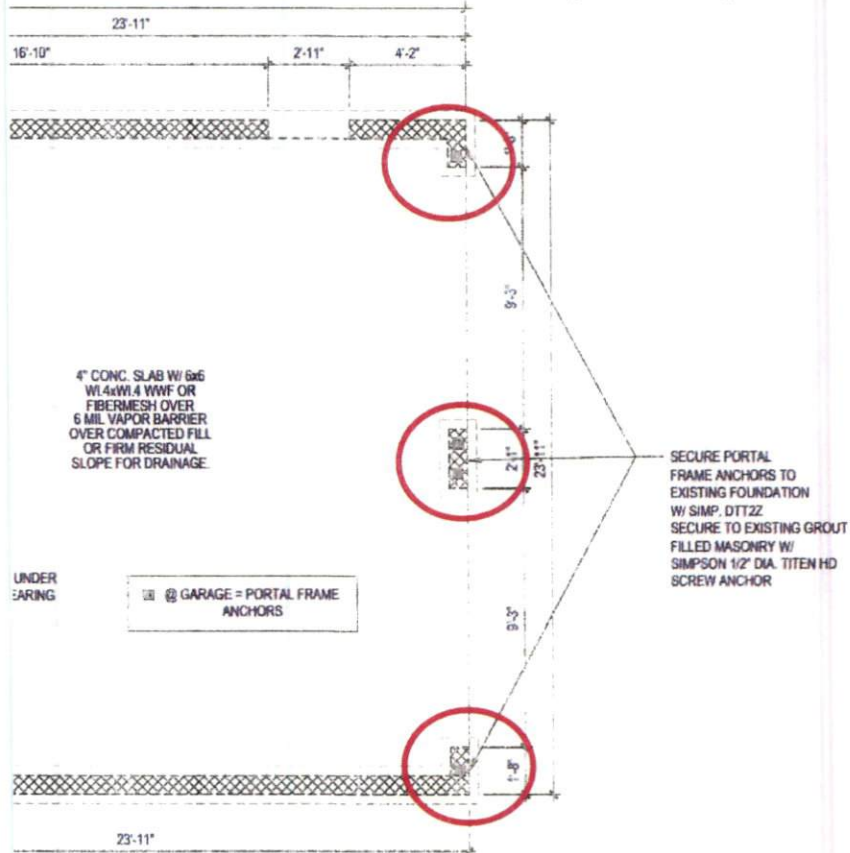
Item 9) Secure Portal Frame Anchors to Existing Portal Framing Per Plan

9. We observed the portal framing at the garage doors was not secured to the foundation per plan. Based on our observations and analysis, the existing configuration is inadequate to support the anticipated loading conditions. TE&D recommends securing the portal framing to the foundation using Simp. DTT2Z with Simpson 8" x 1/2" diameter Titen HD screw anchors per the structural plan.
