Kelly Le

558752
212 Kotata Ave Bunnlevel, North Carolina 28323
raleigh crew 3

Job Setup

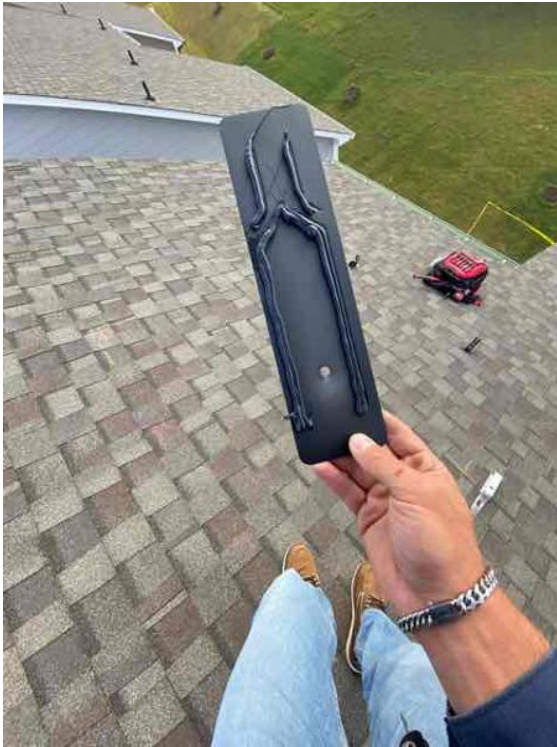
Roof Leak Prevention / Photo of 1 flashing with sealant applied in the correct U-shape

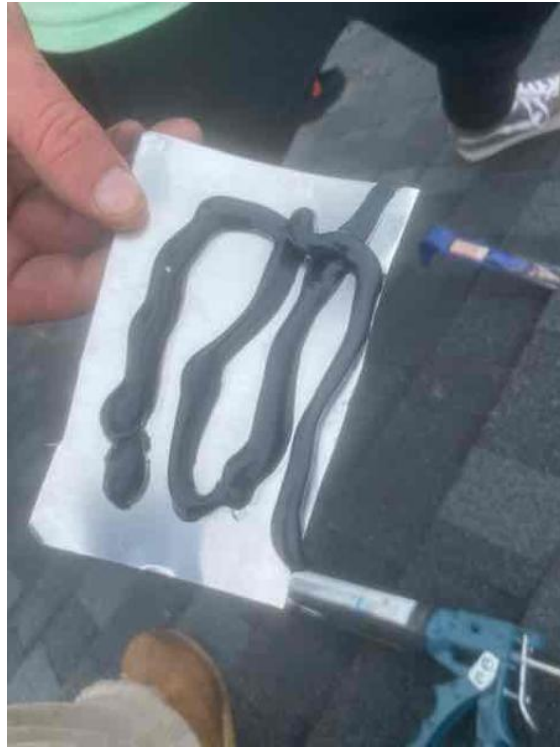
Roof Leak Prevention / Photos of any unused penetrations properly flashed and sealed with aluminum

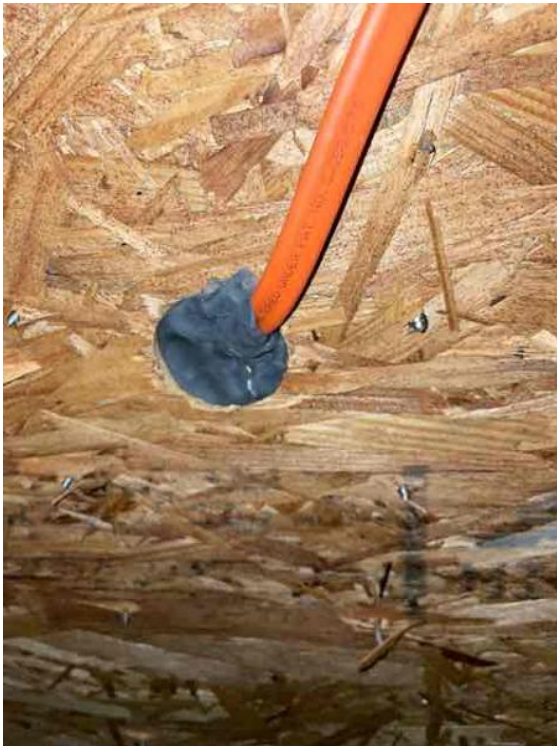
Attic / Wire Run - All wire entrances showing the wire is stapled within 12" of entrance, full wire run with staples every 4 feet, penetration out of attic showing staples within 12" of the exit (pictures of the entire run, showing all the staples).

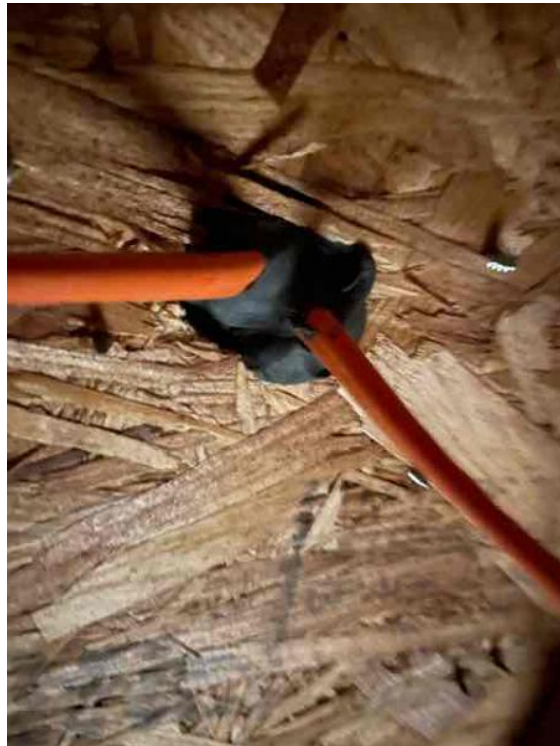
Attic / Wire Run - All wire entrances showing the wire is stapled within 12" of entrance, full wire run with staples every 4 feet, penetration out of attic showing staples within 12" of the exit (pictures of the entire run, showing all the staples).

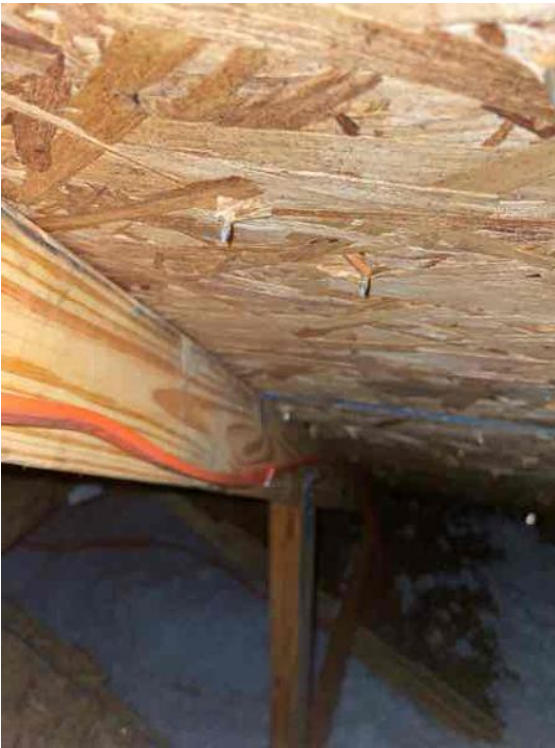
Attic / Wire Run - All wire entrances showing the wire is stapled within 12" of entrance, full wire run with staples every 4 feet, penetration out of attic showing staples within 12" of the exit (pictures of the entire run, showing all the staples).

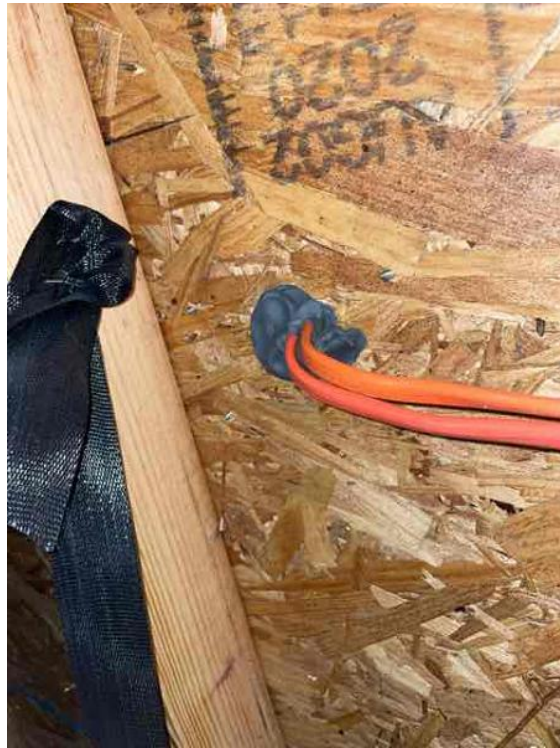
Attic / Wire Run - All wire entrances showing the wire is stapled within 12" of entrance, full wire run with staples every 4 feet, penetration out of attic showing staples within 12" of the exit (pictures of the entire run, showing all the staples).

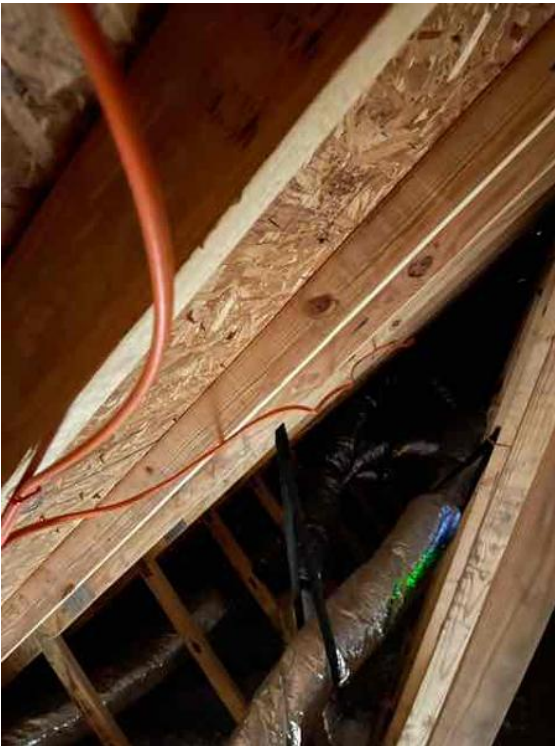
Attic / Wire Run - All wire entrances showing the wire is stapled within 12" of entrance, full wire run with staples every 4 feet, penetration out of attic showing staples within 12" of the exit (pictures of the entire run, showing all the staples).

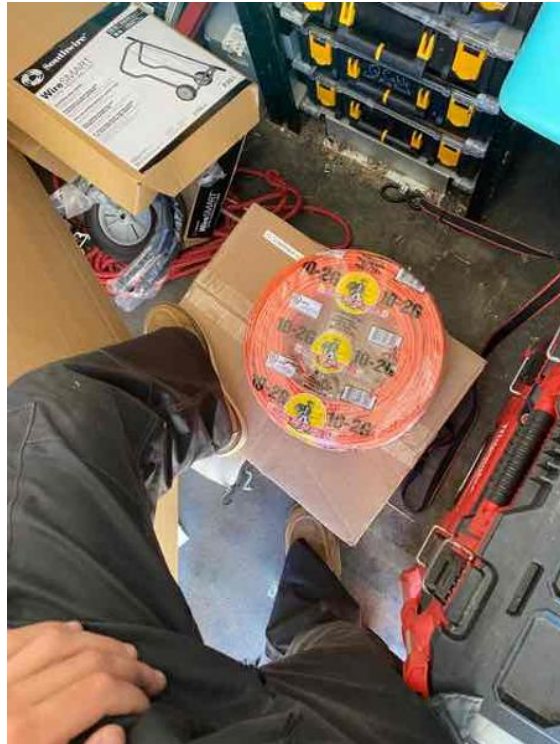
Attic / Photo of spool of wire. If not possible, take a clear photo of writing on wire.
