Rosa Angelica Acosta 1203 Heritage Way Cameron NC 28326

Job Setup			
Powur OS Site ID	3579187	Pre-Existing - issues, damages?	Yes
Customer Name	Rosa Angelica Acosta	Pre-existing issues notes and	As shown
Address	1203 Heritage Way Cameron NC 28326	pictures	
Time of Arrival	8:00	Pre-existing issues: Homeowner notified?	Yes
What time was the equipment delivered?	9:19	Midpoint Inspection Required?	No
	as		
Initial Contact w/homeowner - Greet, job review and walk through completed? Note any initial homeowner concerns /issues?	Yes	Are there any Shading Issues?	No
Array			
Design Error - Layout	No	Was this a ground mount installation or a roof mount	Roof mount
Design Changes - any array layout changes?	No	installation?	
Conduit and Wire Run			
Was the conduit run on the roof, in the attic, trench run, or multiple?	Roof Run	What type of conduit and wire was installed?	1in emt, #6, #8, #10
What size conduit and wire was installed?	1in emt, #6, #8, #10		
Structural Upgrades

Page 1 of 32 Report Created: 06/13/2023

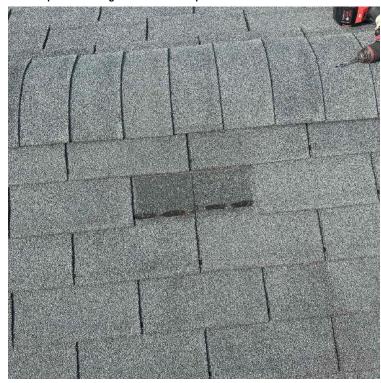
Job Setup / Pre-existing issues notes and pictures

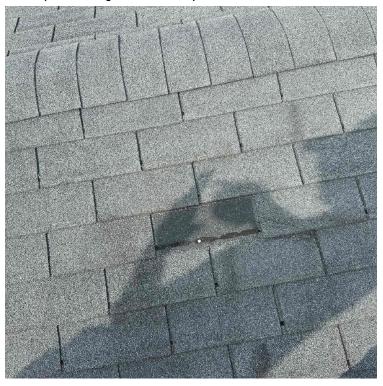
Job Setup / Pre-existing issues notes and pictures

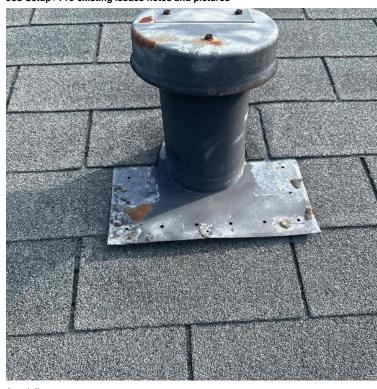
Job Setup / Pre-existing issues notes and pictures

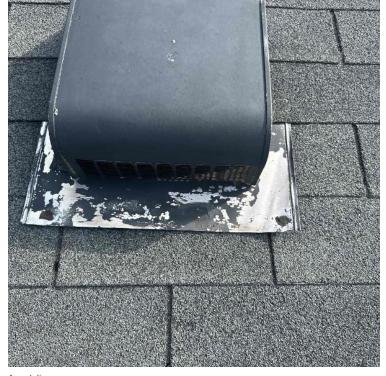
Job Setup / Pre-existing issues notes and pictures
