December 12, 2023

Project No. 23-2778

Re: Structural Observation — 458 Jamestown Dr, Spring Lake, NC 28390

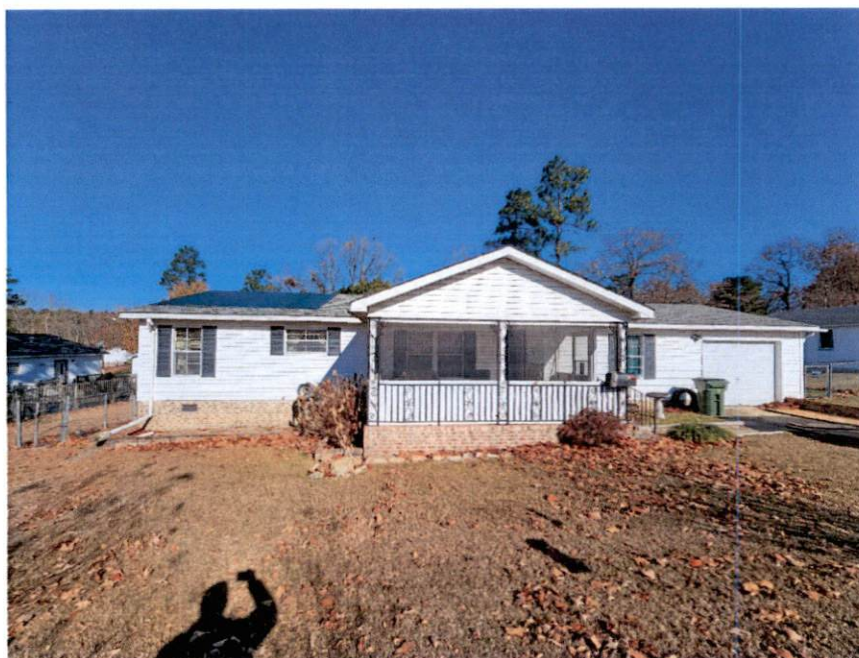
Picture 1 – 458 Jamestown Dr, Spring Lake, NC 28390

At your request, on November 29, 2023 we performed a visual structural observation of damaged roof framing from a reported tree impact at the Spring Lake residence noted above. The structure is a double wide manufactured home over a pier/curtain wall with interior masonry piers (see picture 1).

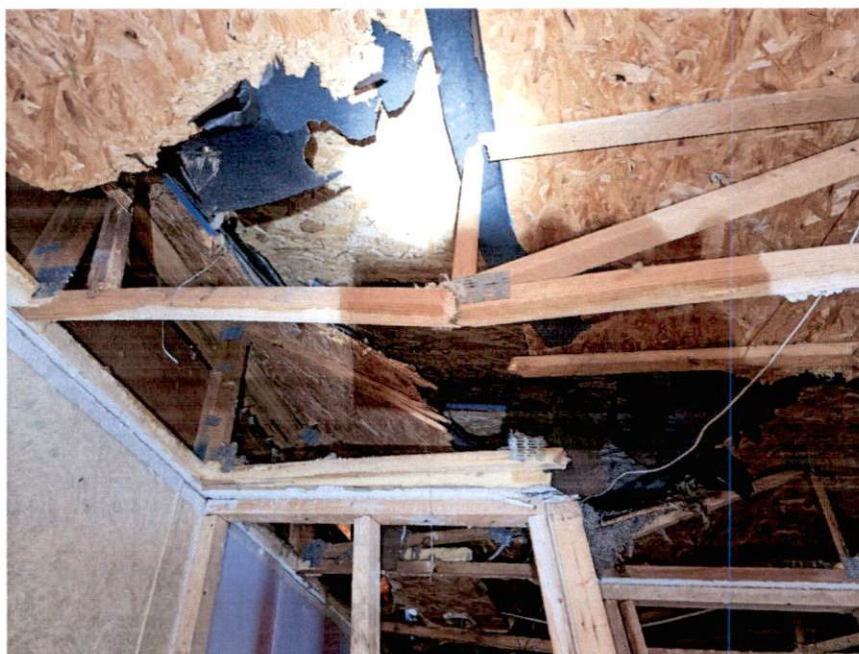
- Investigation from within the home revealed that the following roof members were damaged (see pictures 2-7 for examples):
 - Along the back right truss bay of the home within the back bedroom/bathroom, the 1st-6th trusses from the left were broken.
 - Roof sheathing near the above noted trusses.
 - Along the front truss bay within the kitchen/dining room, the 1st truss from the left was broken member.
 - Numerous small portions of roof sheathing where tree branches had impacted the roof.
- The exterior wall at the back left of the home was visibly out of plumb.
 - Measurement by laser plumb indicated that the above noted wall had an interior lean by as much as approximately 1/2" over a small section of the wall.

Picture 2 – Example of broken trusses in the back left bay of the home

- 1) Remove and replace the above noted (7) broken or damaged trusses. The design of new trusses should be performed by a qualified truss manufacturer.
 - a) Sheathe the new portion of the roof with sheathing of matching thickness, fastened to roof framing members with 8d common nails at 6" o.c. at panel boundaries, and 12" o.c. to rafters within the panel field. Splice panels over centerlines of rafters as needed with 1/8" minimum edge nail distance. No section of new or remaining sheathing should be smaller than 2'-0" in any direction.

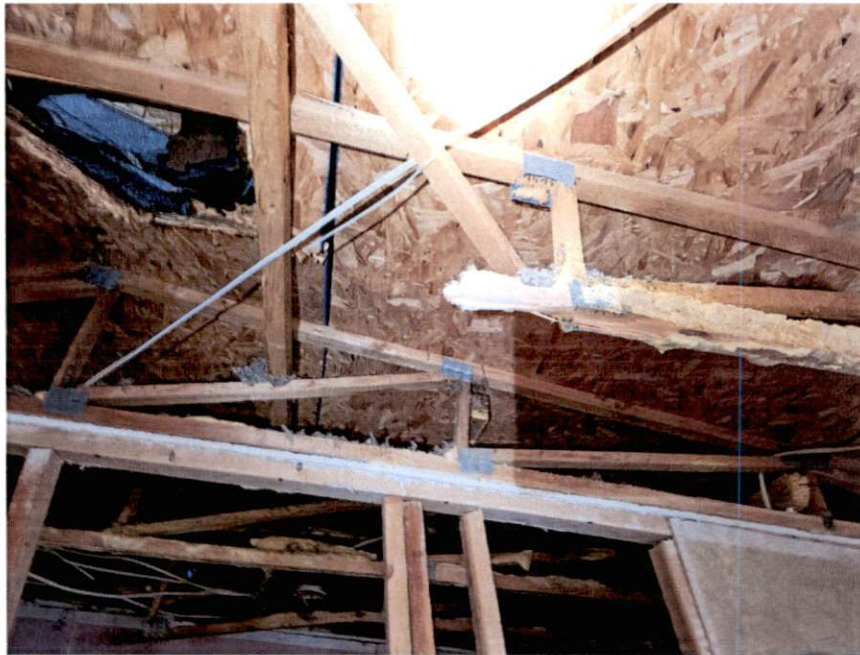
Picture 3 – Example of broken trusses in the back left bay of the home

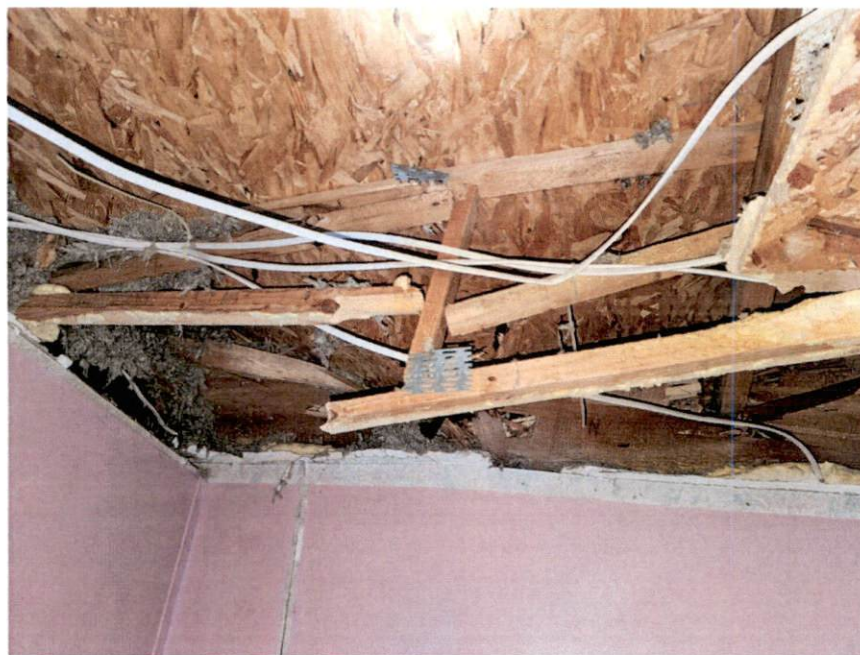
Picture 4 – Example of broken trusses in the back left bay of the home

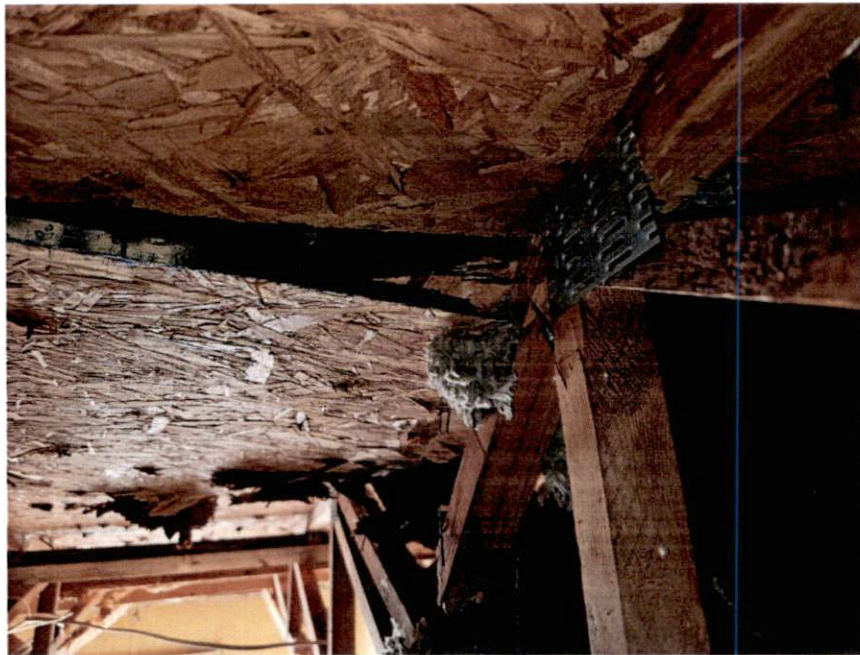
Picture 5 – Example of a damaged truss member in the front left bay of the home

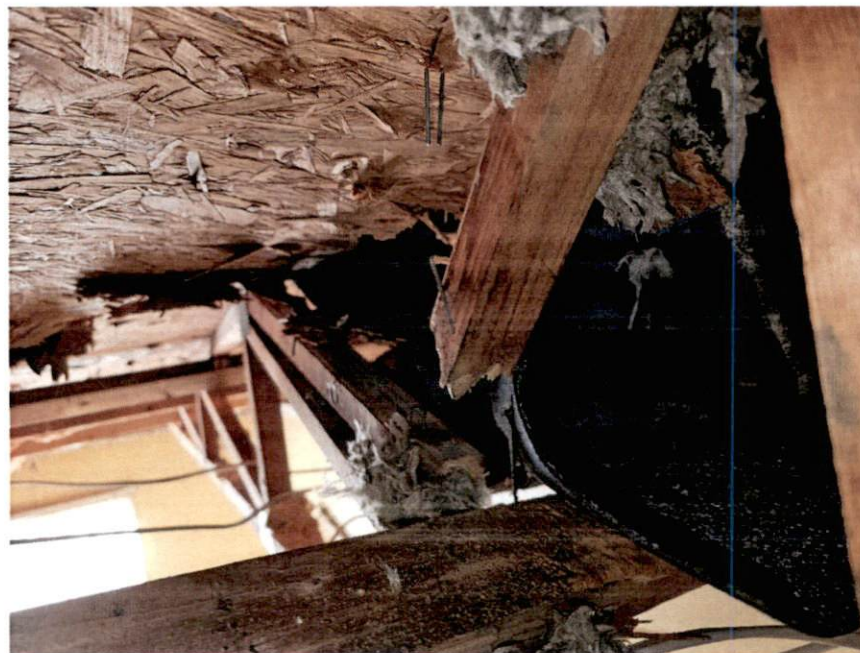
Picture 6 – Example of a damaged truss member in the front left bay of the home

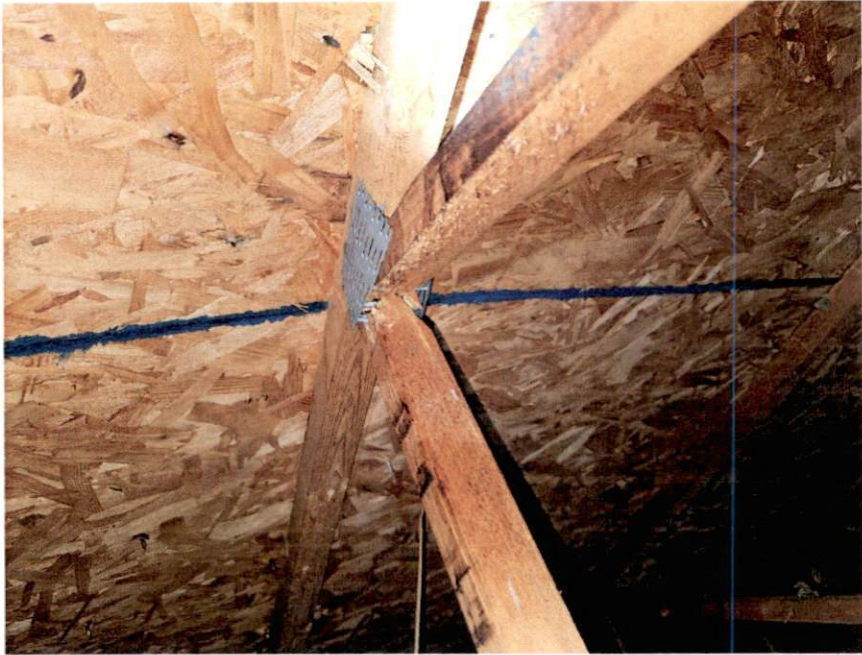
Picture 7 – Example of truss members not properly connected to the gusset plate
