Reference: Detailed Soil Investigation And Septic System Designs

Lots 34 and 35 of The Highlands at Sherwood Forest, Phase Two

And Pool Site for Sherwood Forest Subdivision

The Highlands at Sherwood Forest, Lot 34 and Pool

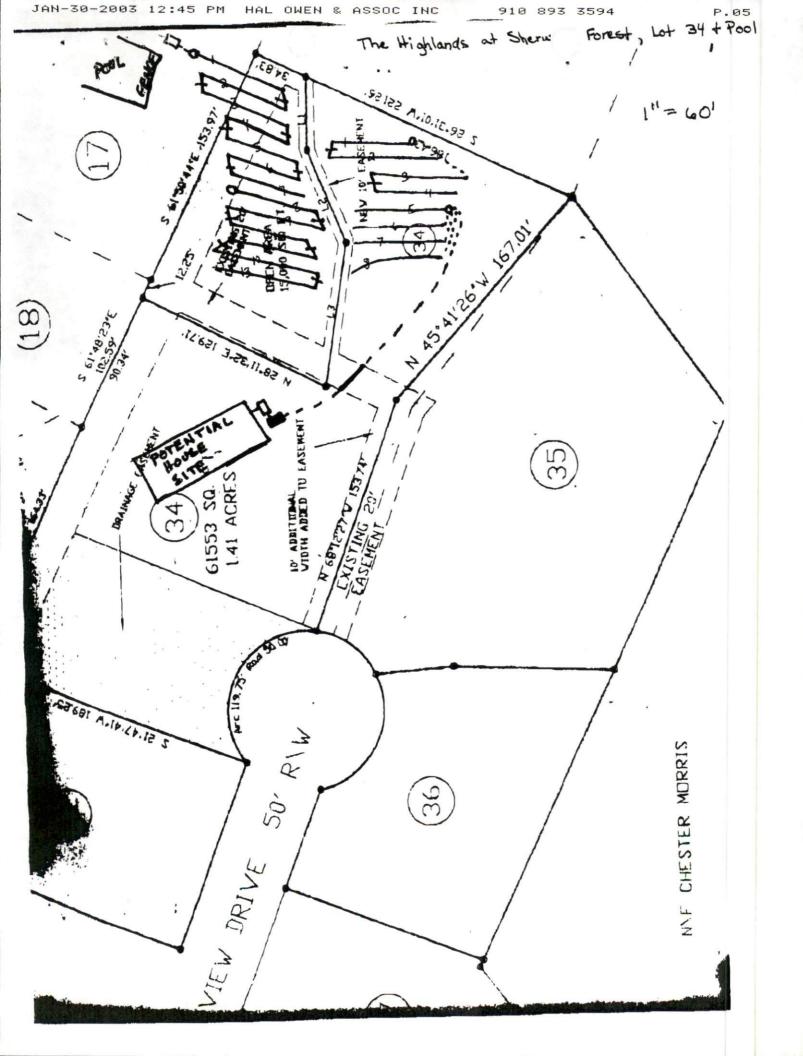
Lot 34

Lines flagged at site on 9-ft centers.

Bedrooms: 3 w/ conventional 4 w/ innovative

Pool

Initial System: Pump to 4 x 60-ft (L5-L8)

Repair System: Pump to 2 x 120-ft (L1-L4)

Initlal System: Gravity Serial Distribution 370-ft of Innov. Drainlines

Repair System: Gravity Serial Distribution
