HAT OWEN & ASSOCIATES TNC.

16 September 2005

Reference: Existing System Investigation and Comprehensive Soil Investigation Heatherbrook Subdivision – Lots 70A, 70B, and 70C

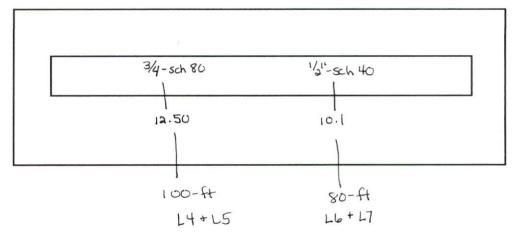
Manifold Diagram:

Repair System: Pressure-Manifold Innovative (180-ft)

Line Number	Line Color	Drainline Length(ft)	Tap Size/ Schedule	Flow/tap (gpm)	gpd/ft	LTAR (gpd/sqft)
4	R	100	3/4"sch 80	12.50	1.991	0.664
5	Y	,,,,	0, 1, 00, 1, 00			
6	В	80	1/2"sch 40	10.10	2.011	0.670
7	W	00
