MDL Engineering Services

Date: January 28, 2019

Re: Footing Soils Inspection
25 Willow Stone Dr.
Fuquay-Varina, NC 27526
MDL Project No. SD10293

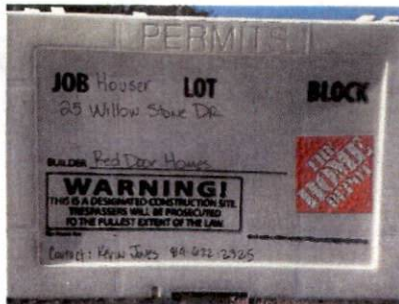
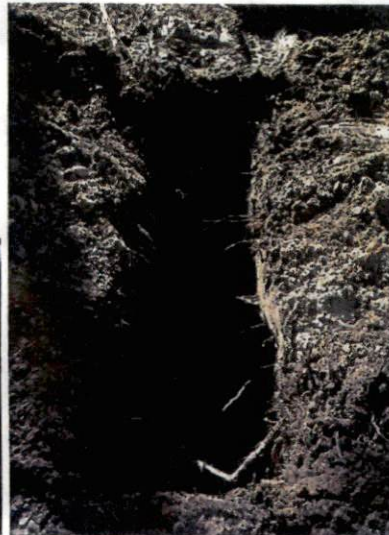
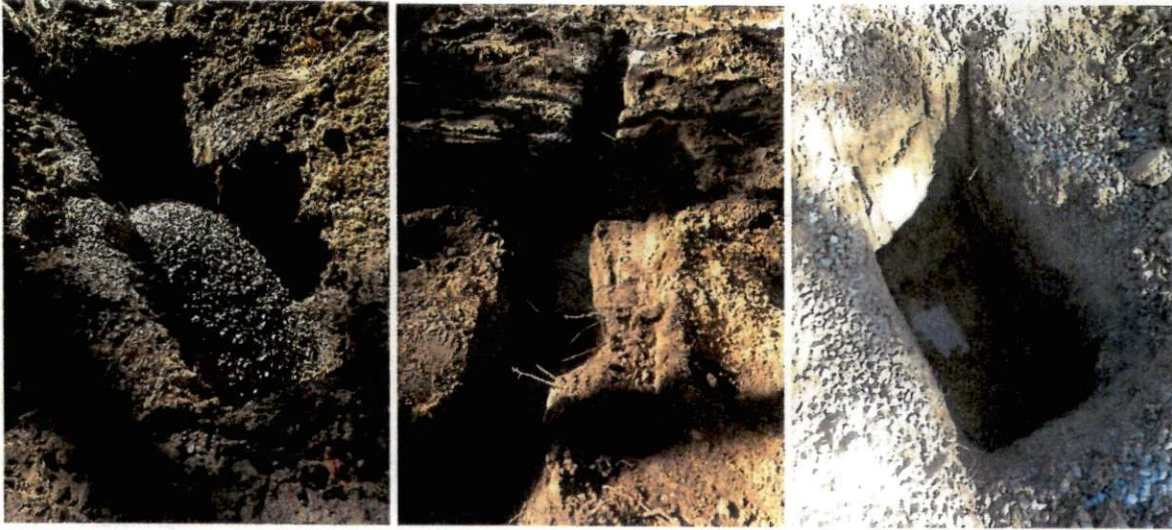
1/26/19 Observations:

The footing trenches were partially complete into a combination of sandy soils with some organics. Trenches were completed under observation and soils beneath probed and visually graded.

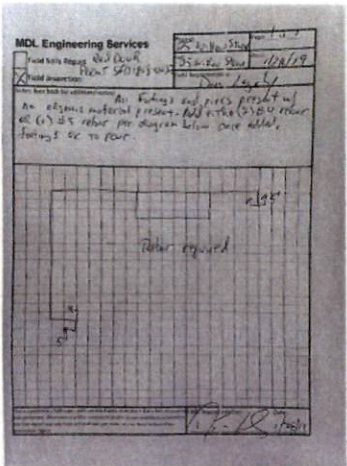
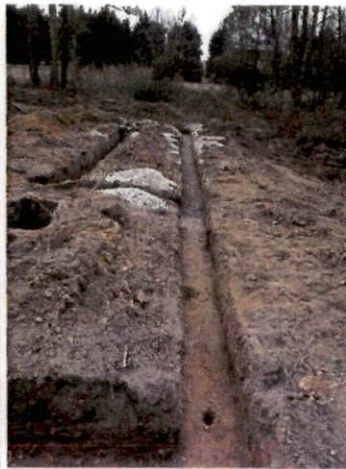
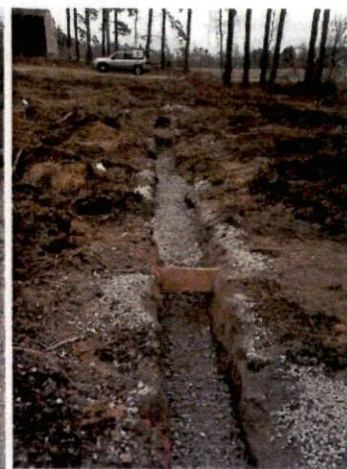
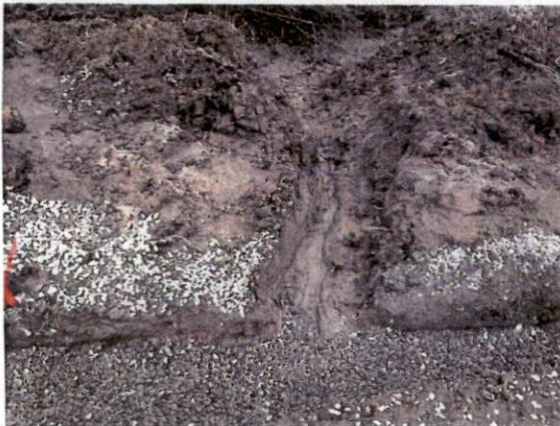
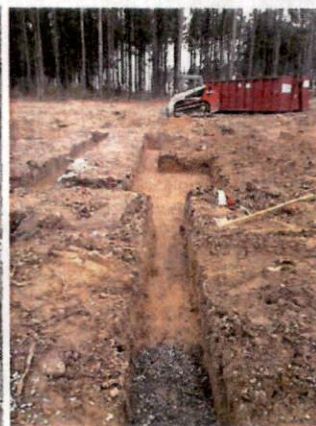
Organics, including root balls were discovered and removed down to virgin soil before filling with stone. The area in the right rear of the building envelope was excavated to approximately 5' depth and filled with washed stone.

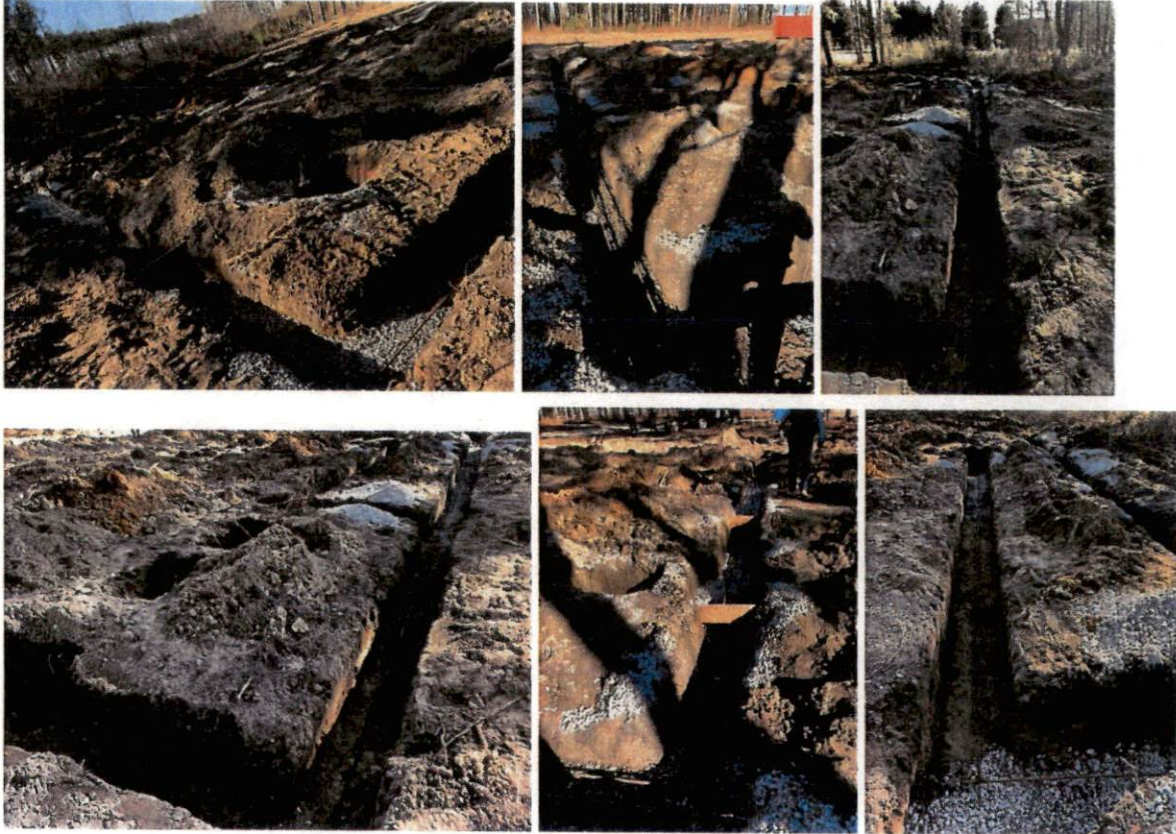
1/28/19 Observations:

The footing soils were visually evaluated, probed with a ½" rod and/or use of a DCP techniques to correlate surface soil conditions with bearing capacity. The area in the right rear of the building envelope had visible subsurface drainage. Rebar was added per instructions.

Results of the inspection indicate that the exposed soils and stone fill in the bottom of the footing will have bearing capacity in excess of the 2000 psf required for this project. The area shown on the attached field report will have 1-#5 or 2-#4 rebars added to the footing in addition to perimeter foundation drains at these locations. It should be noted that minor cracking of concrete foundation elements commonly occur for various reasons including, but not limited to, changes in moisture content, concrete shrinkage during curing, temperature fluctuations
