Client: Guy C Lee - Clayton
Project: 201811-5003 Kensington Park
Address: 460 Carolina Way, Sanford, NC 27332

FIELD DAMAGE REPORT

Name: Kensington Park- 201811-5003- J4 / NC Date: 1/16/2019
Address: 460 Carolina Way, Sanford, NC
Contact Phone: 919-553-6699 Contact Name: Shawn Norris
Contact Company: Guy C Lee Clayton

J4 EEI™ 30 Joist 11.875" - PASSED

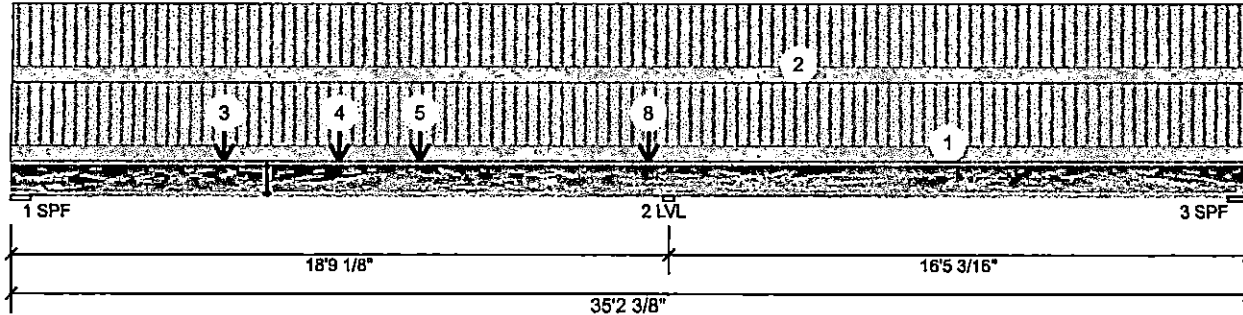
Attached is a jost that had had a notch made in the top flange. Located 7' 4" from the left end, the notch goes into the flange 1/2", and is 3" long. Need repair if necessary, and NC seal.

| Analysis Type | Location | Max Value | Ld. Comb. | Ld. Case |
|---|---|---|---|---|
| Pos Moment | 7'4" | 2600 ft-lb | D+L | L_ |
| Shear | 7'4" | 99 lb | D+L | L_ |
| Down Defl | 7'4" | 0.334 | D+L | L_ |

NO REPAIR REQUIRED – Member OK as is
