RE: Anderson Creek Club - Lot 1095

ECS Job # 4458-L

Project Anderson Creek Club - Lot 1095

#### FIELD REPORT

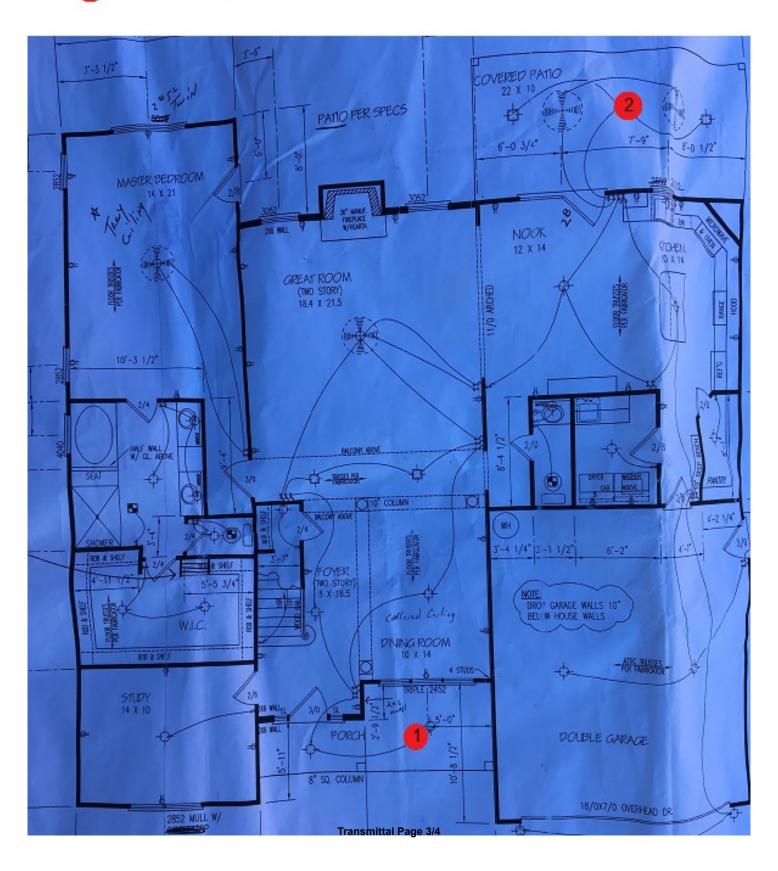
# ODCP Bore Holes

The undersigned arrived on site, as requested, to observe the bearing capacity of soils via hand auger/dcp method for porch backfill at the front and rear of the residence. Please see the attached sketch.

A total of 2 hand auger/DCP evaluations were performed to a depth of approximately 3 feet from top of fill. DCP blow counts ranged from 4 to 8 blows per increment. Soils do appear to have been sufficiently placed and compacted for support of the proposed construction.
