Project: Quail Glen Lot 55

Location: Angier, NC

Subject: Roof Truss Repairs

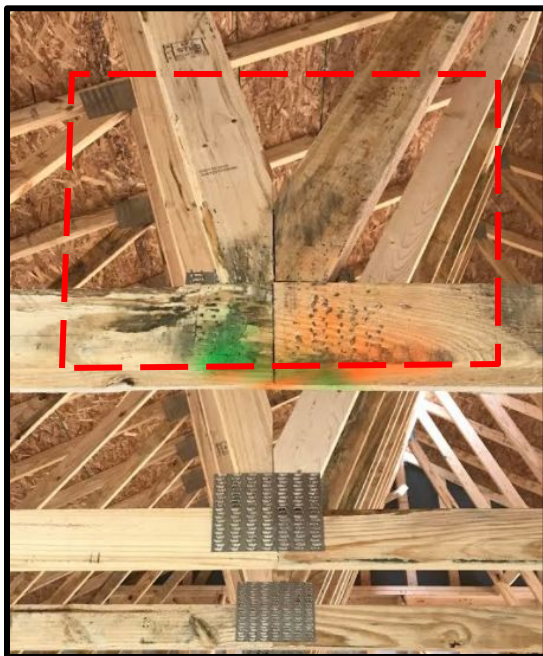
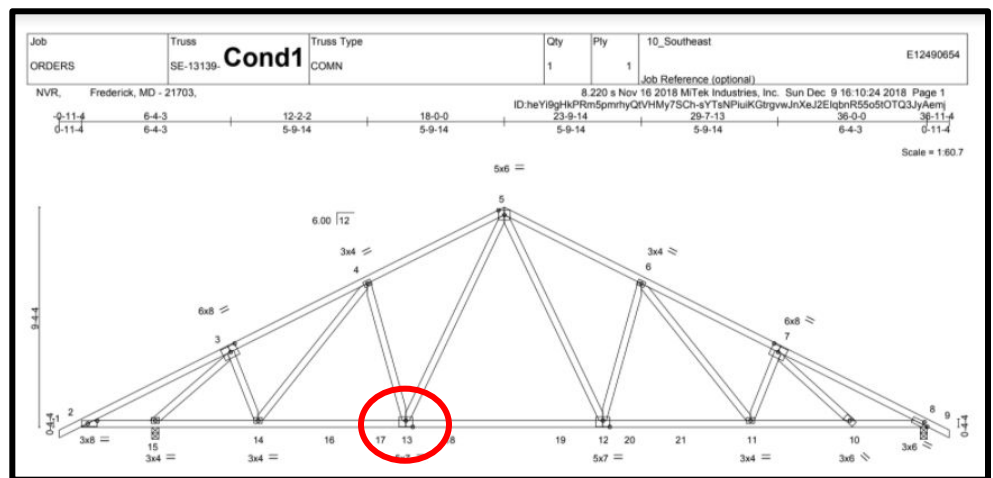
As requested, Andy A. Takla, PE prepared this report on August 18th, 2020 to provide a repair the missing/damaged mending plate at one side of roof truss SE 13139 at bottom chord joint 13. See pictures below for reference.

- 1) Install a 30"x30"x7/16" OSB gusset plate to the one side of the roof truss joint which lacks the mending plate.
- 2) Center the gusset plate horizontally on the joint with the bottom edge of gusset plate flush with bottom edge of bottom chord.
- 3) Attach using (2) 10d 1.5" long nails at 4" on center to all adjoining truss members.
