H & H Homes  
2919 Breezewood Avenue  
Suite 400  
Fayetteville, NC 28303

**RE:** Daily Field Report for 10/20/2020  
Lot 110 Anderson Creek Academy ACA (CMT) Spring Lake, NC  
Building & Earth Project No : RD200658

## Field Observations Report

Project Name:	<b>Lot 110 Anderson Creek Academy ACA (CMT) Spring Lake, NC</b>	Project Number:	<b>RD200658</b>
Client Name:	<b>H &amp; H Homes</b>	Placement#:	<b>FO-1</b>
Contractor:	<b>H &amp; H Homes</b>	Technician:	<b>Bang Nhi Pham</b>
Monitoring:	<b>DCP</b>

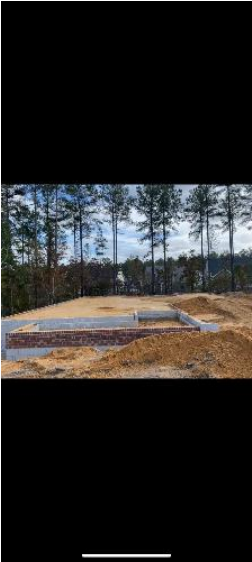
Picture ID	Street view of Lot 110.
23679
