RE: Daily Field Report for 03/03/2021
Lot 109 Anderson Creek Academy ACX (CMT) Spring Lake, NC
Building & Earth Project No : RD210139

Field Observations Report

1 : Foundation Inspection

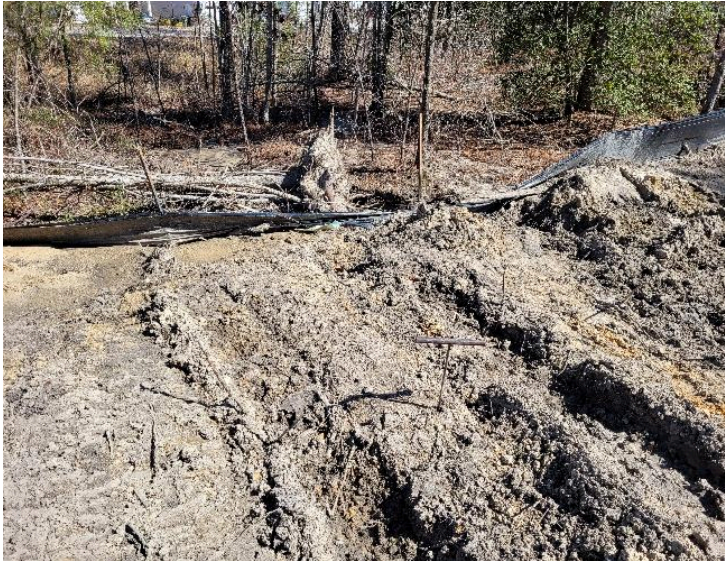
Hand Rod Probing: Our representative performed hand rod probing of the surface of the building pad. Hand rod probing of the bearing material generally showed an average penetration of approximately 2-4 inches. Areas of (soft/loose) material were noted at the back left corner with the hand rod probing to a depth of about 10-12 inches.

Picture ID	Lot 109 problematic probe
26943

1. Undercut the perimeter footings an additional 12 foot from the intended bottom of the footings.
2. Install a tail drain to remove water from the foundation to drain to the lowest point.
3. Replace with washed NCDOT #57, wrapping in filter fabric such as Mirafi 140N.
