**RE:** Daily Field Report for 03/09/2021  
Lot 173 Anderson Creek Crossing ACX (CMT) Spring Lake, NC  
Building & Earth Project No : RD210167

## Field Observations Report

Project Name:	<b>Lot 173 Anderson Creek Crossing ACX (CMT) Spring Lake, NC</b>	Project Number:	<b>RD210167</b>
Client Name:	<b>H &amp; H Homes</b>	Placement#:	<b>FO-1</b>
Contractor:	<b>H &amp; H Homes</b>	Technician:	<b>Frank Hamlin</b>
Monitoring:	<b>Shallow Footing Testing</b>

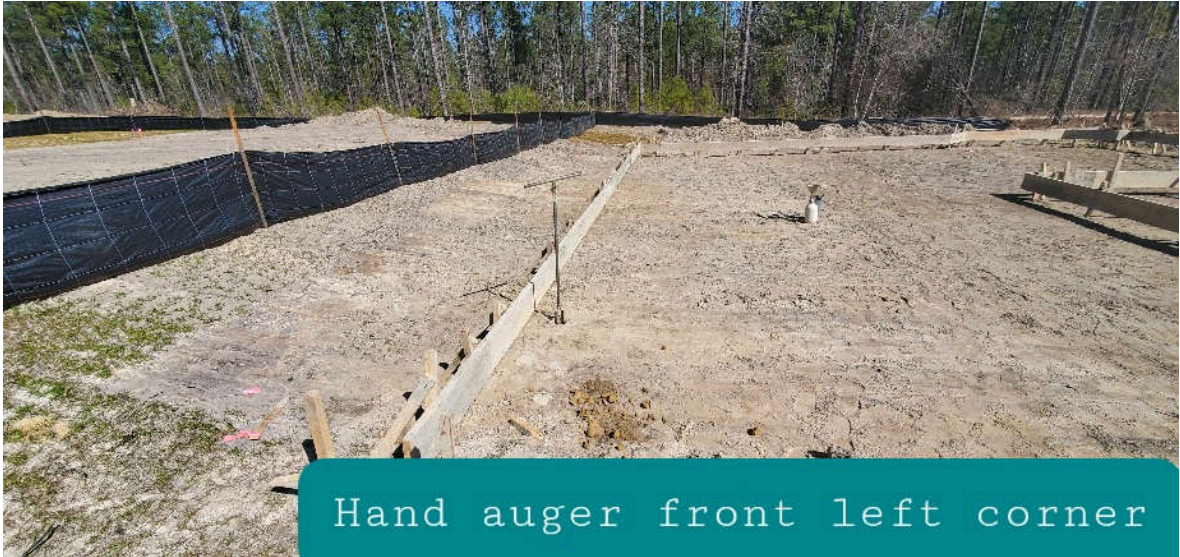
Picture ID	Hand Auger
27194

Test 1: [Front Left Corner]

-- Depth---"N"-----Soil Color---USCS-----  
--- FSG --- 13 --- Greyish tan --- SM -----  
--- -1' --- 15+ --- Light Tan --- SM -----  
--- -2' --- 15+ --- Light tan --- SC ----  
--- -3' --- 15+ --- Light tan --- SC ----

<p style="text-align: center; background-color: #008080; color: white; padding: 5px;">Hand auger front left corner</p>

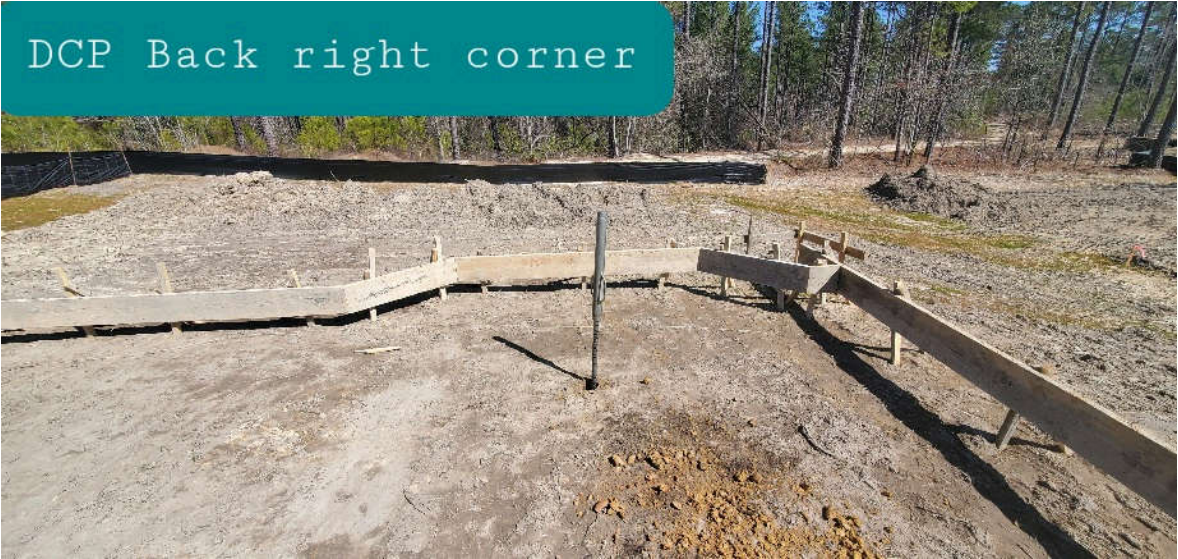
Picture ID	DCP
27195

DCP Testing: Our representative performed Dynamic Cone Penetration (DCP) testing in general accordance with ASTM STP-399 at four representative locations to a depth of 36 inches. Our representative did not observe water within the DCP boreholes as noted below.
