RE: **Forest Ridge Lot**  
ECS Job # **33:5565**

Permits:  
Location: **106 Tanna PI**  
**Spout Springs, NC 28326**

## FIELD REPORT

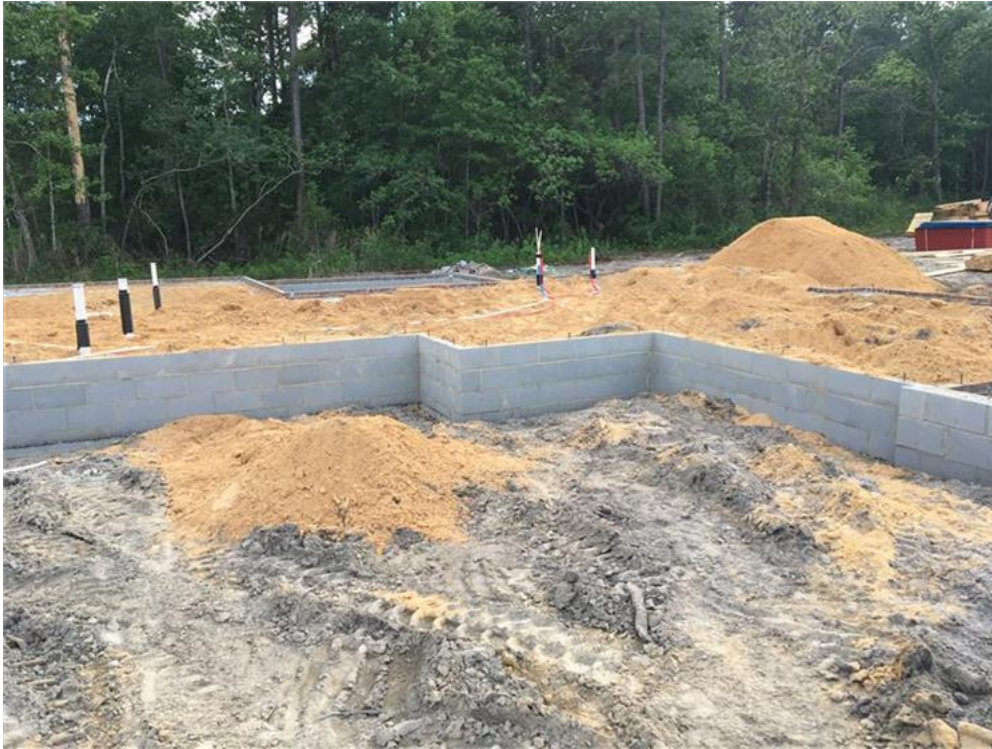
Figure 1

Upon arrival, the stem wall backfill was not complete and DCP testing could not be performed. Please see the attached images.

ECS will return, as requested, for additional services.
