April 26, 2023

Re: Undermined Footing – Foundation Support
156 Heatherspring Way
Spring Lake, North Carolina

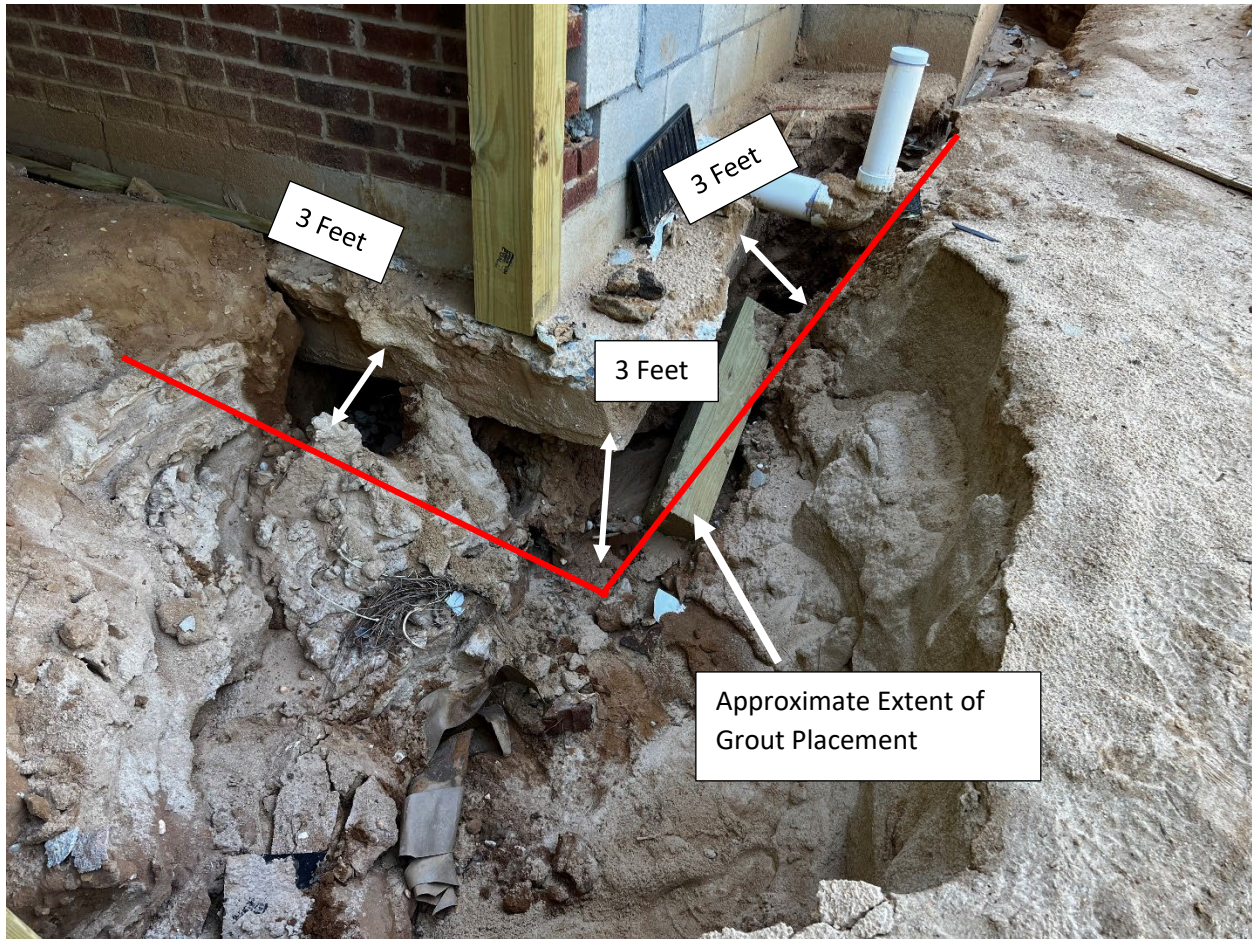
Figure 1: Approximate Extents of Repair (Not to Scale)

To provide support for the undermined footing, we recommend that the cavity be backfilled with non-shrink grout (not dry packed). The non-shrink grout can be mixed onsite or ordered from a ready-mix concrete company. Prior to placement, we recommend that the undermined area be cleared of loose soil and debris and the bottom of the excavation probed to verify stability. The area should be bulkheaded and the non-shrink grout pumped into the cavity. The grout should extend/make full contact with the bottom of the existing footing. The area of grout placement should extend up to the sanitary line cleanout (approximately shown in Figure 1).

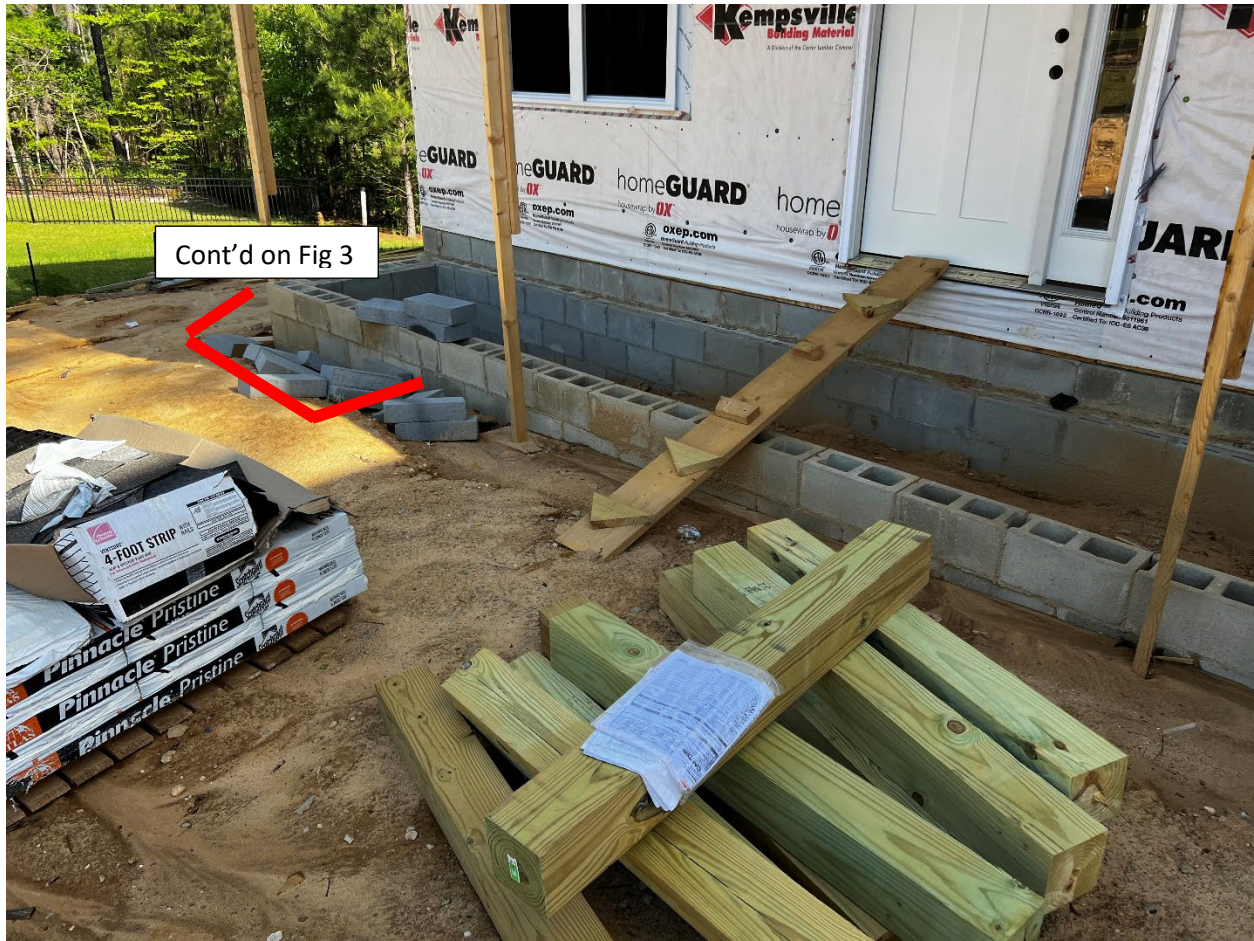
Figure 2: Approximate Start Location of Temporary Diversion Berm

In addition, we recommend that a diversion berm be constructed along the side of the home starting at the North end of the front porch, extending along the East side of the home and terminating past the Southern-most deck supports (See Figures 2 and 3 for Approximate Location). The berm should consist of SC, SM or CL soils and be sufficiently compacted to minimize erosion.

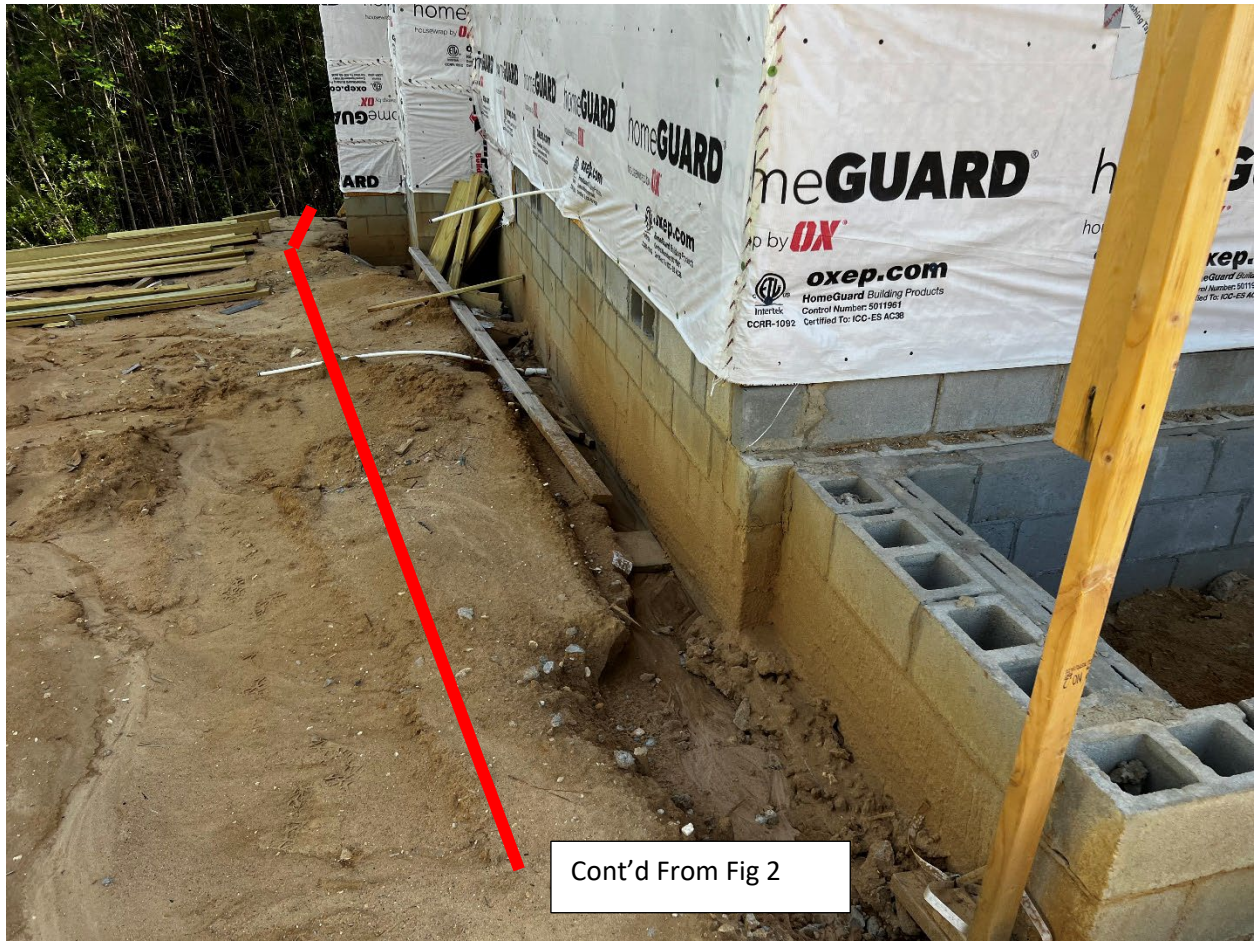
Figure 3: Approximate Extents of Diversion Berm

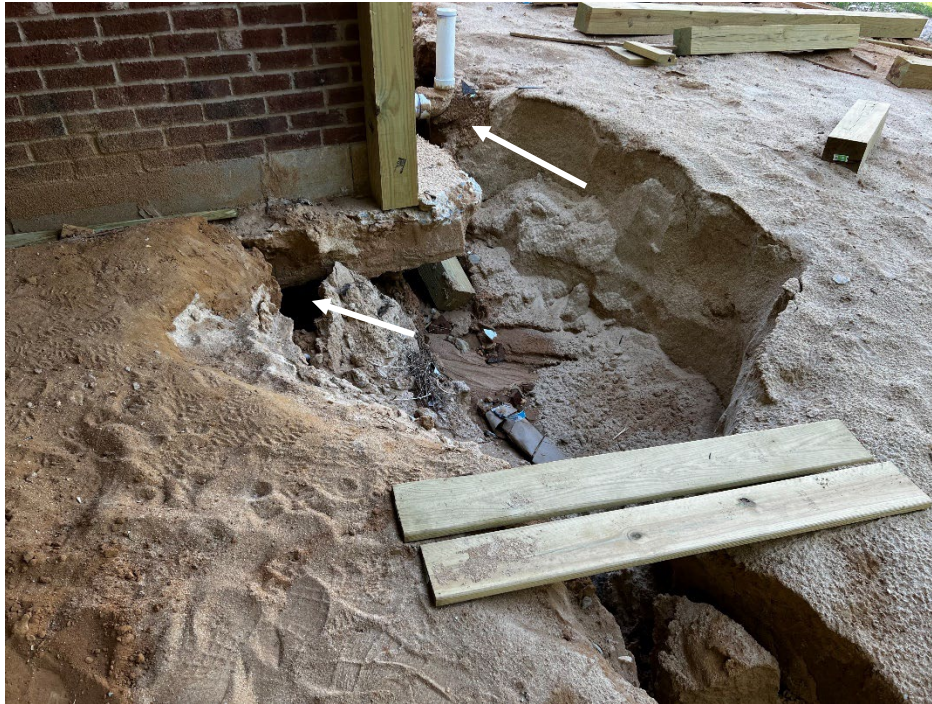
As noted from our previous site visit, it appears that while the overall grading of the lot has positive drainage away from the building, areas directly adjacent to the foundation walls (within approximately 2 to 3 feet) are trenched to allow construction of the foundation walls and veneer (Pictures 1 to 3). While this trenching is standard practice and not typically detrimental, it can result in undermining of the footings when the site is sloped.

Picture 1: Foundation Support Eroded, Trench/Slope Along Foundation

The areas directly adjacent to the foundation, where they were trenched to allow for foundation and veneer construction, should be temporarily backfilled and compacted with SC, SM, or CL soils until veneer construction begins. In addition, once veneer construction is completed, we recommend that the areas be permanently backfilled as promptly as possible and covered with erosion control matting to minimize erosion.

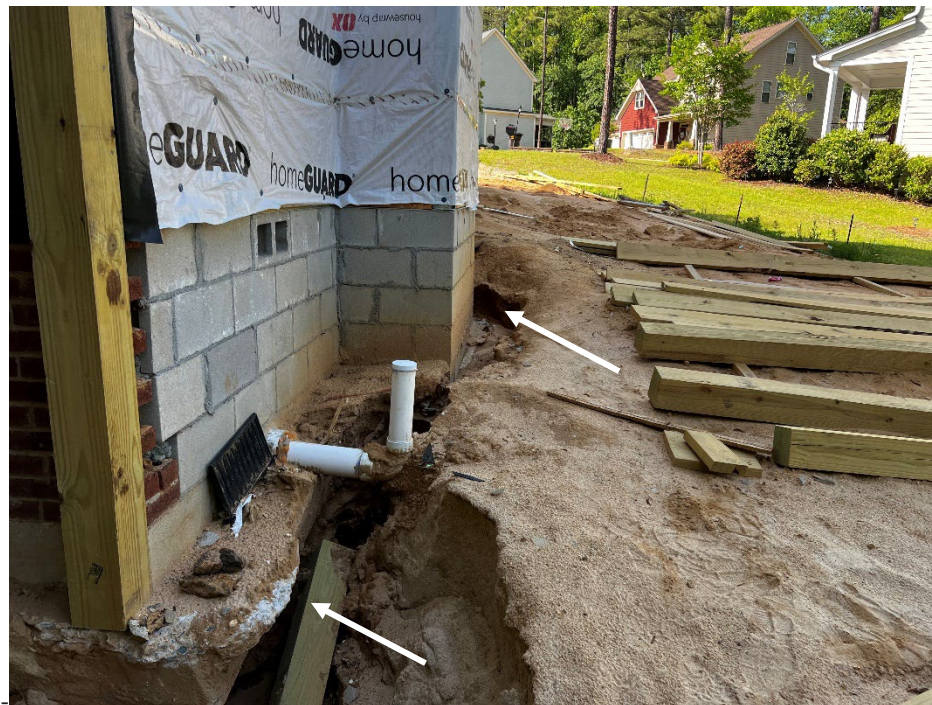
Picture 2: Foundation Support Eroded, Trench/Slope Along Foundation

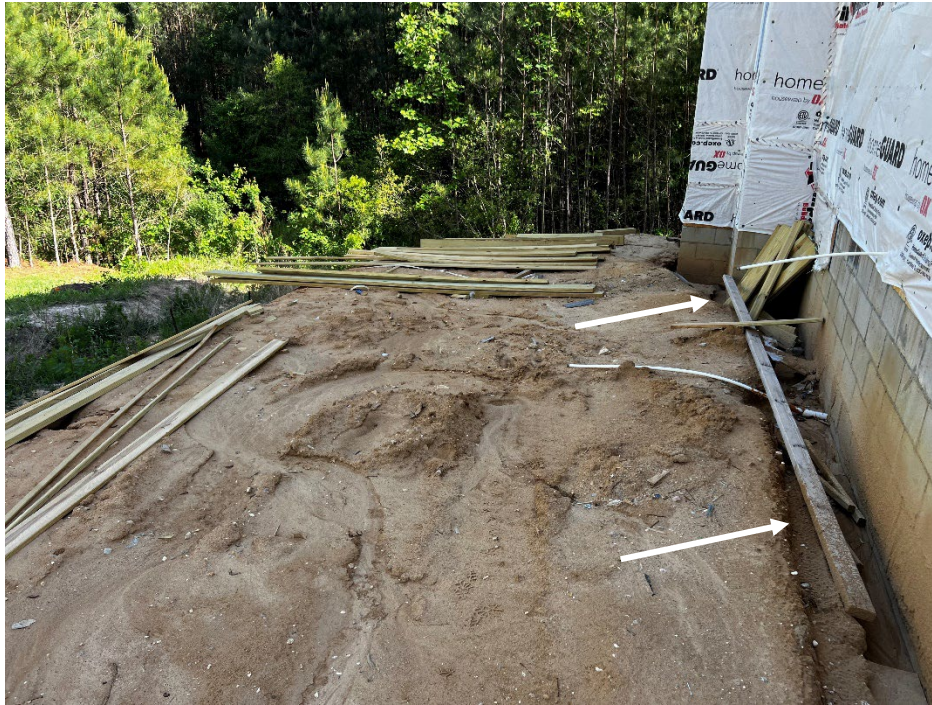
Picture 3: Negative Slope/Trench

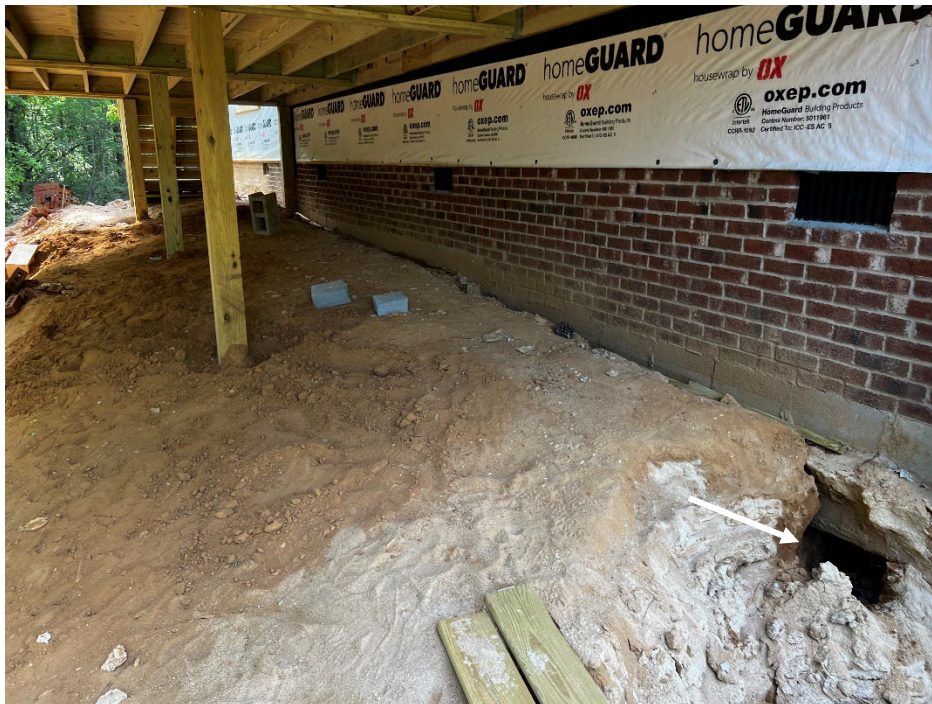
During our most recent site visit (April 24, 2023), we observed significant foundation support erosion at the Southeast corner of the home. Currently, the home is framed and under roof. A 2-story deck has also been constructed at the rear of the property, above the eroded soils at the SE corner.

Picture 4: Footing Undermine
