Roof Report

Robert Wiggins

Overview of the condition of the roof...

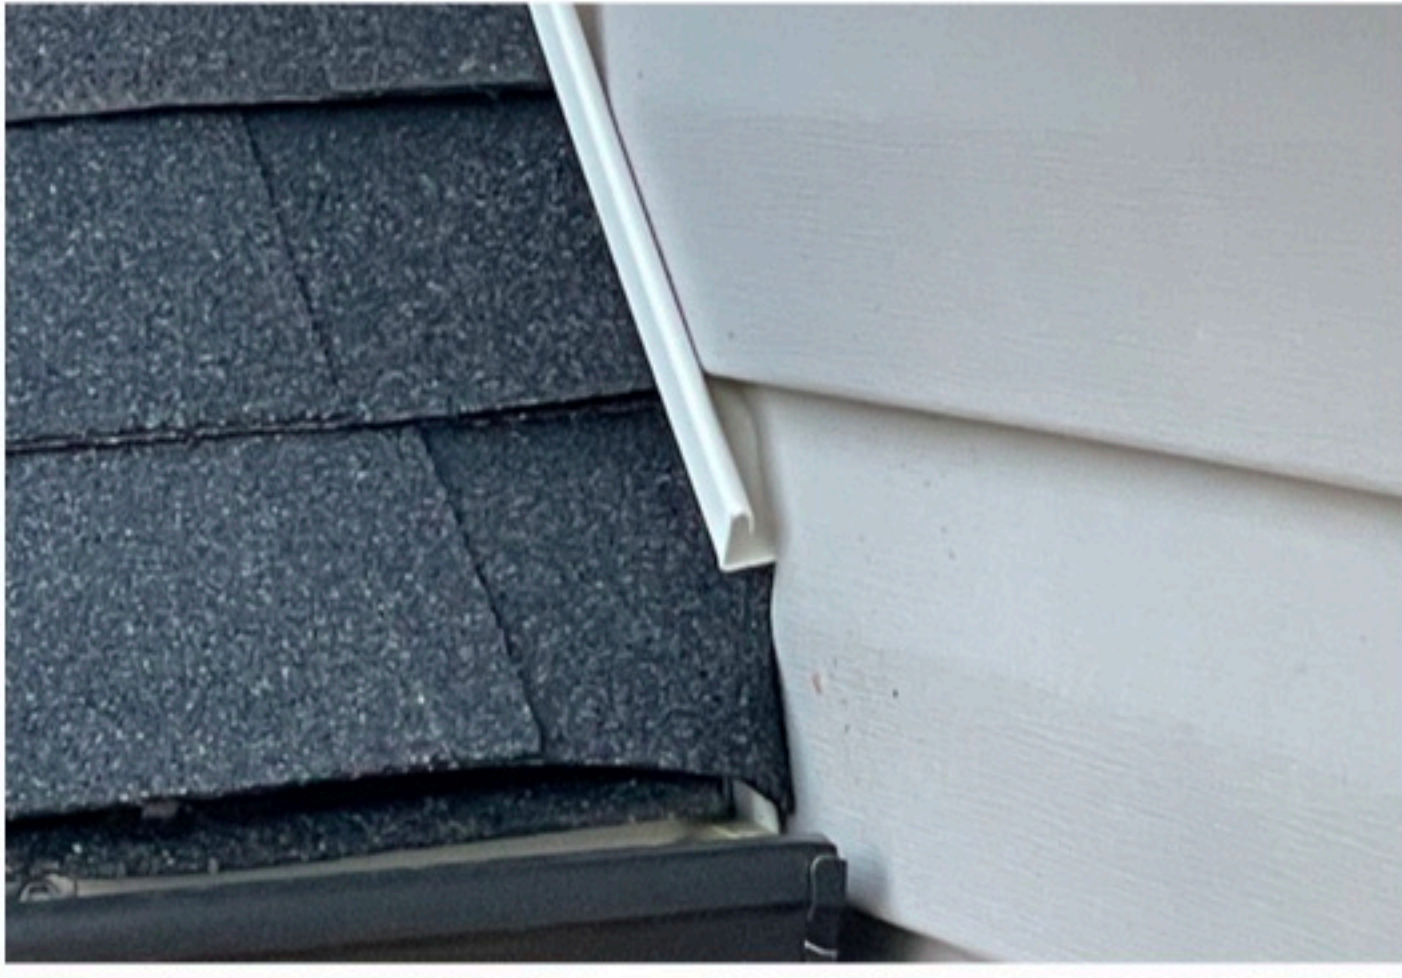
(Upper left) Missing kick out flashing

Due to the many previous repairs on this new roof, and the extensive amount of current issues - a full replacement is suggested.

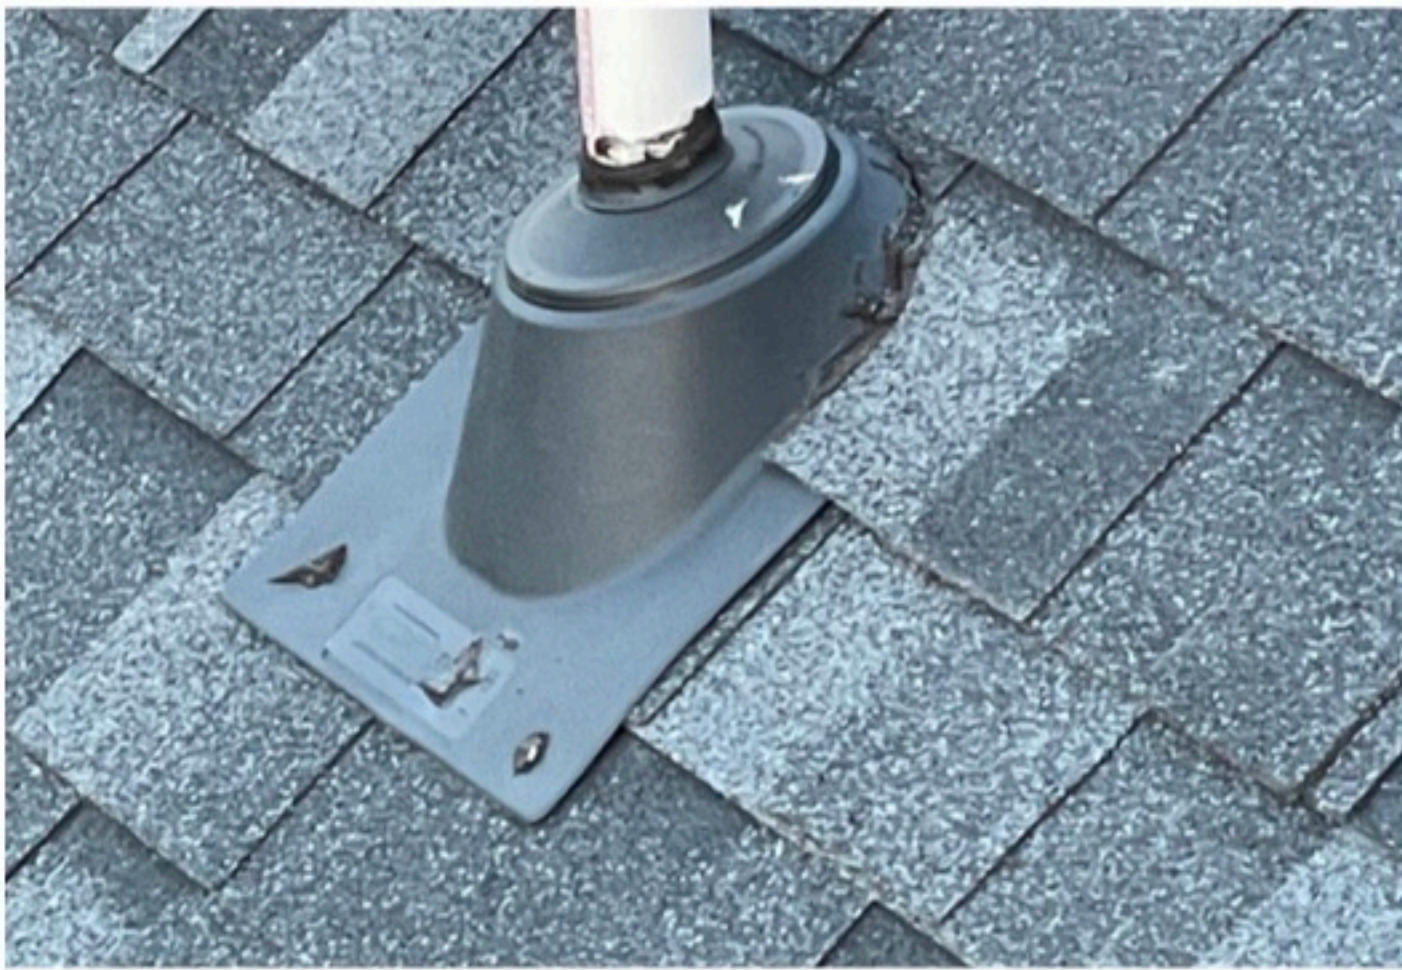
(Mid Left) Nails and shingles improperly installed around the pipe boots

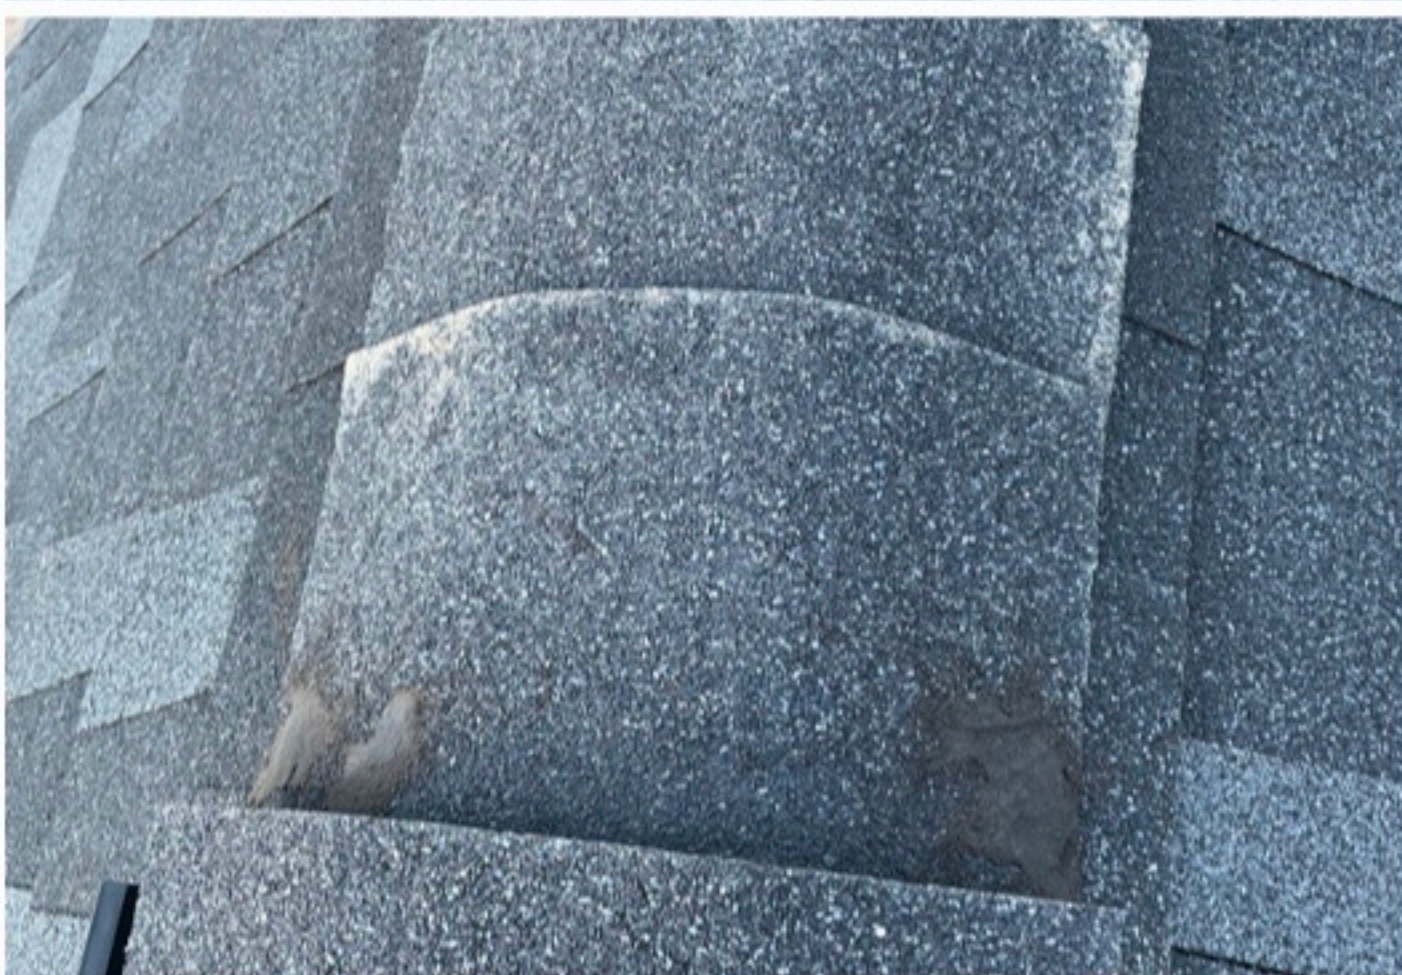
(Bottom Left) Ridge cap extended and heavily caulked

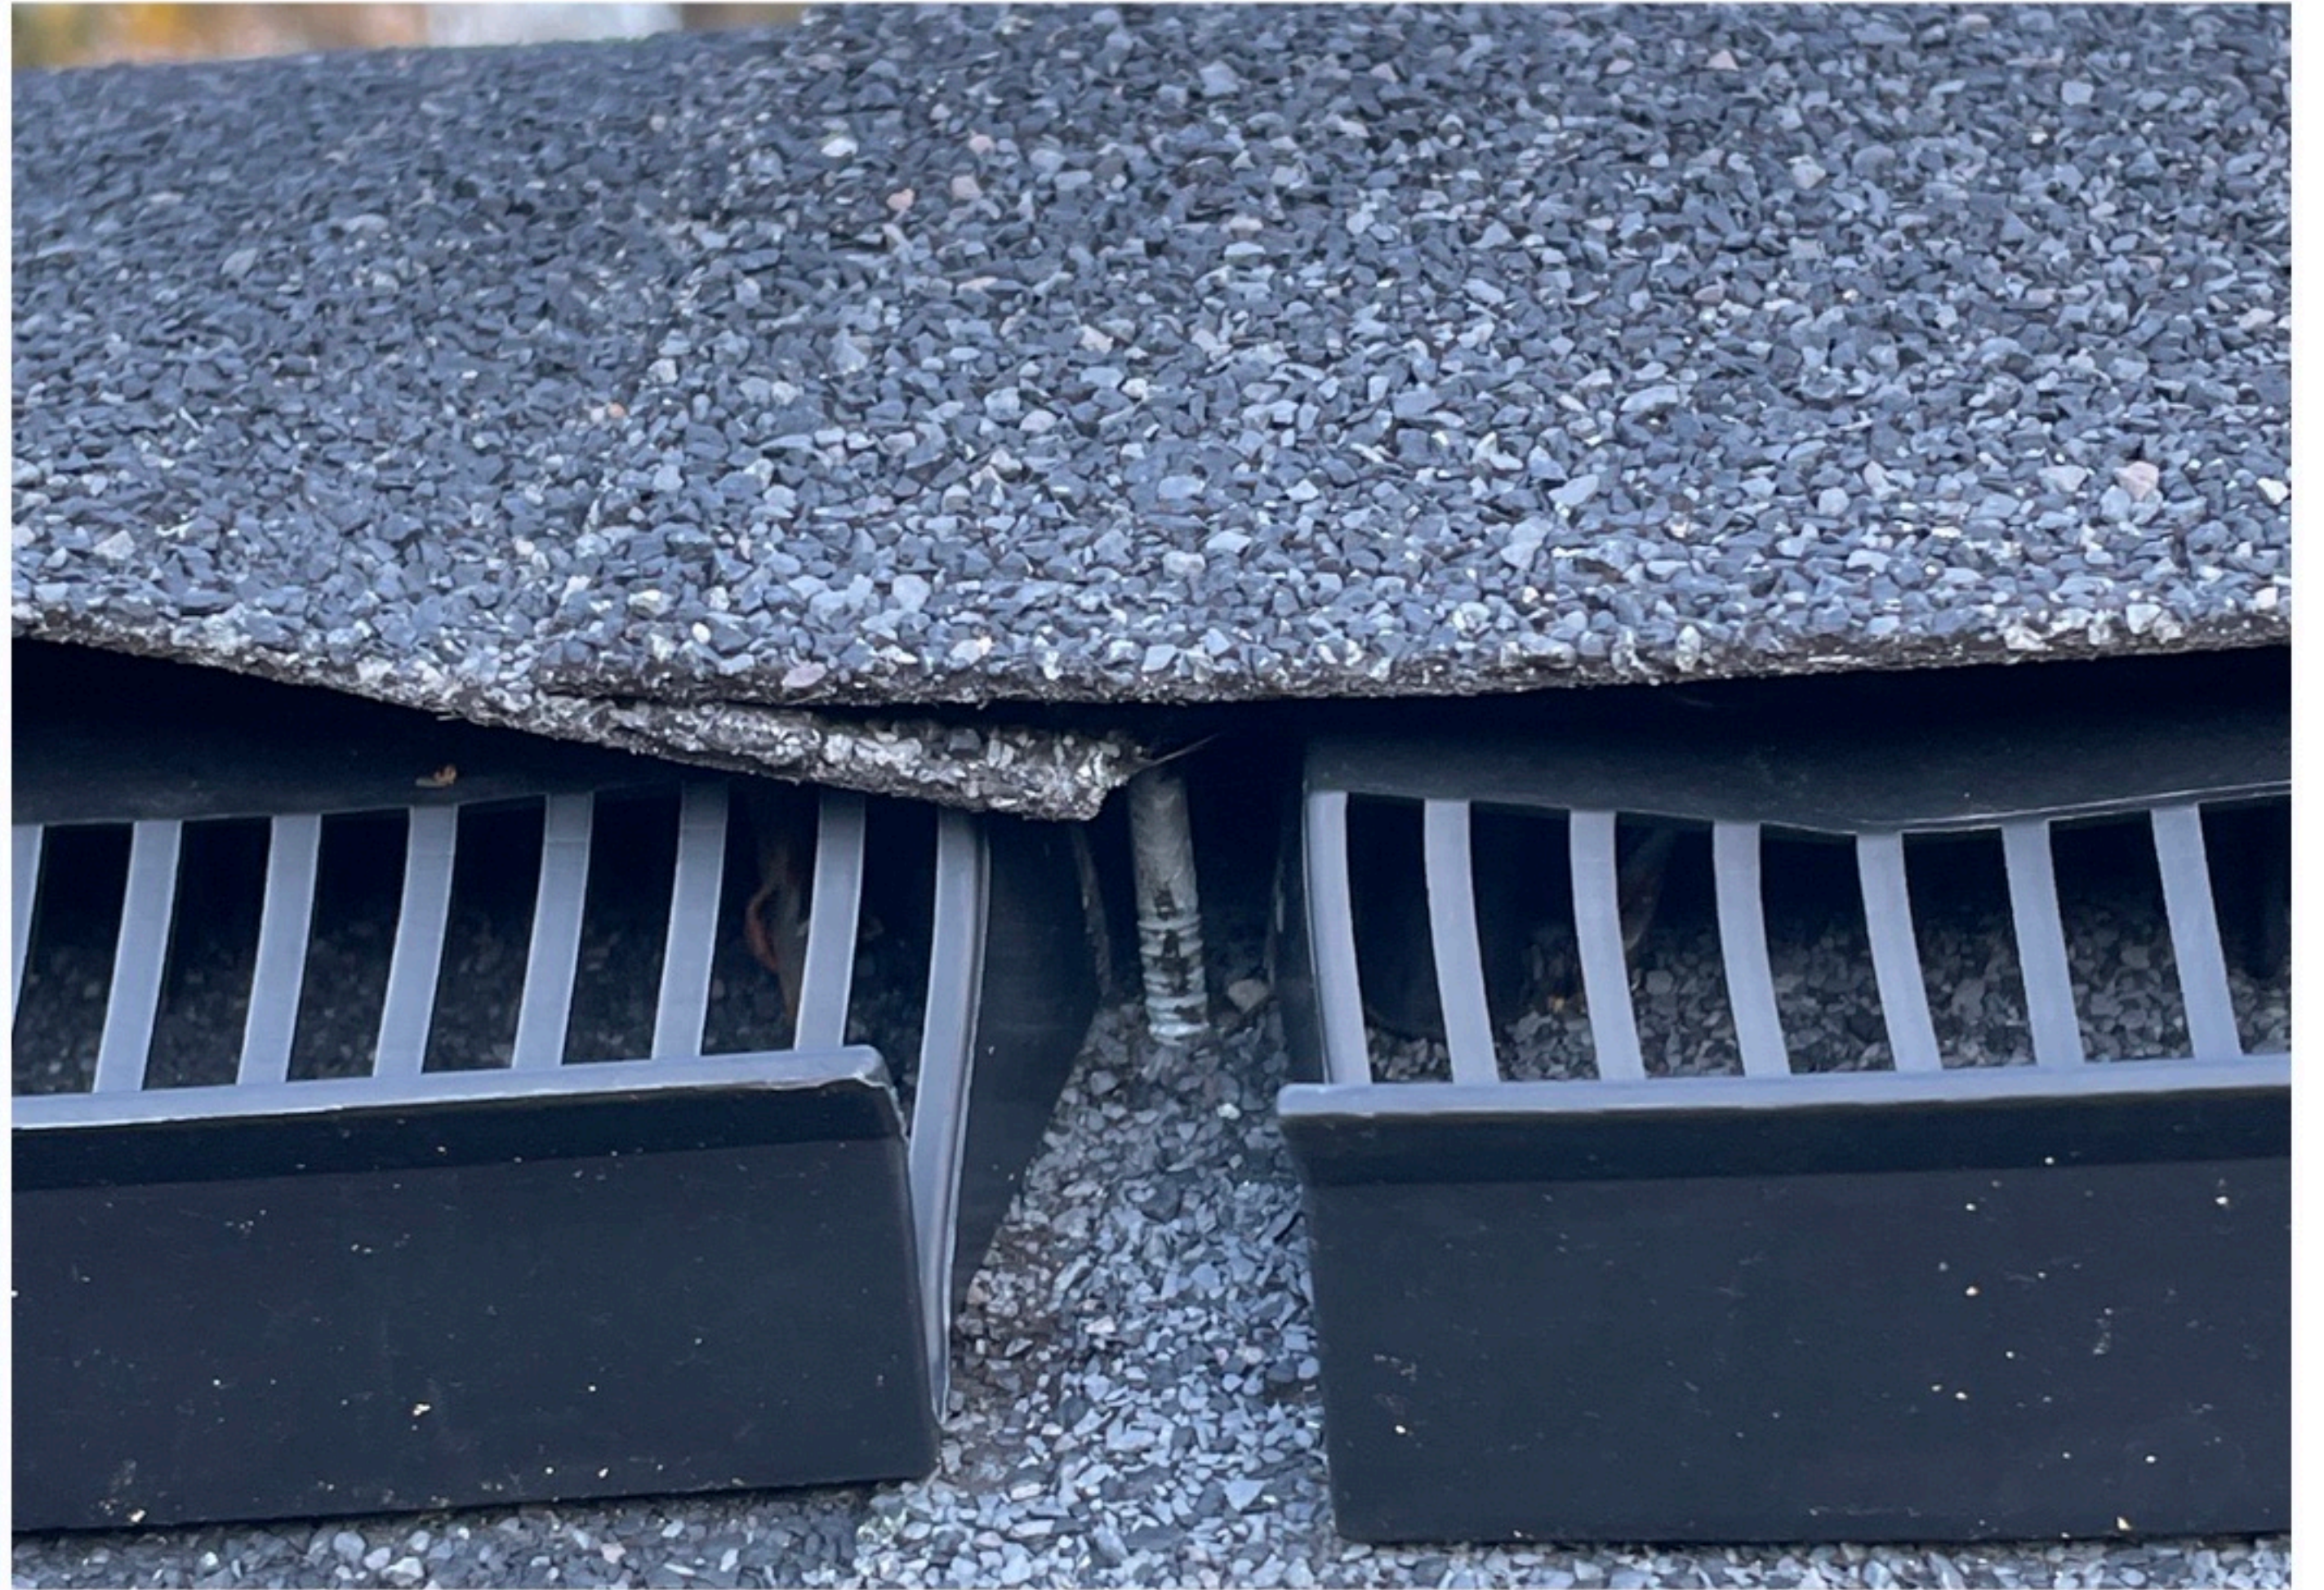
(Upper Right) Poor fastener location on the ridge

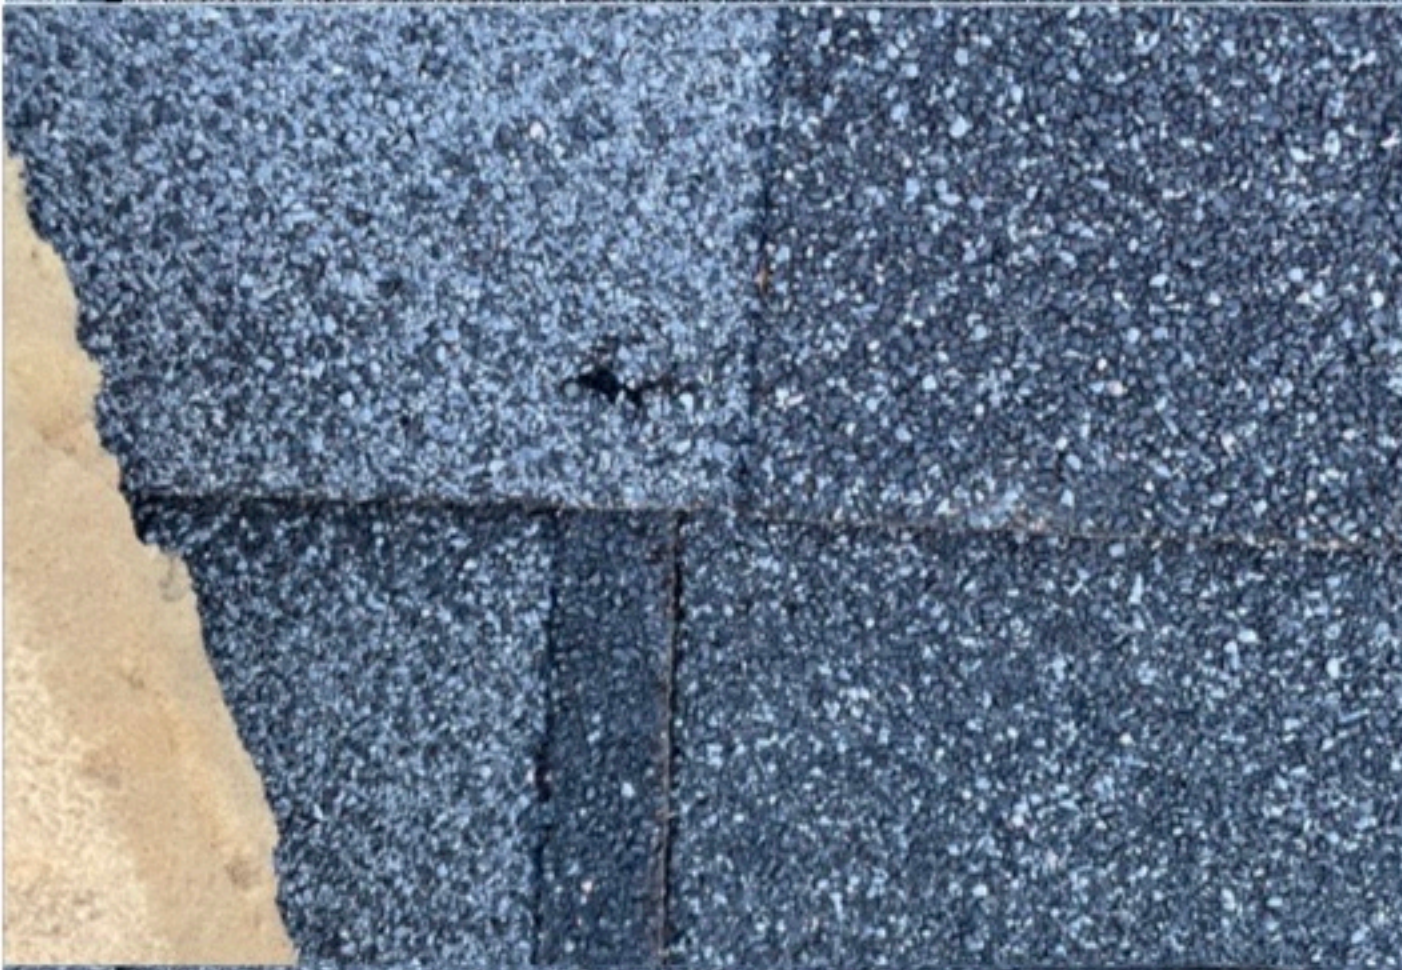
(Upper left) Hole near the valley

(Mid Left) Multiple tears near front valleys

(Bottom Left) Ridge cap and vent improperly installed
