July 31, 2022

Reference: Engineering Services
Walker Rd. – Lot 3
724 Walker Rd.
Bunn Level, NC 28323
TE&D Project No.: 2201-020538_A

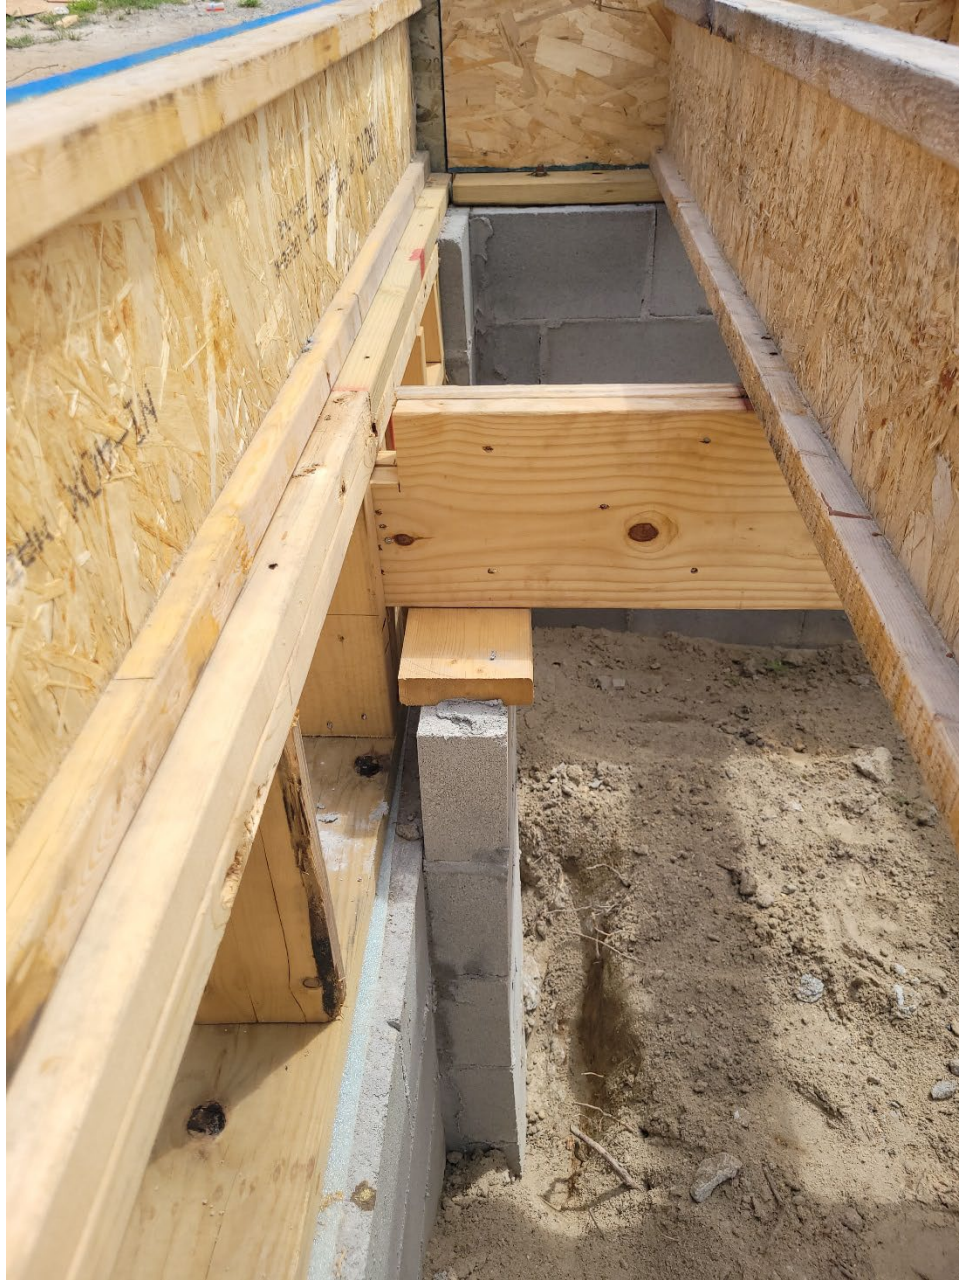
- 1) We observed a new 4 x 8 pilaster was installed for girder support. The construction of the pilaster in regards to the footing and tie in to the foundation was unknown to TE&D. The (2) 2 x 10 girder extended into the pony wall and was supported with (2) 2 x 4 jacks and (2) 2 x 4 king studs. The girder was notched to accommodate for the pony wall top plate. Based on our observations and analysis, the existing girder requires modification. The girder is to be increased to a (4) 2 x 10 girder from the adjacent pier to the pony wall. The new plys are to be added on each side and fastened with (3) rows of 16d nails at 4" o.c. New plys may be notched at the pony wall. The entire new girder is to be supported with (4) 2 x 4 jacks and (2) 2 x 4 kings at the pony wall. The pilaster is not providing significant structural support to the girder and may remain or be removed if required.

Item #1 – New plys to be added to each side of girder

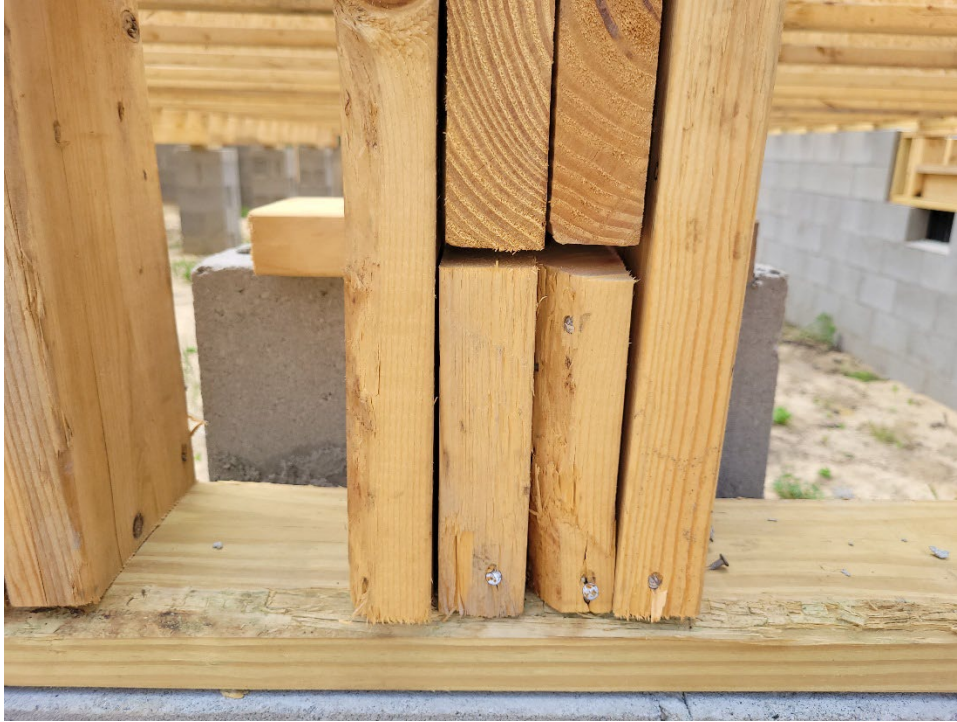
- 2) We observed a new 4 x 8 pilaster was installed for girder support. The construction of the pilaster in regards to the footing and tie in to the foundation was unknown to TE&D. The (2) 2 x 10 girder extended into the pony wall and was supported with (2) 2 x 4 jacks and (2) 2 x 4 king studs. The girder was notched to accommodate for the pony wall top plate. Based on our observations and analysis, the existing girder remains suitable to support the anticipated loading conditions. The existing jacks are to be removed and replaced with tightly fitting members. The pilaster is not providing significant structural support to the girder and may remain or be removed if required.

Item #2 – Jacks to be installed tightly

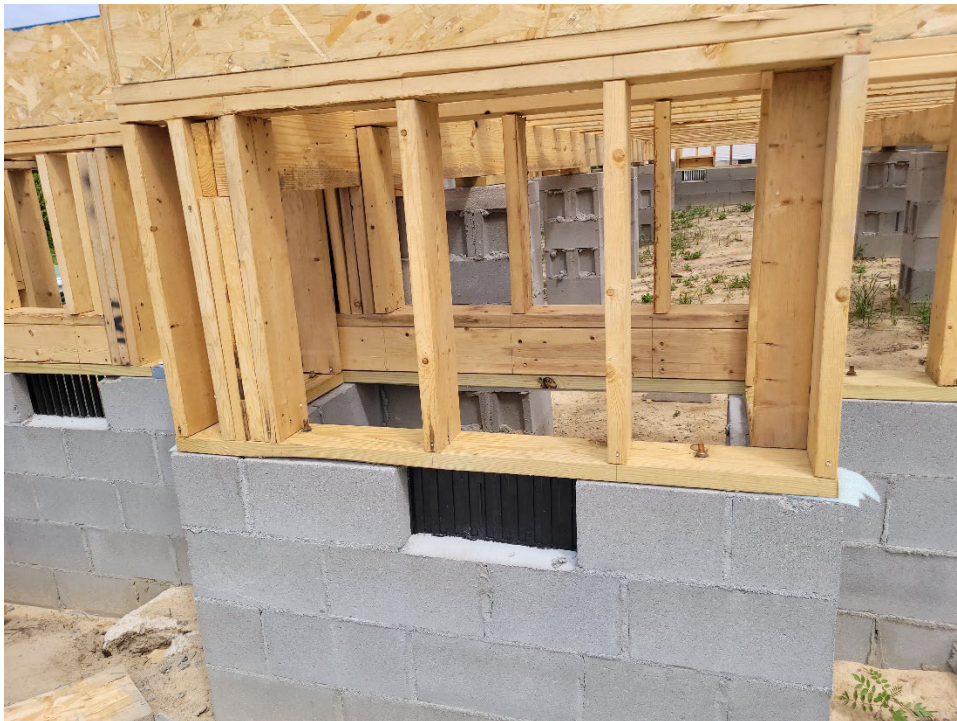
- 3) We observed a new 4 x 8 pilaster was installed for girder support. The construction of the pilaster in regards to the footing and tie in to the foundation was unknown to TE&D. Bearing of left end of middle girder. We also observed the girder was supported with a (3) 2 x 6 dropped header. Based on our observations and analysis, the existing girder and supporting framing remains suitable. No structural modification required. The pilaster is not providing significant structural support to the girder and may remain or be removed if required.

Item #3 – Girder remains suitable

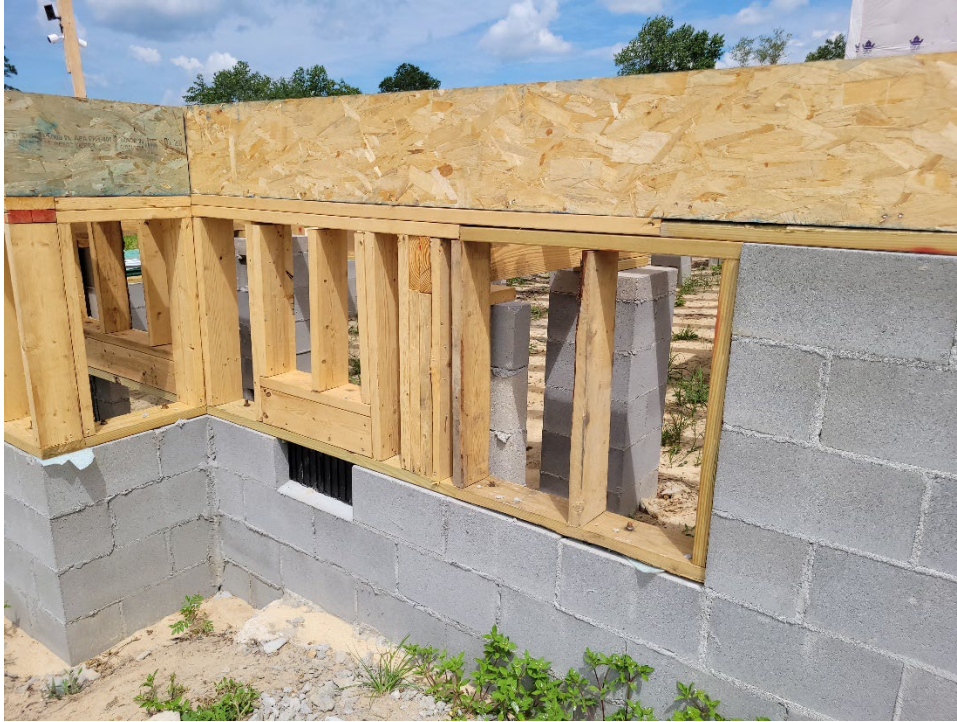
- 4) We observed a new 4 x 8 pilaster was installed for girder support. The construction of the pilaster in regards to the footing and tie in to the foundation was unknown to TE&D. The (2) 2 x 10 girder extended into the pony wall and was supported with (2) 2 x 4 jacks and (2) 2 x 4 king studs. Based on our observations and analysis, the existing girder remains suitable to support the anticipated loading conditions. The pilaster is not providing significant structural support to the girder and may remain or be removed if required.

Item #4 – Girder remains suitable

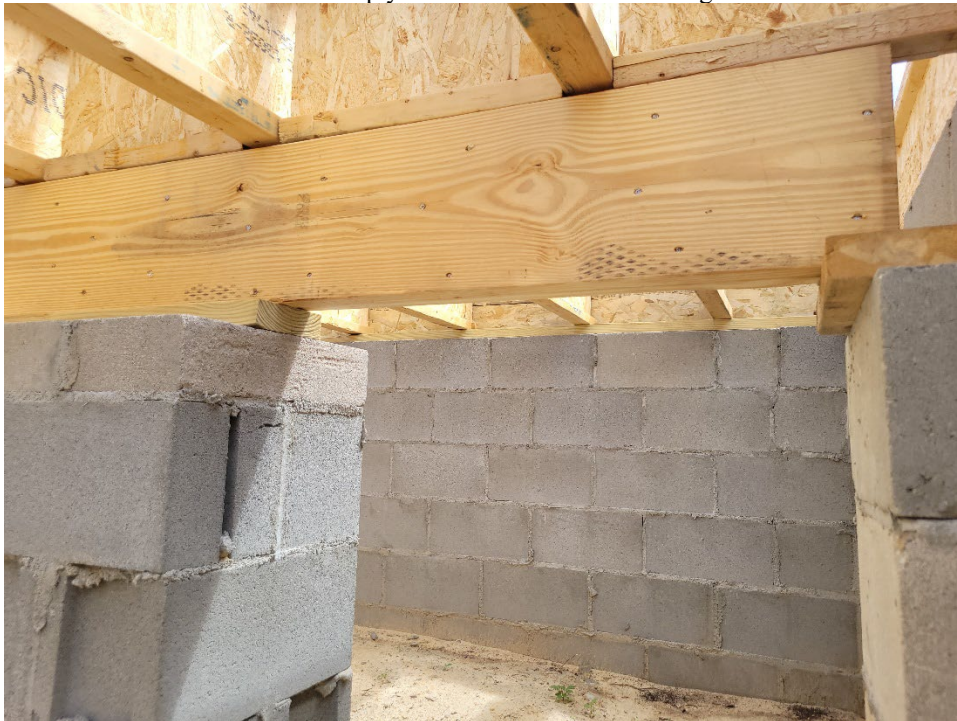
- 6) We observed a new 4 x 8 pilaster was installed for girder support. The construction of the pilaster in regards to the footing and tie in to the foundation was unknown to TE&D. The (2) 2 x 10 girder extended onto the pilaster; however, did not have full bearing. Based on our observations and analysis, the existing girder requires modification. The girder is to be increased to a (4) 2 x 10 girder from the adjacent pier to the pony wall. The new plys are to be added on each side and fastened with (3) rows of 16d nails at 4" o.c. Due to the minimal imposed load to the pilaster, the existing pilaster remains suitable as constructed.

Item #6 - New plys to be added to each side of girder

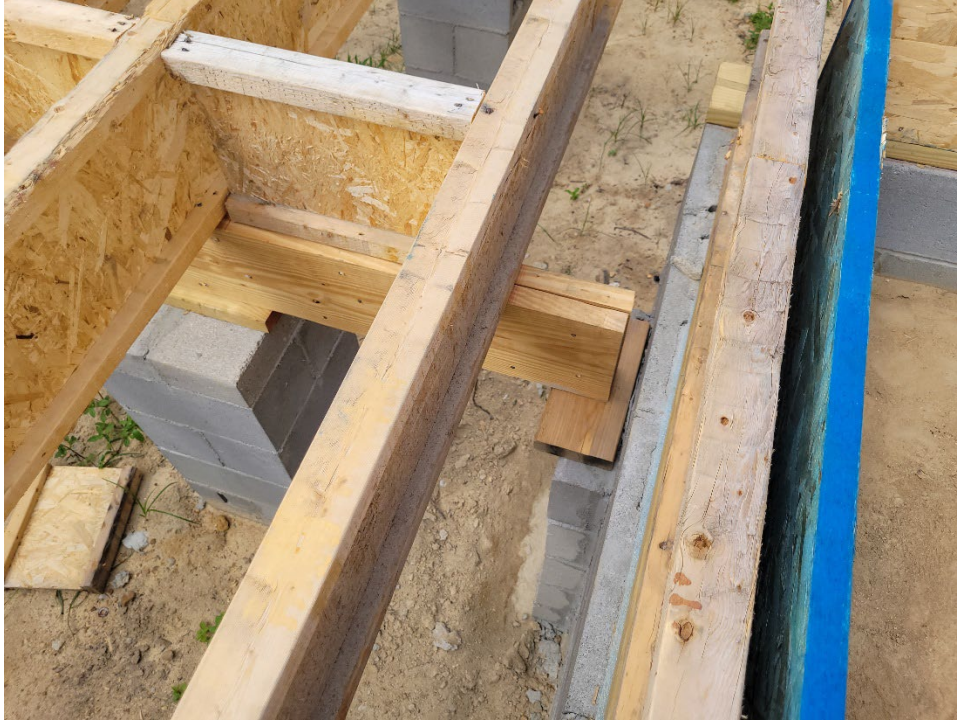
Item #7 - New plys to be added to each side of girder
