Takla Engineering, PLLC

Project: Quail Glen Lot 151
Location: Fuquay Varina, NC
Company: NVR
Care Of: Travis Peed
Subject: Roof Truss Repairs
Job Number: 2-2465-22

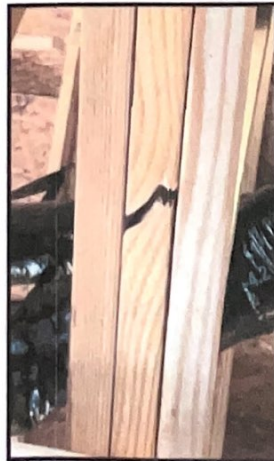
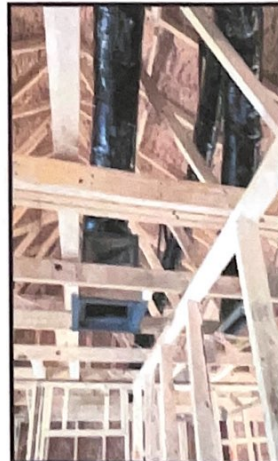
1) Roof truss SE-16904 (7th truss from the left elevation wall) features a cracked bottom chord (as shown in the picture below). We understand repairs have already been implemented by means of 2x4 scabs on each side of the bottom chord. Based on review, the repairs may be deemed acceptable provided they comply with the following characteristics:

- 1) Scabs extend no less than 4' in both direction away from the scab.
- 2) Scabs on both sides are attached with at least (2) 10d nails spaced at ~ 6" on center.

Add nails, and/or increase scab lengths as required to comply.
