**Project:** Prince Place Lot 34

**Location:** Fuquay Varina, NC

**Subject:** Notched LVL

**Job Number:** 2-2847-22

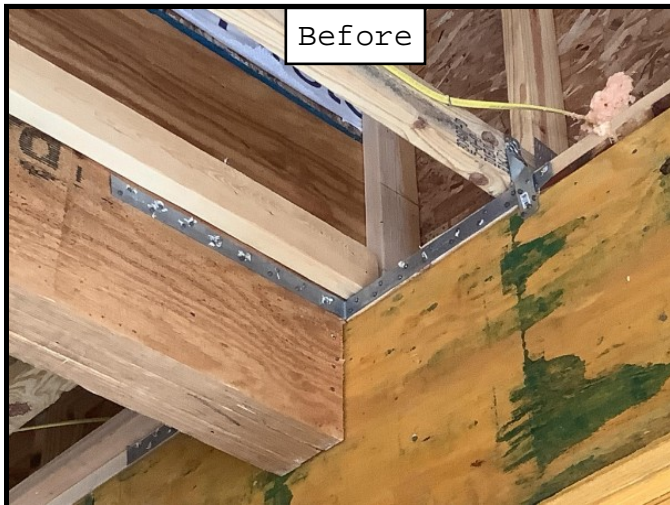
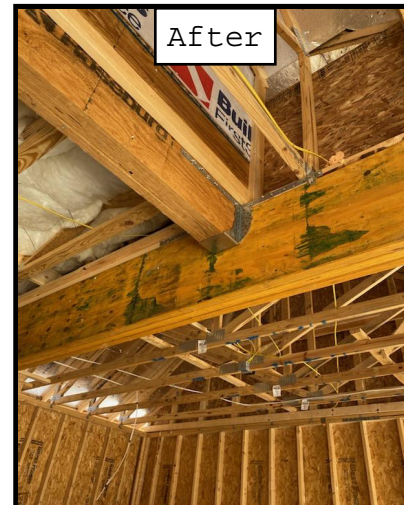
(3) 24" LVL beam over the garage is notched ~8" about the supporting (3) 18" LVL.

To accommodate the notch, engineer recommended installing hanger Simpson HGUS5.5/10 at the bottom section of the (3)24" LVL to prevent any potential of a shear failure resulting from the notch.

Based on review, the repairs have been implementing in accordance with our recommendations; No further change is required.
