**RE:** Daily Field Report for 06/11/2022  
Lot 70 Oakmont OKM (CMT) Lillington, NC  
Building & Earth Project No : RD220327

Project Name:	Lot 70 Oakmont OKM (CMT) Lillington, NC	Project Number:	RD220327
Client Name:	H & H Homes	Placement#:	FO-2
Contractor:	H & H Homes	Technician:	Bruce Rohr
Monitoring:	Shallow Footing Testing

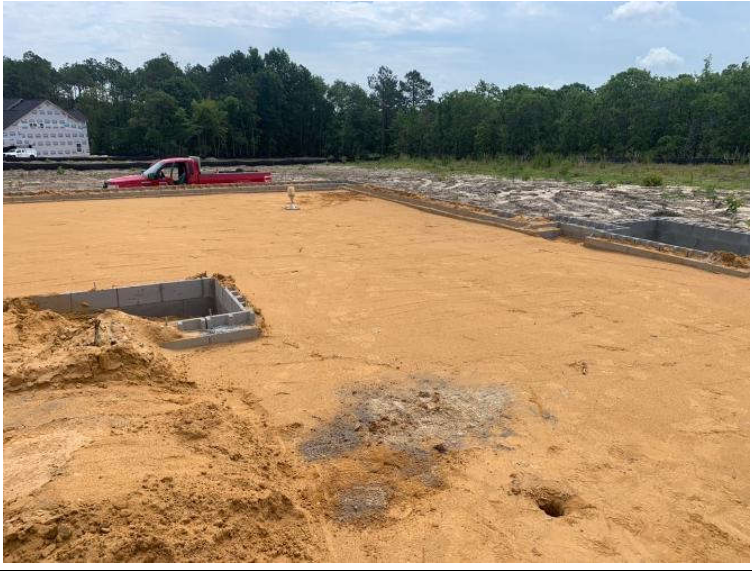
Picture ID	Caption
42976	Lot from front right

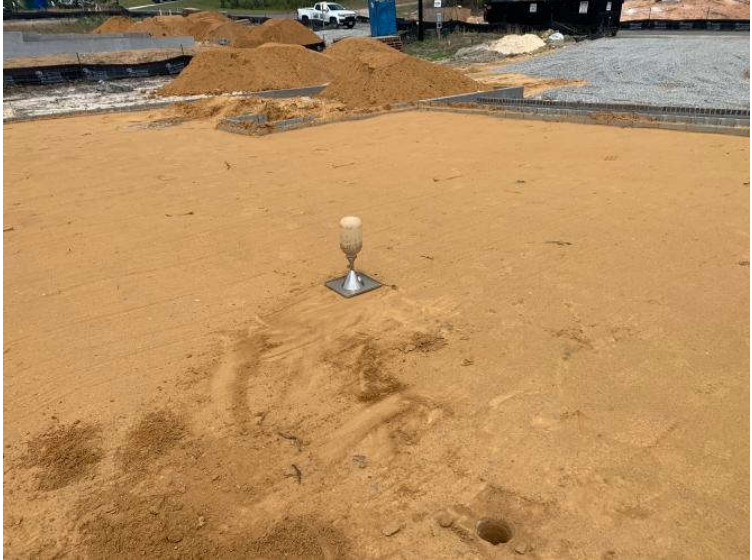
42977	Lot front back left
