**RE:** Daily Field Report for 03/21/2022  
Lot 688 Manor @ Lexington MLP (CMT) Cameron, NC  
Building & Earth Project No : RD220154

Project Name:	<b>Lot 688 Manor @ Lexington MLP (CMT) Cameron, NC</b>	Project Number:	<b>RD220154</b>
Client Name:	<b>H &amp; H Homes</b>	Placement#:	<b>FO-1</b>
Contractor:	<b>H &amp; H Homes</b>	Technician:	<b>Bruce Rohr</b>
Monitoring:	<b>Shallow Footing Testing</b>

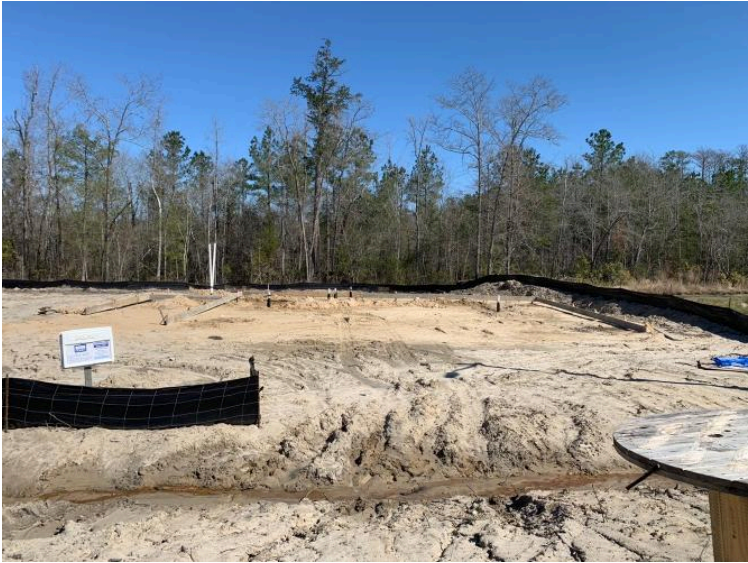
Picture ID	Caption
39351	<b>Lot from street</b>

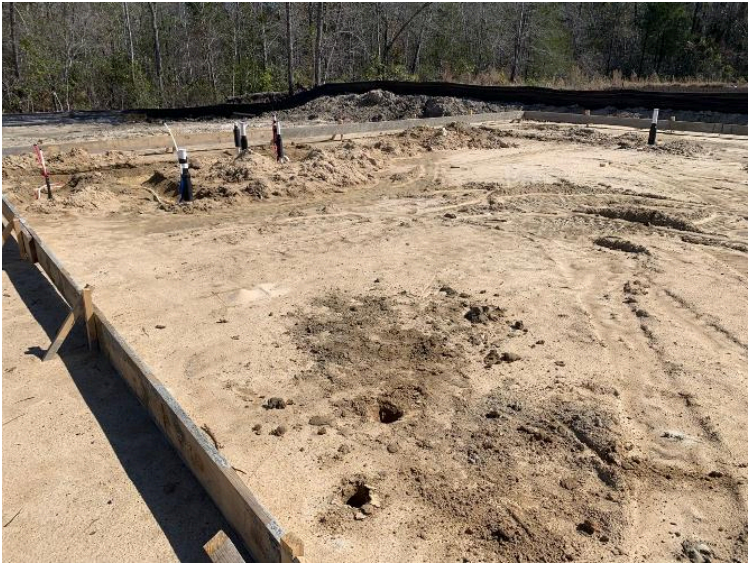
39352	<b>Lot from front left</b>
