# Takla Engineering, PLLC

**Project:** Prince Place Lot 21  
**Location:** Fuquay Varina, NC  
**Company:** David Homes  
**Care Of:** Lee Aversano  
**Subject:** Roof Truss Repairs  
**Job Number:** 2-2670-22

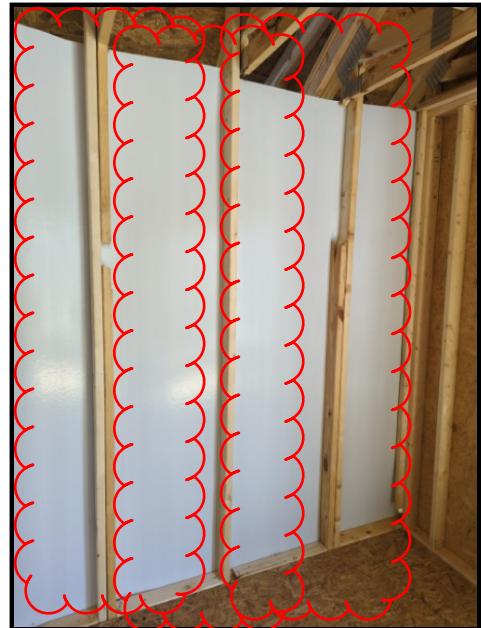
2) The three (3) left most roof trusses near the left wall features damaged vertical webs serving as the forward wall of the 2nd story. See picture below for reference. Moving forward we recommend the following:

- A) cut damaged portions of broken webs away as to provide a clean, flush end.
- B) Fill in the missing portions of the web with field framed 2x4 material.
- c) Install a 4'x4'x1/2" OSB gusset plate to both sides of the top and bottom chord joints, notching away only the material required to not intrude into finished areas. Attach with (2) 10 x 1.5" nails spaced at 3" on center to all adjoining truss and field framed members.
- D) Install a full length 2x4 scab extending from top of top chord to bottom of bottom chord to both faces of the truss (+ gusset plates). Attach with (2) 10d nails at 3" on center.
