# Takla Engineering, PLLC

**Project:** Prince Place Lot 21  
**Location:** Fuquay Varina, NC  
**Company:** Davidson Homes  
**Care Of:** Lee Aversano  
**Subject:** Roof Truss Repairs  
**Job Number:** 2-3275-22

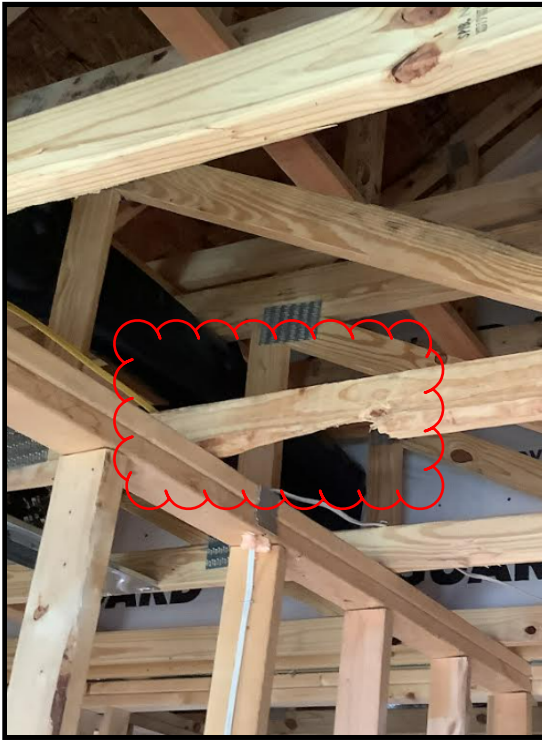
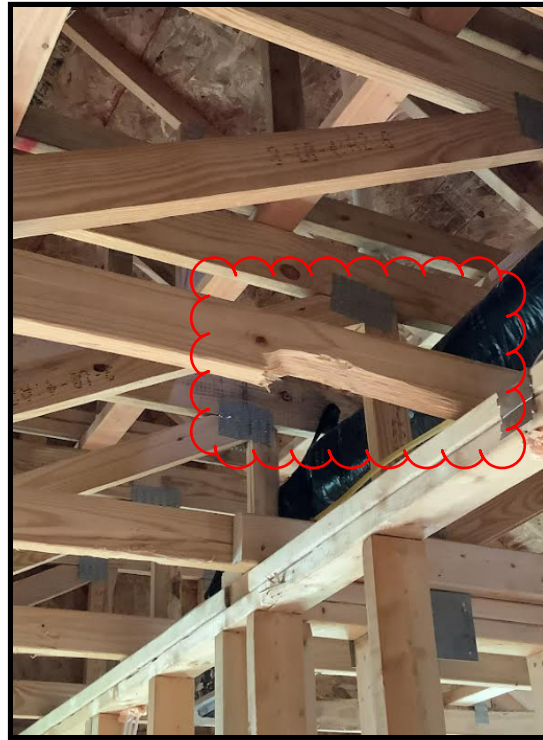
As requested, Andy Takla, PE prepared this report on July 15th, 2022 to provide builder with a reinforcement method to repair roof truss A2 which features a large portion of the cross section missing from the upper section bottom chord (near joint 46). See pictures below for reference.

Based on review, we recommend installing a 8' long 2x4 scab to both faces of the bottom chord, centered on the damage and attached with (2) 10d nails spaced at 6" on center.
