Project: Purfoy Place Lot 4

Location: 90 Lambert Lane, Fuquay-Varina NC

Subject: Rear Porch Foundation Wall Footing and 3rd Party Inspection

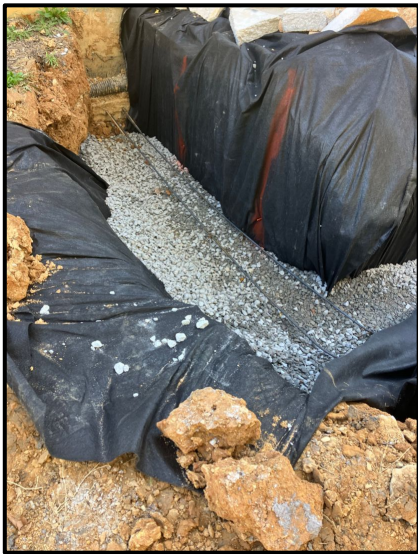
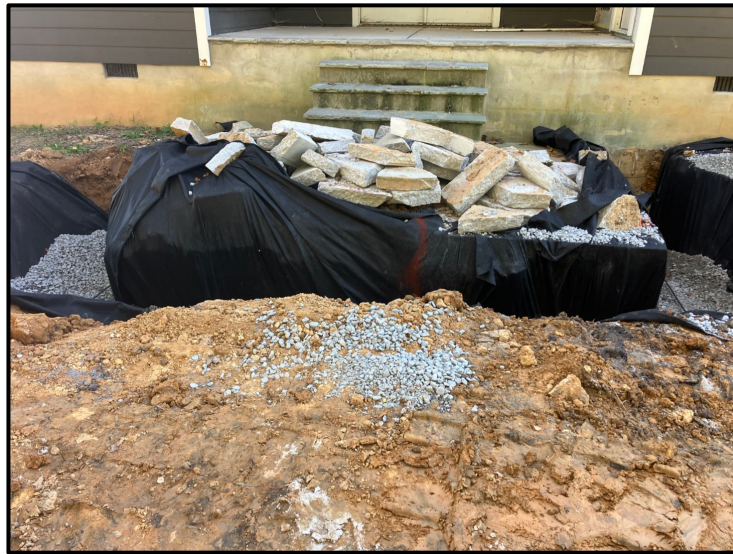
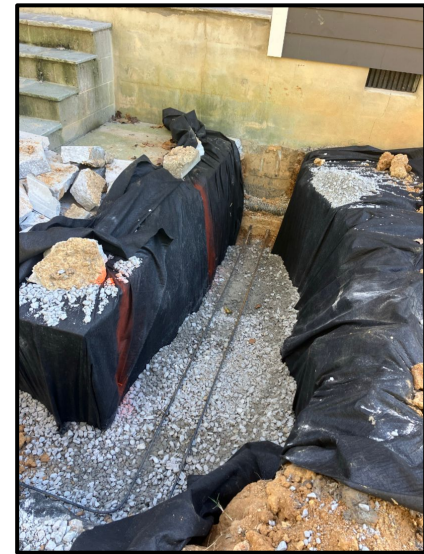
- Steel reinforcement installed at interface where the new rear porch foundation wall continuous footings meets the existing continuous footings for the rear elevation foundation wall of the house as well as the steel reinforcement installed continuously at bottoms of rear porch foundation wall footing excavations were installed in accordance with engineering verbal recommendations provided during our initial visit to this site on October 15th, 2024, see pictures on Page 2 of this report for additional reference.

- Depth and size of rear porch foundation wall continuous footing excavations meets or exceeds per plan specifications and code requirements.
- Locations of rear porch foundation wall continuous footing excavations are found to be per plans.

- Footings are prepared in compliance with NCRC 2018 Chapter 4 (Sections R401-R404)
- All conditions are acceptable to receive concrete.

- To compensate for soft / inconsistent conditions of subgrade soils as well as the high water table encountered at the rear of this lot, during our site visit on October 15th, 2024, we recommended over-excavating rear porch foundation wall continuous footings to a depth of at least 12" below the level of the existing continuous footings for the rear elevation foundation wall of the house, fully lining all sides of footing excavations with non-woven water-permeable fabric, and backfilling the lined footing excavations with #57 washstone, leaving enough space for per-plans concrete footing thickness to be poured over the top of the #57 stone tied to the existing continuous footings for the rear elevation foundation wall of the house. Based on our observations during our site visit on this day, all footings excavations mentioned above have been prepared per our recommendations.
