August 11, 2023  
Revised August 23, 2023

Reference: Engineering Services  
6983 US-401  
Fuquay-Varina, NC 27526  
TE&D Project No.: 2301-020783\_R

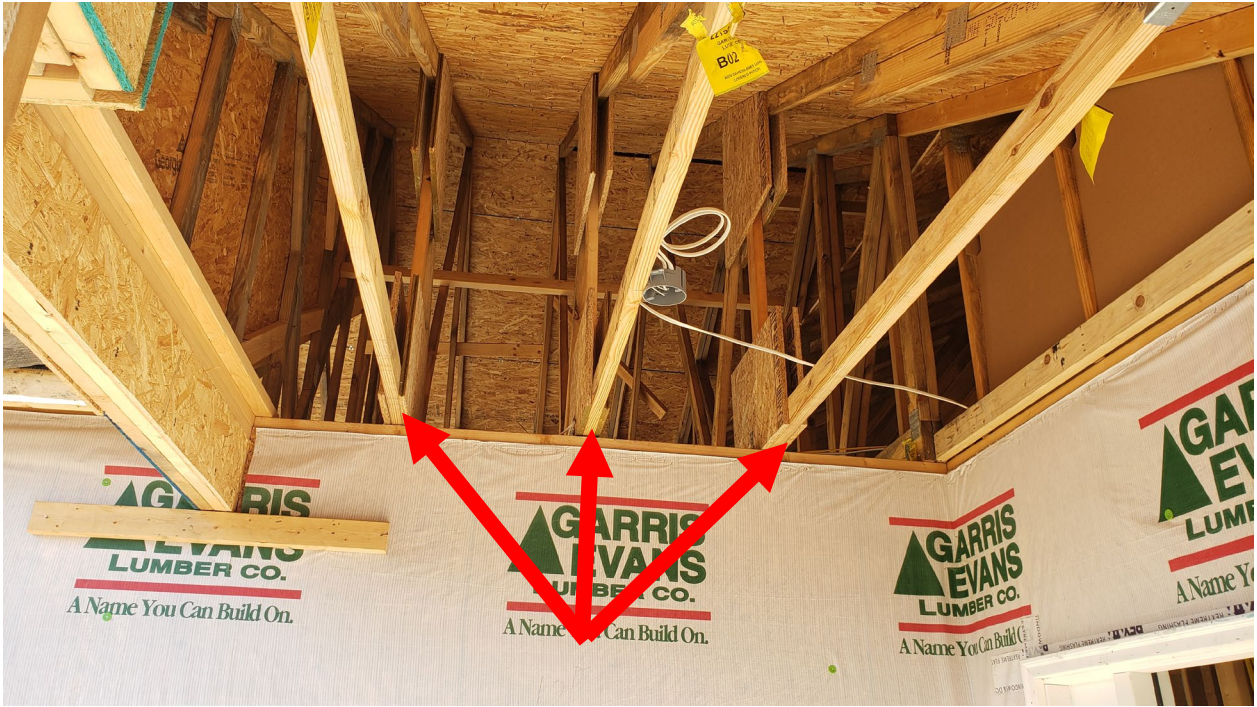
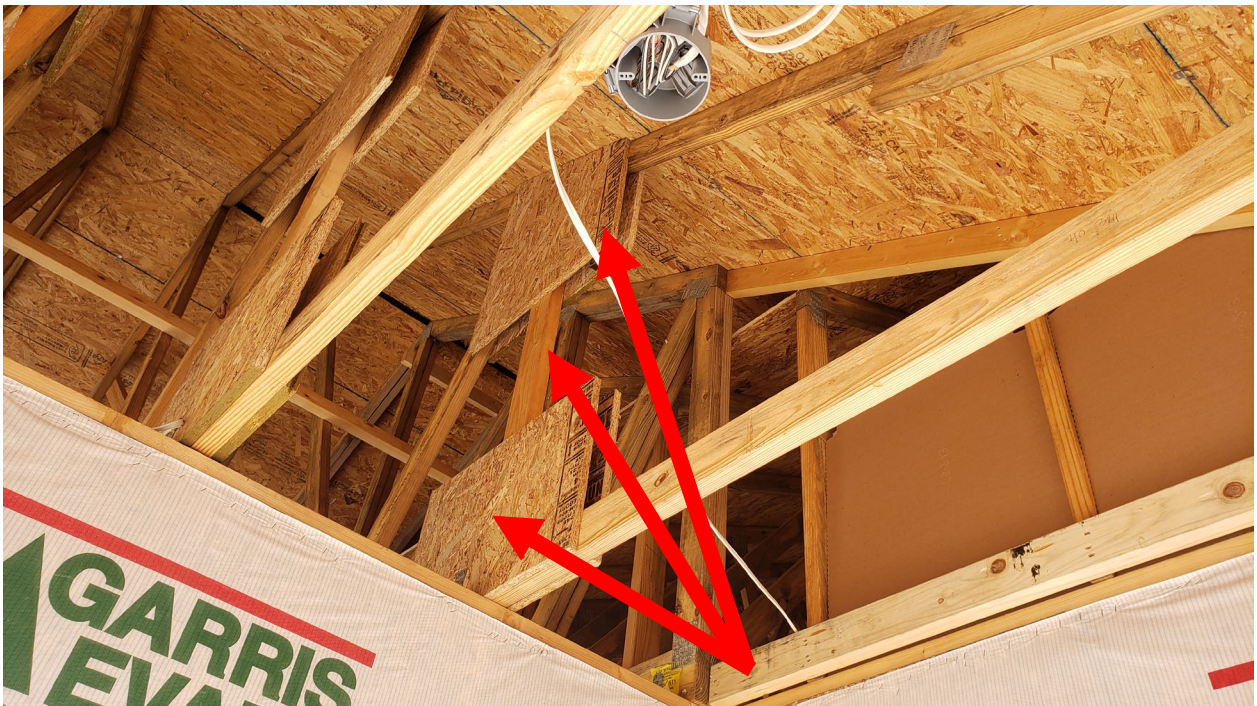
Item 1)

- 1) We observed new 2 x 4 vertical webs had been installed to the B02 trusses between the garage and front porch due to the trusses being installed in the wrong orientation per the provided truss drawings. We observed the new webs had been fastened to the trusses with minimum 16" x 32" x 3/4" OSB gussets at both side of the trusses. Gussets were fastened at all intersecting members with (2) rows of nails at 3" o.c. Based on our observations and analysis, the existing configuration is adequate to support the anticipated loading conditions.

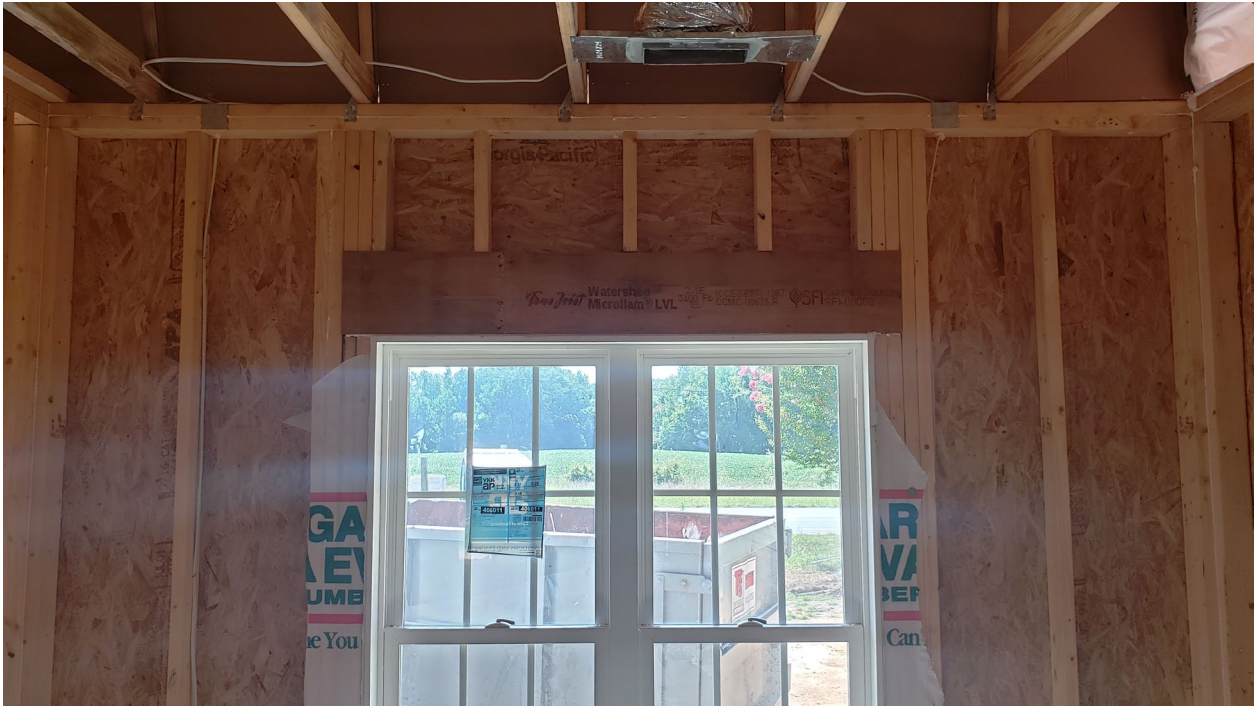
**Item 2a)**

- a. A (2) 1-3/4" x 9-1/4" LVL header at the middle-front bedroom supported by (2) 2 x 4 jacks and (2) 2 x 4 king studs at each end. Based on our observations and analysis, the current header is adequate to support the anticipated loading conditions.

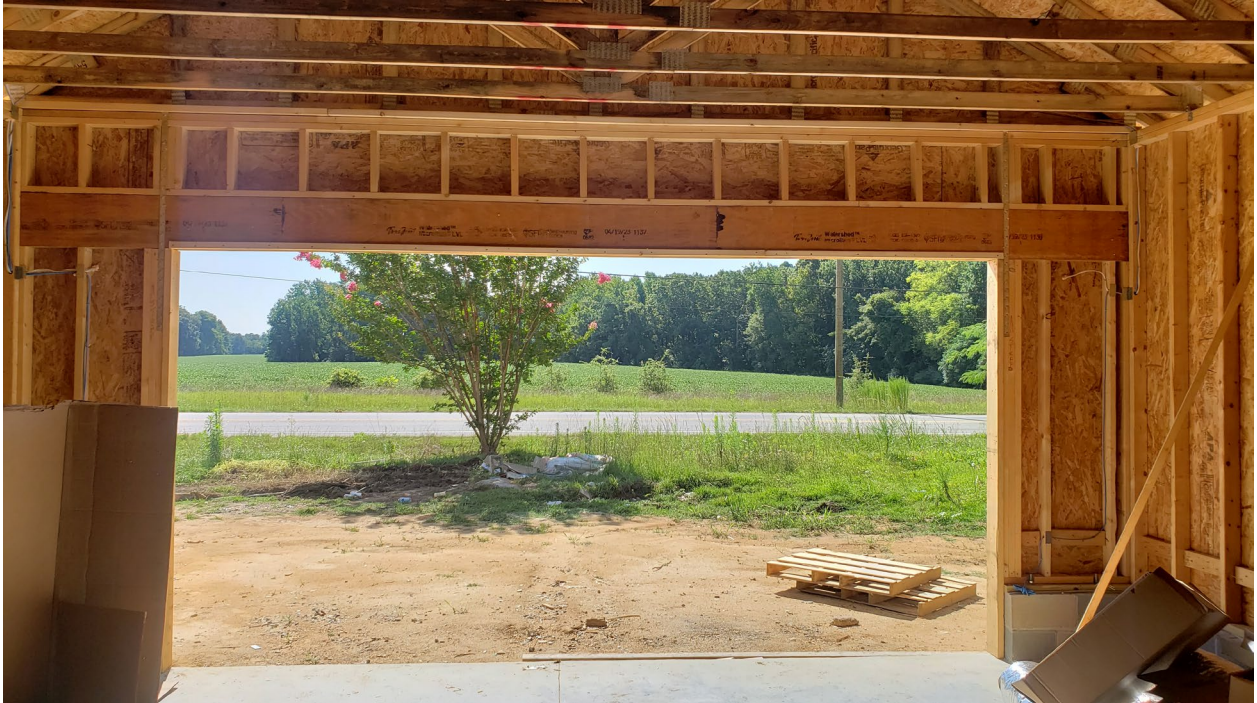
**Item 2b)**

- b. A (2) 1-3/4" x 11-7/8" LVL header at the garage door supported by (3) 2 x 4 jacks at each end. Based on our observations and analysis, the current header is adequate to support the anticipated loading conditions.

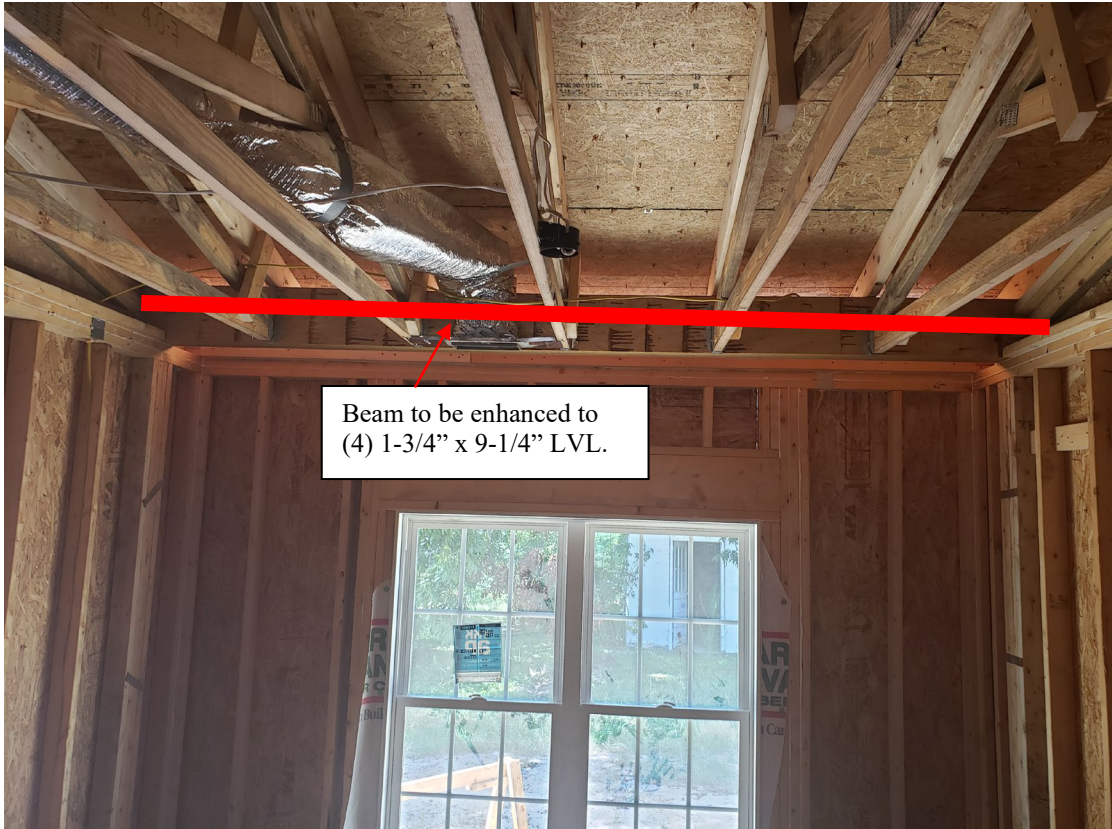
**Item 2c)**

- c. A (3) 1-3/4" x 9-1/4" LVL header above the breakfast area supported by (4) 2 x 4 jacks at each end. Based on our observations and analysis, the current header is inadequate to support the anticipated loading conditions. TE&D recommends that the beam be enhanced to a minimum (4) 1-3/4" x 9-1/4" LVL beam supported at each end by a minimum of (5) 2 x 4 jacks.

Upon completion, the modified framing will provide adequate support for the anticipated loading conditions. We appreciate being able to assist you during this phase of the project. If you need further assistance or require additional information, please do not hesitate to contact us.
