Reference: Engineering Services

Serenity - Lot 55 114 Serendipity Dr. Fuquay-Varina, NC 27526

TE&D Project No.: 2301-020472 A

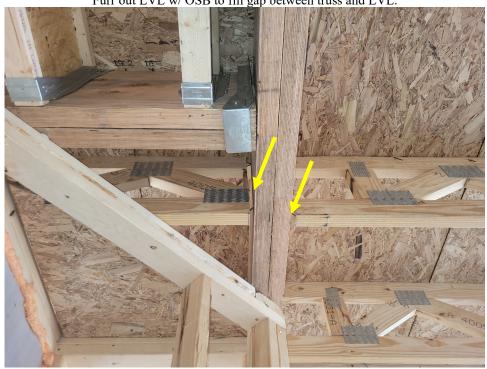
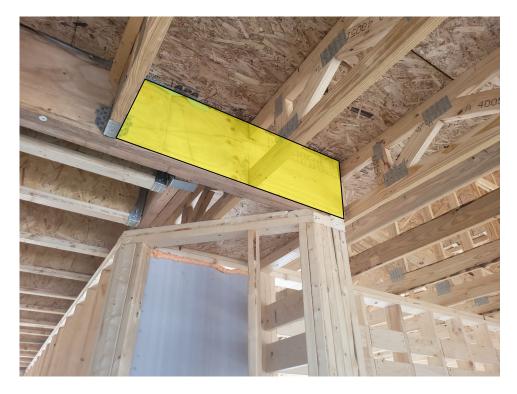
- 1. We observed roof truss "A" was cut at bottom chords 24-25, 23-26, as well as web 23-24. Based on our observations and analysis, the existing truss is not suitable as installed due to the anticipated compression and tension loads associated with the damaged members. The truss is to be repaired and reinforced with the following recommendations:

- a. Each side of the LVL beam is to be furred out with 7/16" OSB sheets as needed. Sheets are to be fastened to the beam with (3) rows of 8d nails at 4" o.c. Sheets are to extend to adjacent intersecting members on each side of the damaged truss.

Furr out LVL $\ensuremath{\text{w}}/$ OSB to fill gap between truss and LVL.
