RE: **Lot 539 OHC**  
ECS Job # **33:6230-DA**

Permits:  
Location: **272 Caldwell St**  
**Spring Lake, NC 28390**

## FIELD REPORT

Remarks **Recommendations**

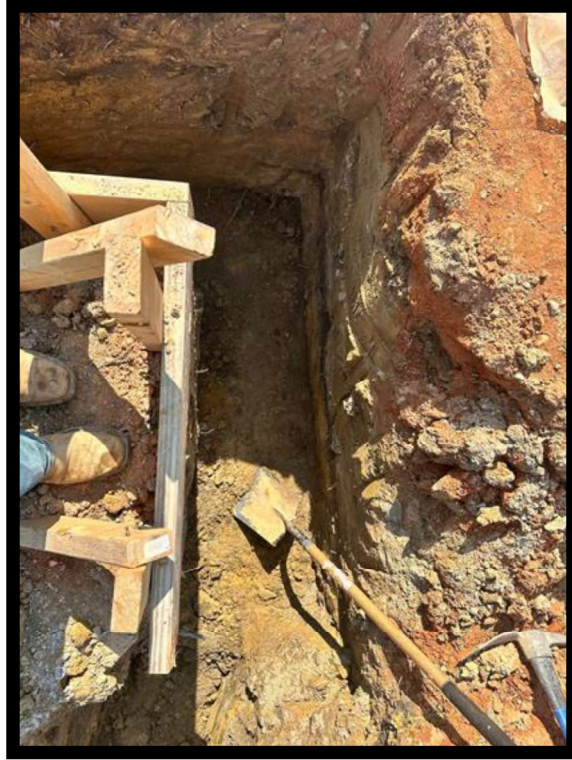
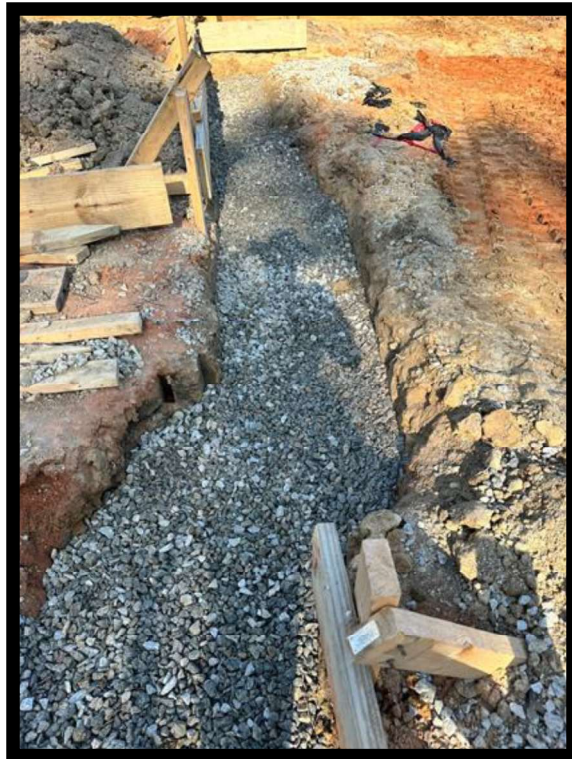
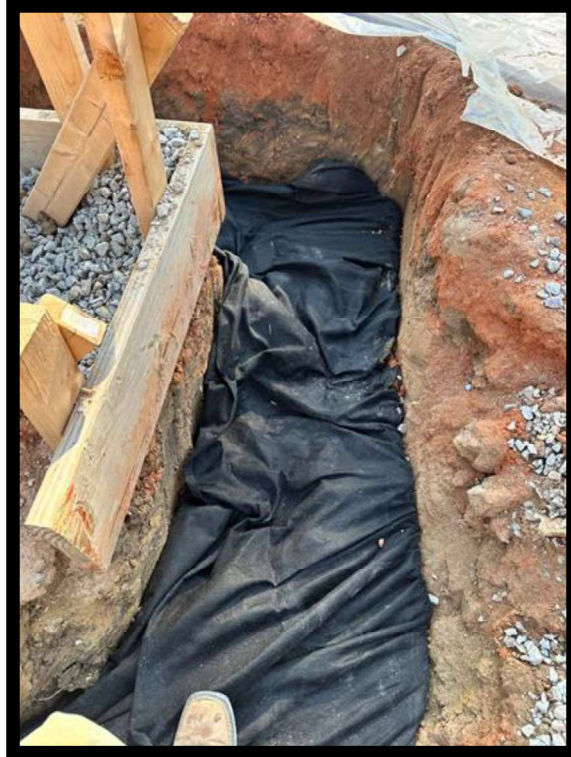
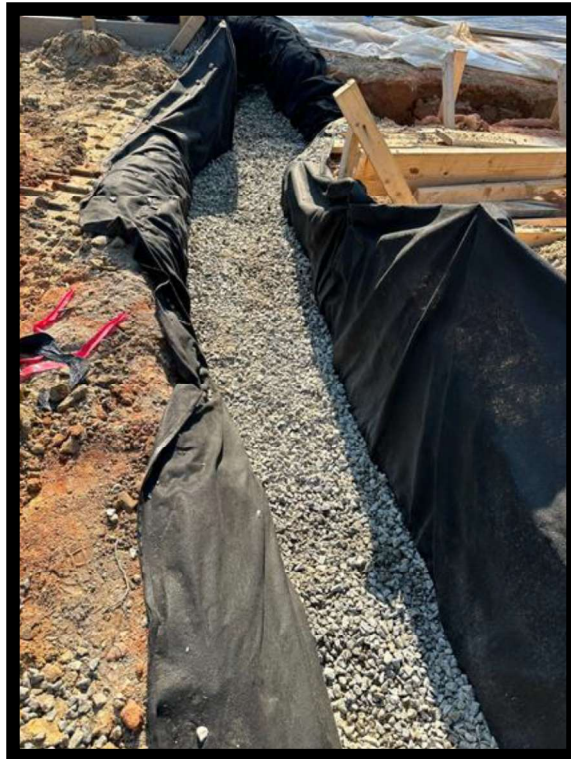
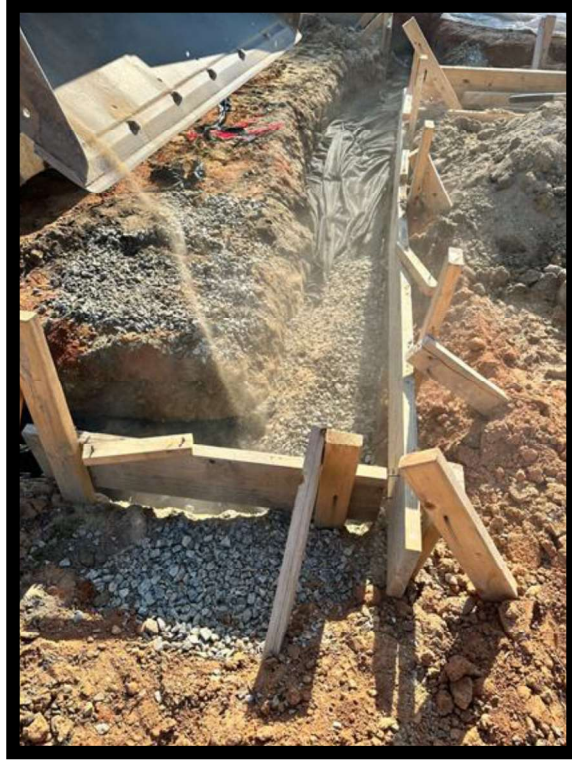
ECS arrived on site, as requested, to observe a portion of the garage footing that had ground water seepage. Upon arrival, ECS probed the footing throughout to determine the stability of the soils in place. Due to the soils being saturated, ECS spoke with Chandler Jones w/ Wellons Realty. ECS provide the recommendation of undercutting the soft and saturated soils down to 3 feet below the current footing subgrade. Once undercut, ECS recommended backfilling the footing with 57 stone and wrapping the stone with an engineering non-woven fabric. Please see the attached photos for the documented repairs.
