| Job 72341284REP2 | Truss A1F | Truss Type Truss | Qty 3 | Ply 1 | PROFESSIONALRALEIGH FARMHOUSE ROOF Job Reference (optional) |

UFP Mid Atlantic LLC, 5631 S. NC 62, Burlington, NC, clm

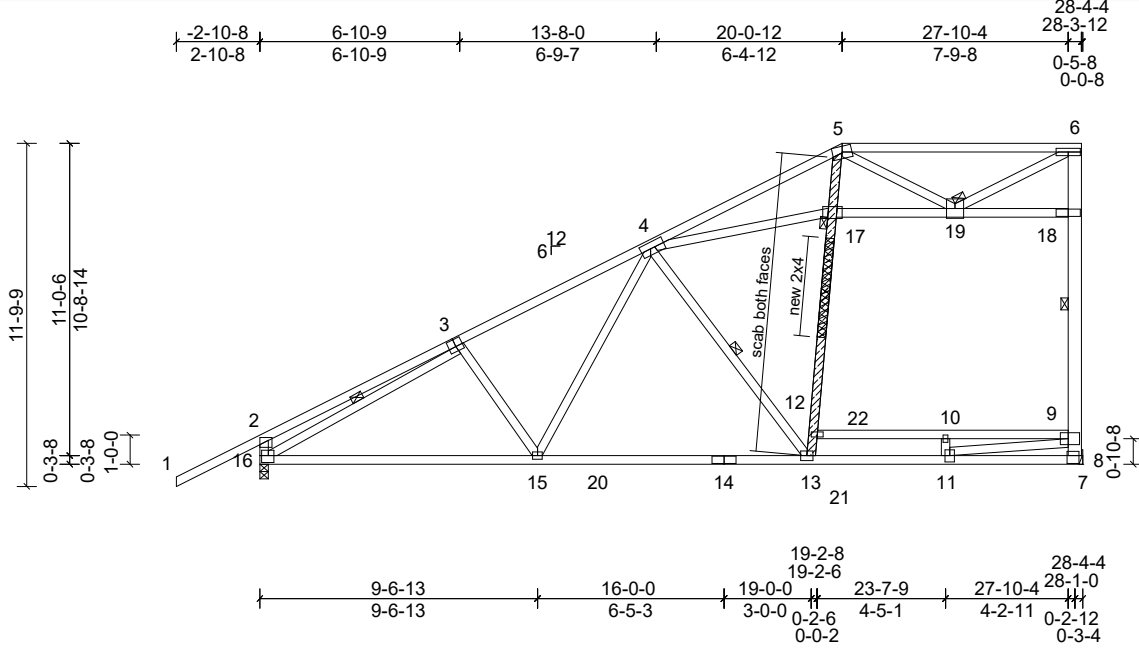
Repair for a section of web missing starting +/- 6" below joint 17.

Cut and fit tight a new 2x4 x 41" SP or SPF No.2, and attach 2x4 SP or SPF No.2 scabs to each face of truss as shown with 2 rows of 10d (.131" x 3") nails spaced 4" oc
