# Takla Engineering, PLLC

**Project:** McKay Place Lot 35  
**Location:** Lillington, NC  
**Company:** Builder First Source  
**Care Of:** Tatiyana Karim  
**Subject:** I-Joist Repairs  
**Job Number:** 2-4801-24

**Damage or Modification observed:**

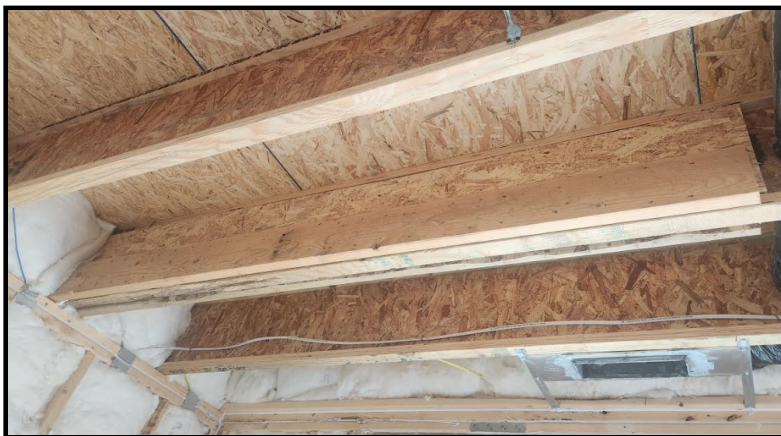
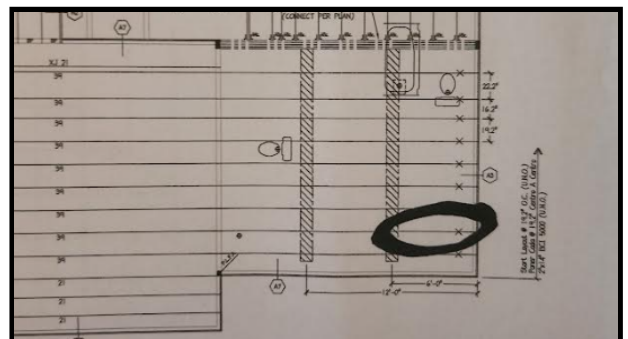
One (1) I-joist located at the location noted on the snip of the I-joist layout below was damaged during transport and was pro-actively repaired; See pictures below for reference.

**In-place repairs by means of OSB web fillers and 2x8 scabs to both faces of bottom chord are appropriate and adequate to restore structural integrity. No further repairs are required.**

Implement the Repair Detail included with this report to one side of (each) I-joist.
