RE: Daily Field Report for 12/02/2024
62 Peach Orchard Lane (CMT) Lillington, NC
Building & Earth Project No : RD240854

Field Observations Report

Project Name:	62 Peach Orchard Lane (CMT) Lillington, NC	Project Number:	RD240854
Client Name:	On-site Homes, LLC	Placement#:	FO-3
Contractor:	On-site Homes, LLC	Technician:	Ahmad Shelton
Monitoring:	DCP

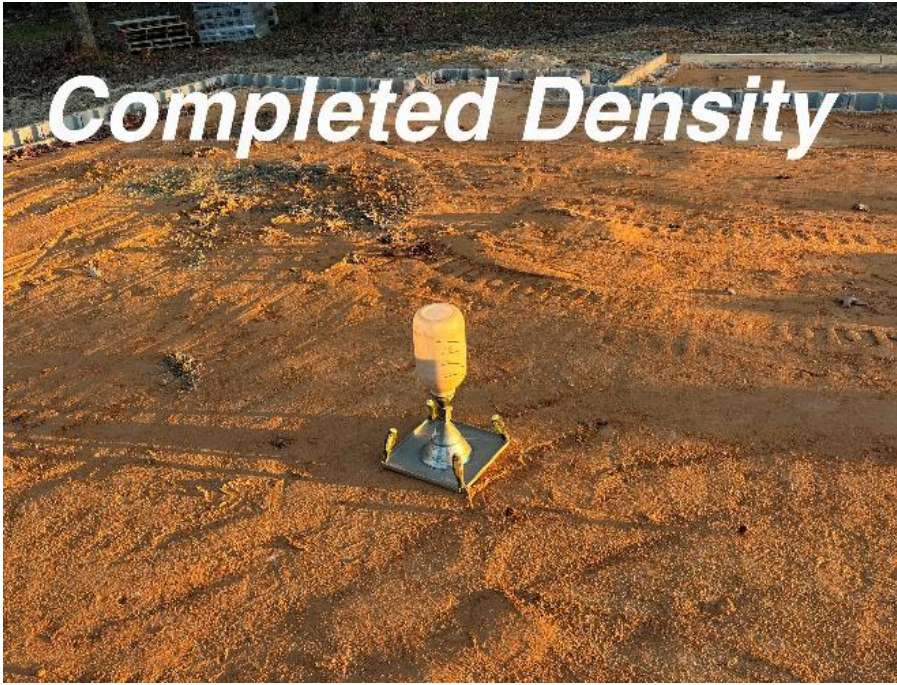
Picture ID	Completed Density
97646

Test #	IDs		Test Type	Location	Probe Depth (in)	Elev. (ft)	Dry Density(pcf)	% Moisture	% Compaction	Result
	Area	Proctor								
1	FSG-Bldg	1-point	ASTMD1556	Finished Subgrade Soils -Building : Back Left Corner 25' Northwest :		FSG	119.7	10.0	100+	PASS
