## DESIGN PROFESSIONAL INSPECTION FORM

Residential Single-Family Project: Y <input checked="" type="checkbox"/> N <input type="checkbox"/>	Commercial Project: Y <input type="checkbox"/> N <input checked="" type="checkbox"/>
Code Enforcement Project No:	Permit No: SFD2404-0034
Project Name: 122 Jones Creek Lane	Owner: A&G Residential, LLC
Project Address: 122 Jones Creek Lane, Lillington, NC 27546	Suite No:
Date Inspected: 4/23/2025	Contractor Name: A&G Residential, LLC
Component Inspected: Footing Repair at Front Left Corner of Front Porch

Reference: Engineering Services  
122 Jones Creek Lane  
Lillington, NC 27546  
Project No.: 2501-020310\_R1

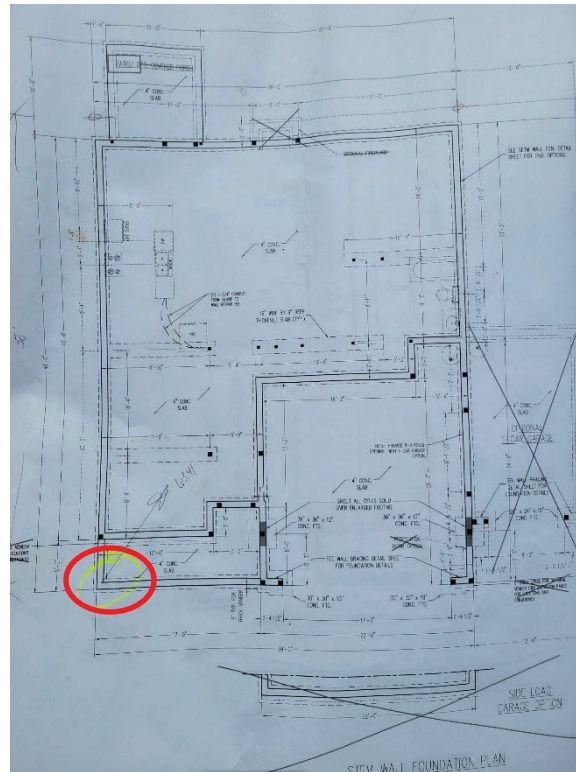
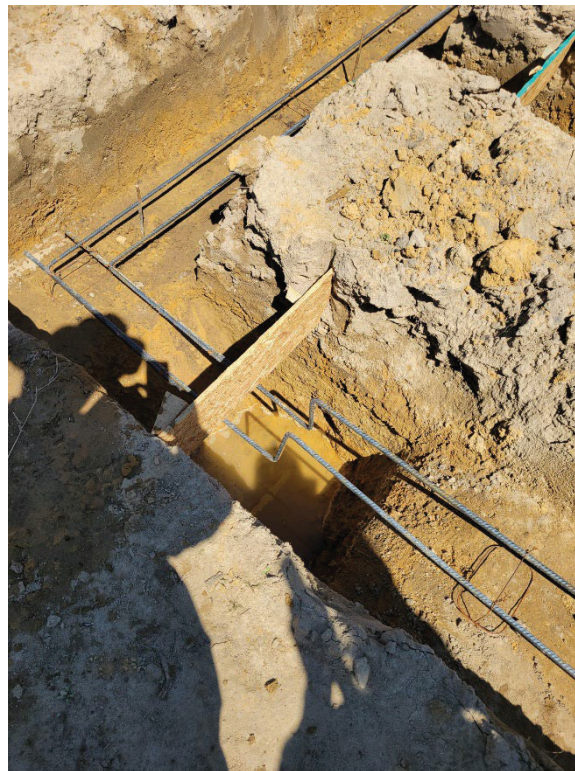
- 1) The existing footing at the front left corner of the front porch had been overexcavated due to a tree stump. The footing in this area was reinforced with (2) #4 rebar at the bottom of the specified footing depth and filled solid with concrete. Based on our analysis, the completed repair is adequate to support the anticipated loading conditions.
