Description: Floor Joist F-J-4(i14486)

Project: Lot 593 Colony
 Address: 98 White Doe Crossing
 City, St: Cameron, NC
 Retailer: Builders FirstSource
 Distributor:
 Date: 8/9/24

2nd Floor\Floor Joists\FJ-4(i14486) (Joist)

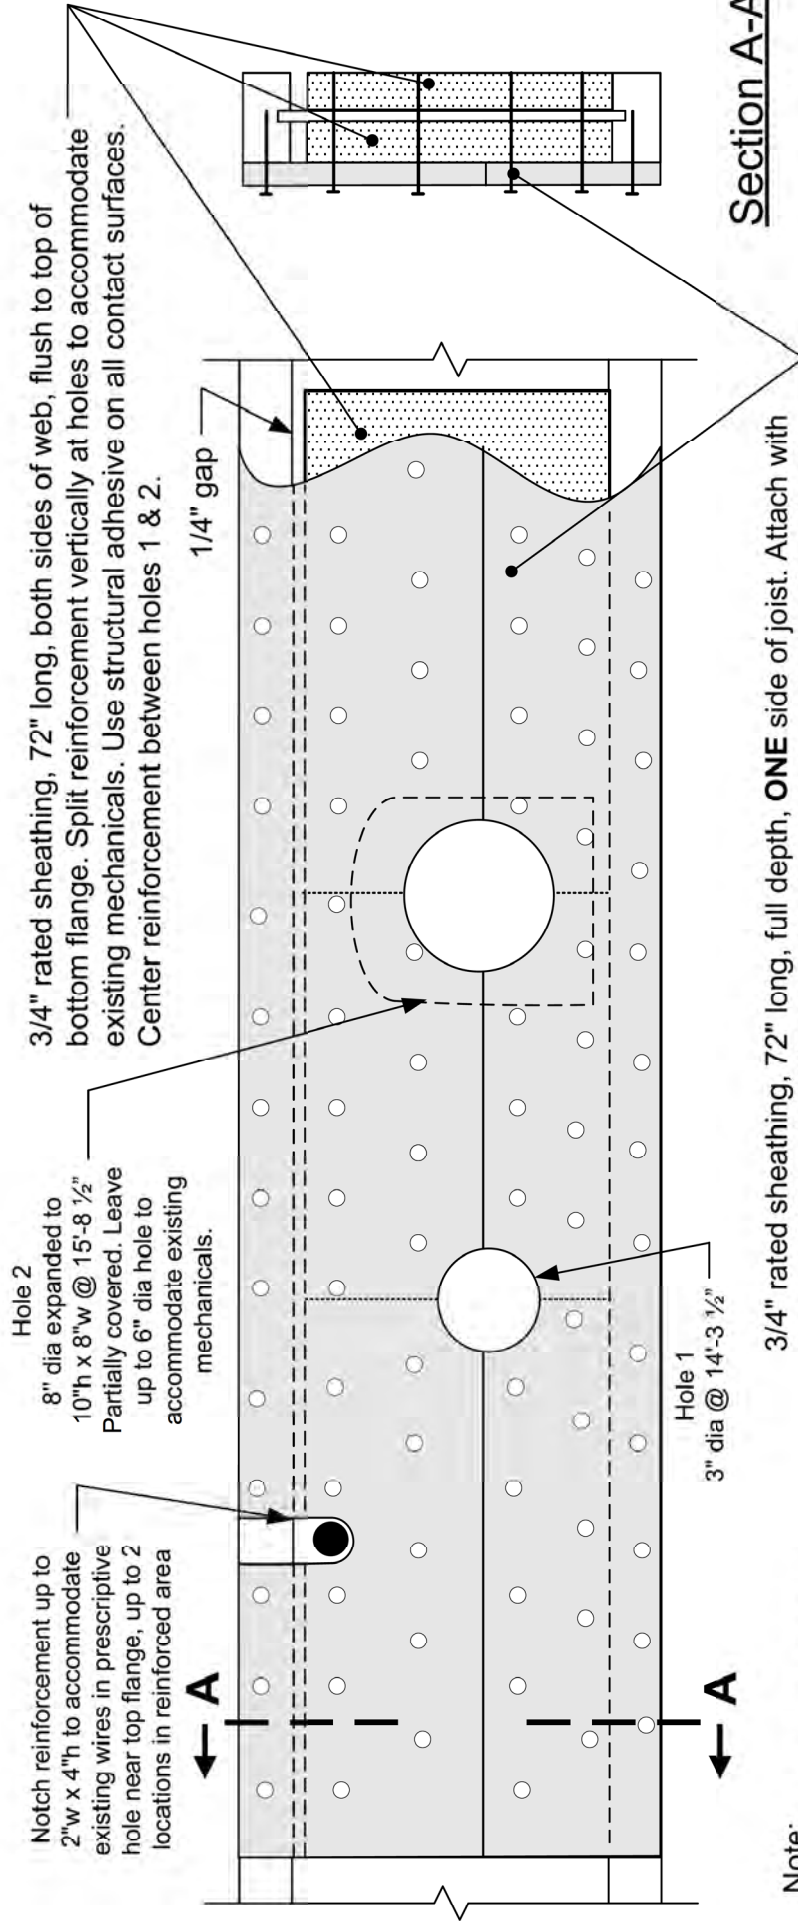
Section A-A

Hole 2
 8" dia expanded to 10" h x 8" w @ 15'-8 1/2"
 Partially covered. Leave up to 6" dia hole to accommodate existing mechanicals.

Notch reinforcement up to 2" w x 4" h to accommodate existing wires in prescriptive hole near top flange, up to 2 locations in reinforced area

No additional holes allowed in reinforced area.

3/4" rated sheathing, 72" long, both sides of web, flush to top of bottom flange. Split reinforcement vertically at holes to accommodate existing mechanicals. Use structural adhesive on all contact surfaces. Center reinforcement between holes 1 & 2.

3/4" rated sheathing, 72" long, full depth, **ONE** side of joist. Attach with 4 rows of 16d nails at 4" on center in web area and 1 row 8d nails at 6" on center in top/bottom flange. Split reinforcement horizontally to accommodate existing mechanicals. Use structural adhesive on all contact surfaces. Center reinforcement between holes 1 & 2.

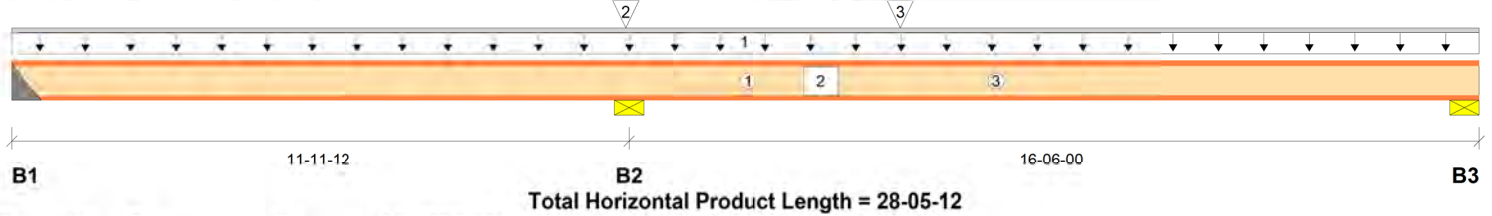
FAILED

Value	% Allowable	Duration	Case	Location
Pos. Moment	2604 ft-lbs	72.6%	100%	3 21-01-05
Neg. Moment	-2736 ft-lbs	76.3%	100%	1 11-11-12
End Reaction	736 lbs	61.4%	100%	3 28-05-12
Int. Reaction	2000 lbs	79.2%	100%	1 11-11-12
End Shear	715 lbs	39.2%	100%	3 28-03-04
Cont. Shear	1039 lbs	57.0%	100%	1 12-02-08
Hole #1 Shear	831 lbs	64.7%	100%	1 14-03-08
Hole #2 Shear	723 lbs	170.1%	100%	1 15-04-08
Hole #3 Shear	284 lbs	24.1%	100%	9 19-01-04
Total Load Deflection	L/738 (0.266")	32.5%	n/a	3 20-05-15
Live Load Deflection	L/974 (0.202")	49.3%	n/a	12 20-07-07
Total Neg. Defl.	L/999 (-0.046")	n/a	n/a	3 07-04-13
Max Defl.	0.266"	17.7%	n/a	3 20-05-15
Span / Depth	14.0			
Hole Location	Failed - See Cautions

Member has insufficient shear resistance at hole #2 to carry load.

Hole 1 is too close to Hole 2. They must be at least 25-1/2" apart.
