Reference: Engineering Services
7934 NC-210
Bunnlevel, NC 28323
TE&D Project No.: 2301-020499

As requested by the client, a representative of Tyndall Engineering & Design, PA (TE&D) was on-site to inspect and observe the existing footing and foundation. We understand the previous home was severely damaged by a fire (as well as the subsequent fire suppression) and was completely removed from the lot. We inspected and observed the following:

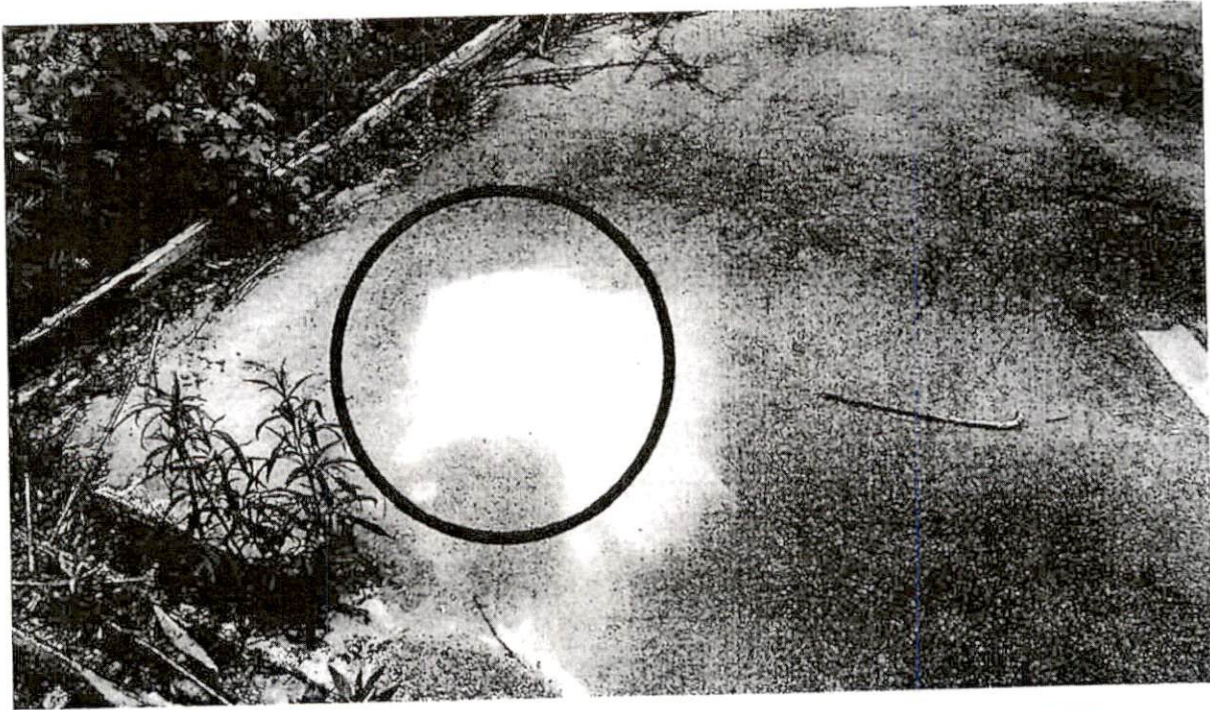
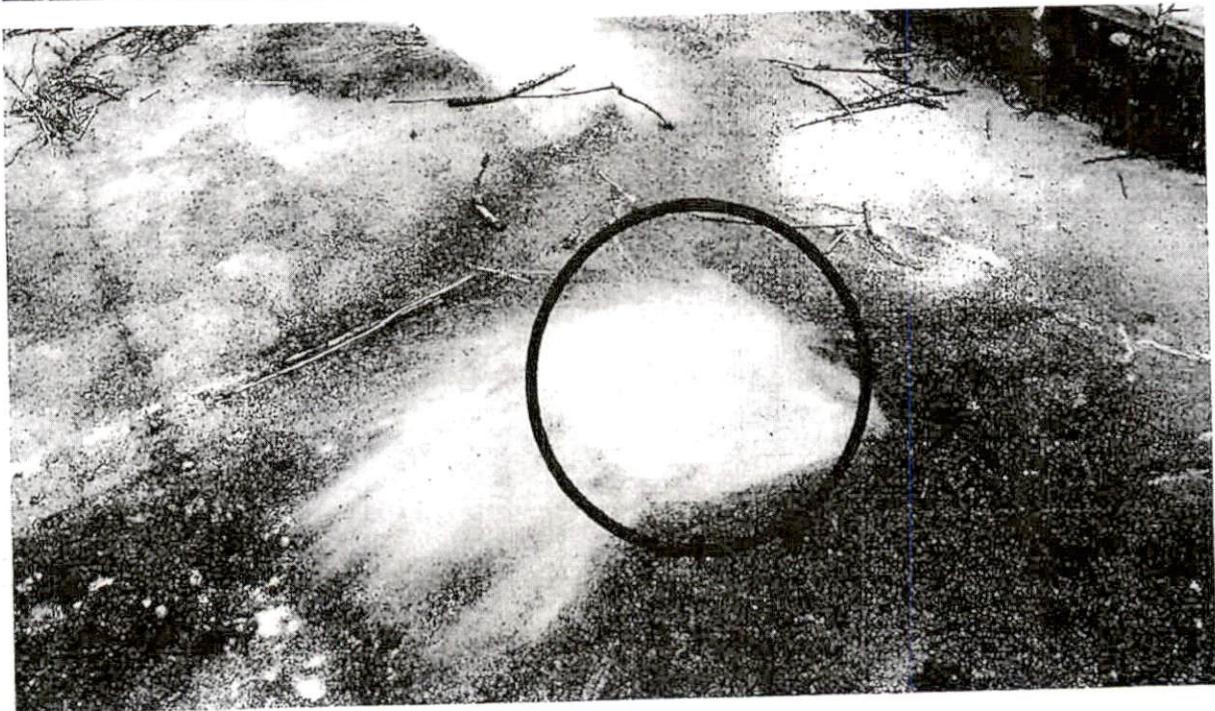
- 2) We visually observed the foundation as consisting of 8" x 16" CMU walls at the interior and exterior and 16" x 16" CMU piers at the porches. The foundation was observed to be supported by concrete footings. The existing foundation was visually observed and inspected for damage as well as subjected to non-destructive (Schmidt rebound hammer) testing at the garage slab. The concrete at the garage slab was found to equal or be in excess of the minimum 2500 psi compressive strength required by the 2018 North Carolina Residential Building Code. Based on our observations, analysis, and the results of our field-testing, the existing foundation is to be repaired/enhanced per the following:

Example of Schmidt rebound hammer testing at garage slab

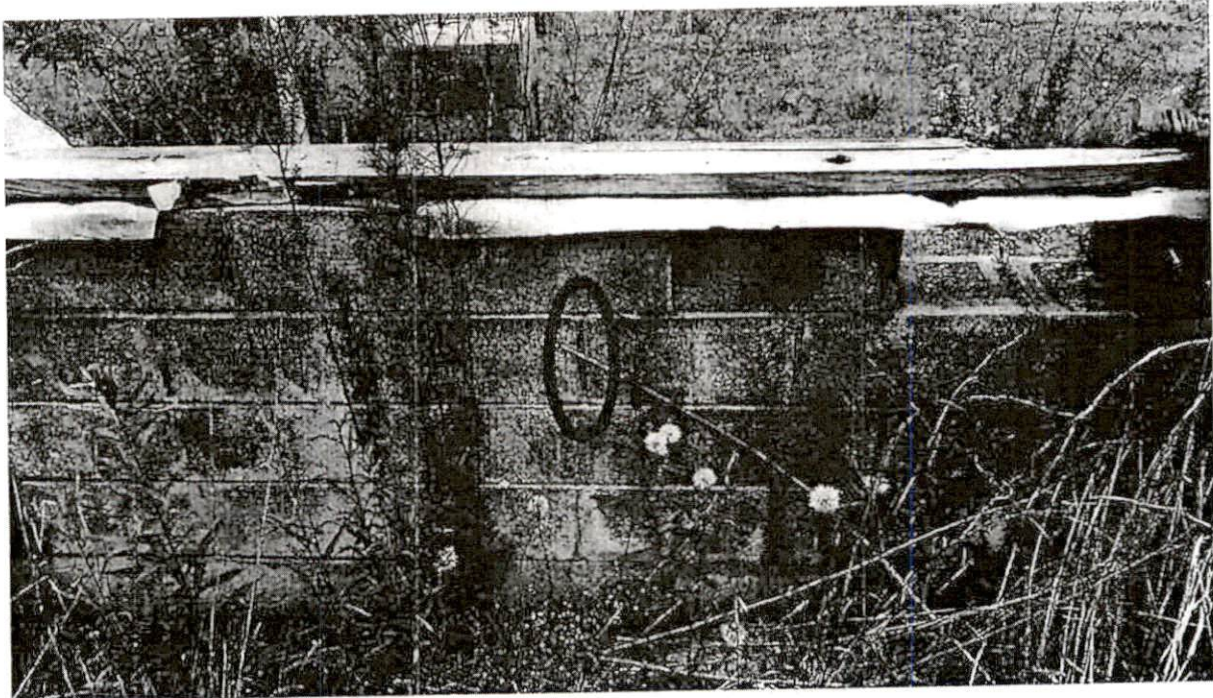
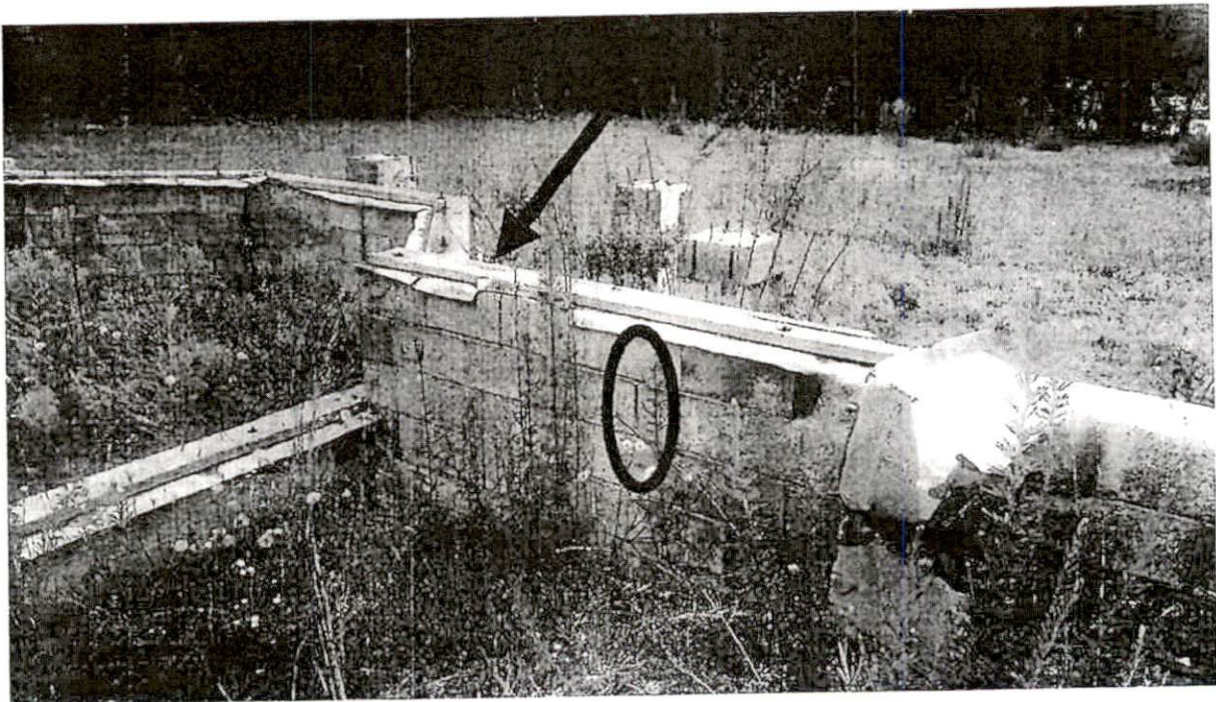
- a. At multiple locations, we observed severe deterioration of the existing mortar joints. Based on our observations and analysis, we recommend the deteriorated mortar joints be removed and repointed with mortar as needed.

Items 2a and 2c) Examples of deteriorated mortar joints and sill plates to be replaced

- c. We also recommend the remaining sill plates be removed and replaced with new pressure treated 2 x 8 sill plates. New sill plates are to be installed so that the existing anchor bolts are within 1'-0" of plate splices. If this cannot be achieved, or the existing anchor bolts are damaged during removal, the sill plate may be fastened to the existing foundation with 1/2" x 8" Simpson Titen HD screws or 1/2" x 12" threaded rods with nuts and washers. The rods are to be embedded a minimum 10" into the turned down footing with Hilti HIT-HY 200 Epoxy per the manufacturer's specifications. Screws and/or rods are to be installed with spacing no greater than 6'-0" o.c. and within 12" of plate splices.

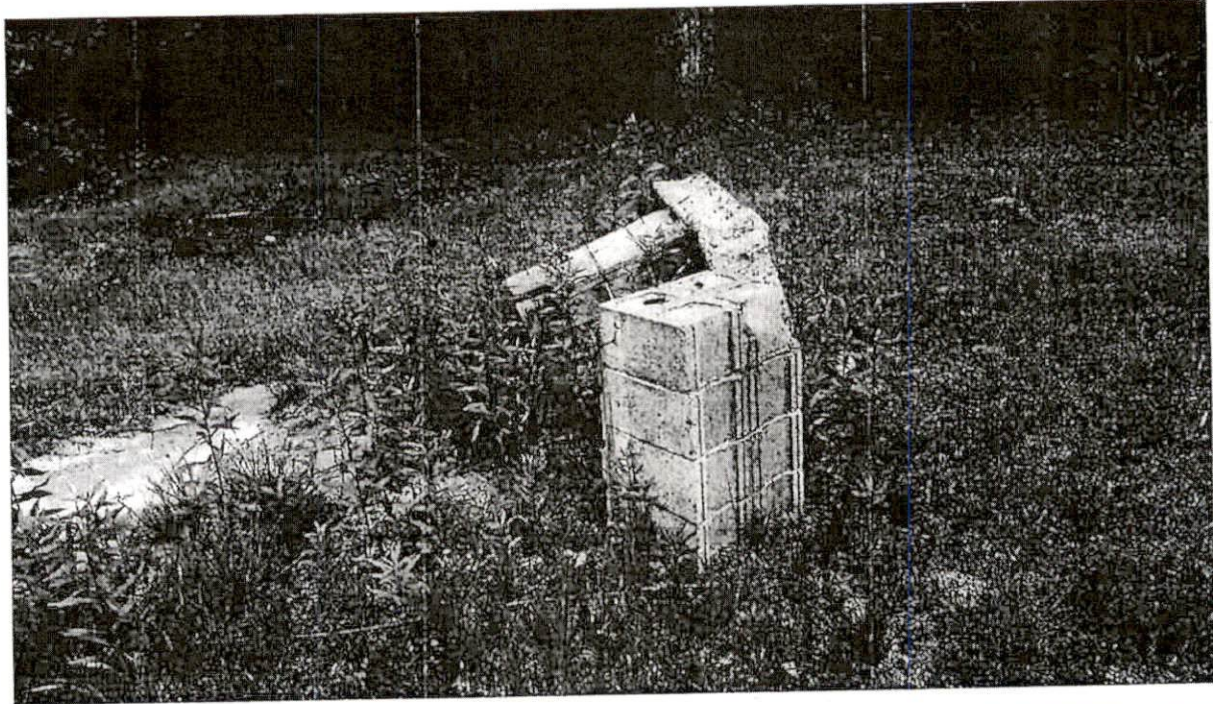
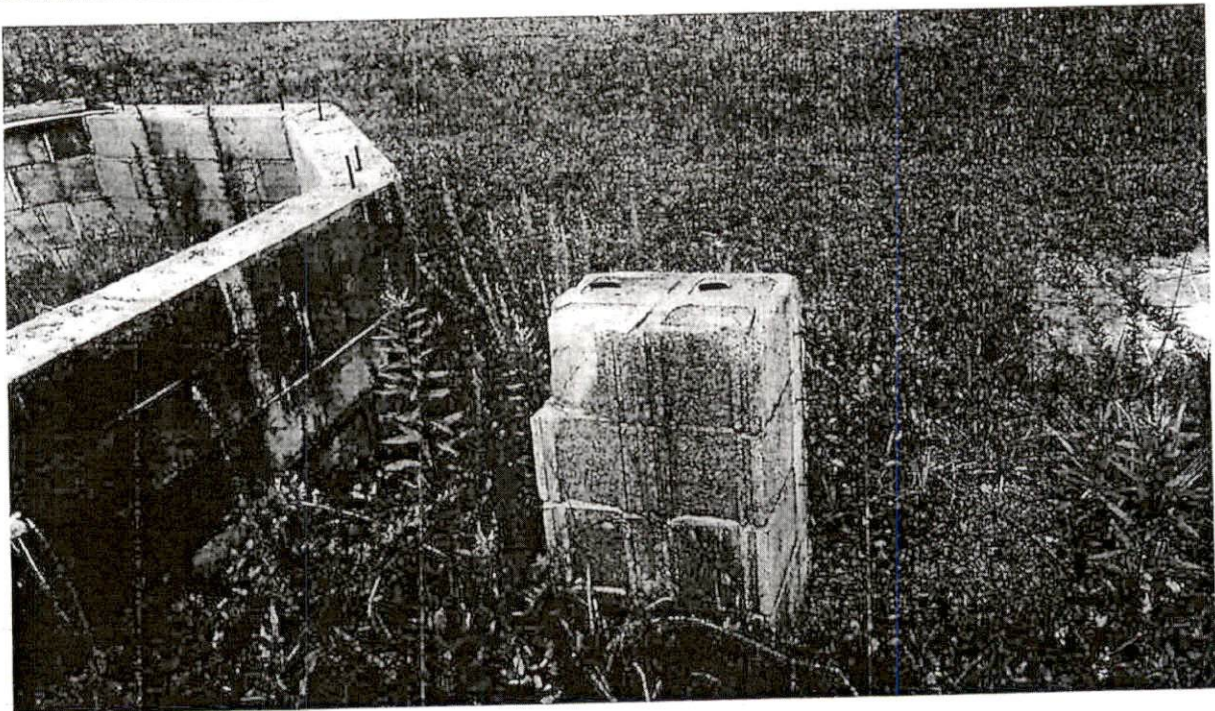
- b. At the front porch piers, we observed several piers as being damaged at the top course. Based on our observations and analysis, we recommend the damaged piers be repaired as needed by removing the topmost course and replacing it with new 16" x 16" CMU blocks.

Item 2b) Examples of damaged piers to be repaired
