Description: Joist 12(i14815)
 Loading: See attached BC Calc® Design Report
 Address: 202 Paper Birch Way
 City, St: Fuquay-Varina, NC
 Retailer: 84 Lumber
 Date: 2/24/25

Single 14" BCI® 6000s-1.8

BASE 2\Floor Joists\12(i14815) (Joist)

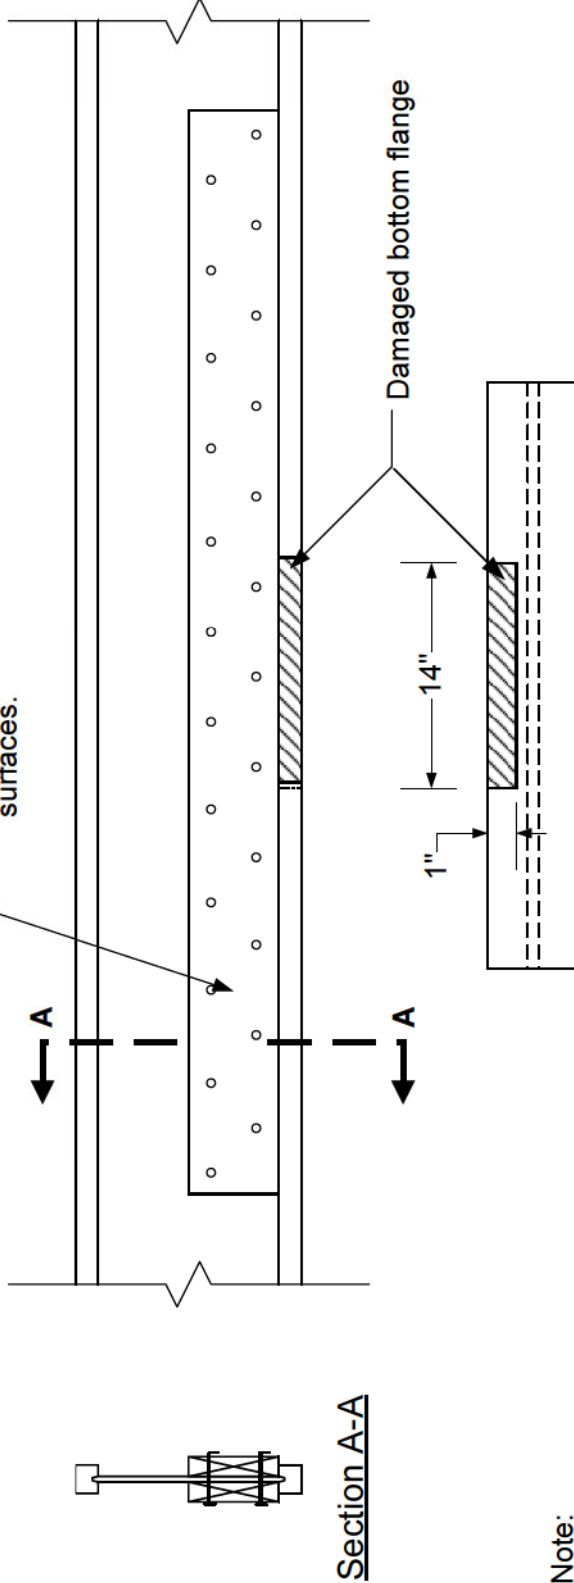
Section A-A

14"w x 1"d damage to side of bottom flange

2x6 SPF #2 or better 6'-0" long, centered @ damaged area, both sides of joist web. Install flush to top of bottom flange. Attach with 2 rows 10d nails or #8 x 2 1/4" wood screws @ 3" o.c., staggered. Use structural adhesive at all contact surfaces.

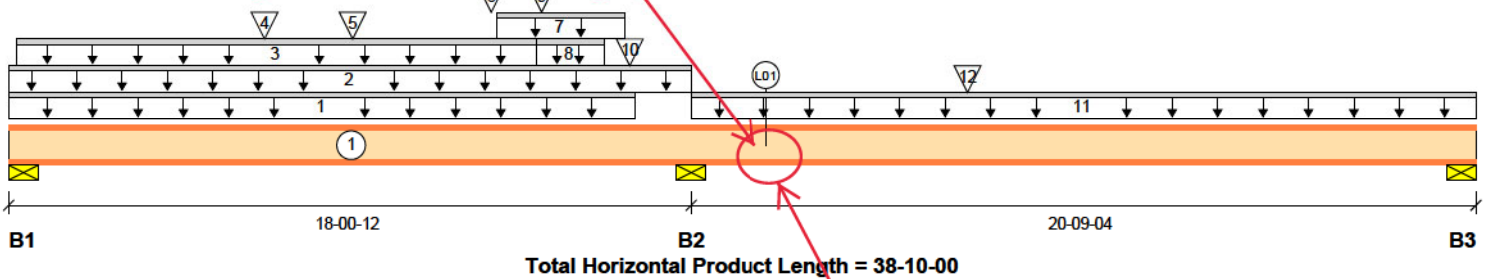
Tag	Description	Location	Pos. Mom. (ft-lbs)	Neg. Mom. (ft-lbs)	Shear (lbs)	Total Defl. (in)	Live Defl. (in)
L01	damage	20-00-12	0(NA)	-2759(1)	934(1)	-0.077(3)	-0.077(8)
